Gilbert Bain Hospital Phase 1 Construction

Report on Condition of External Walls

December 2024

Document reference: 100106891NH03 | 01 | A |

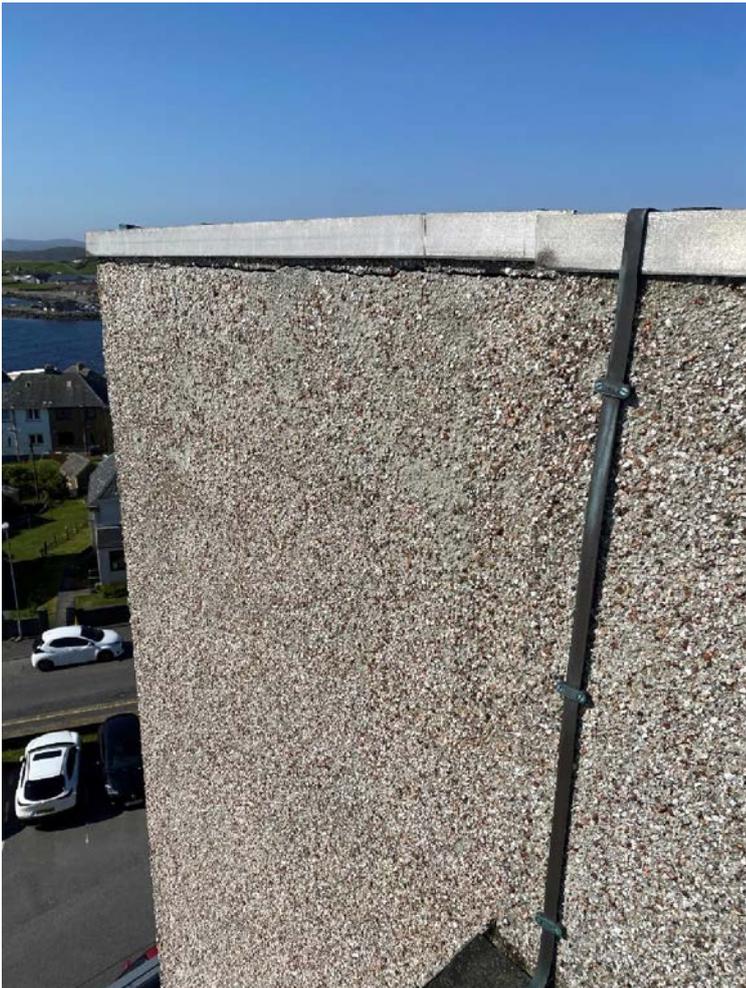
A typical 3 to 5mm wide crack below the coping had been chased out to allow inspection of the construction at the coping. This included a precast or insitu concrete coping on 30mm of soft mortar on DPC. The crack at the wall head coincided with the DPC location.

Figure 2.2: Cracking along the east wall head of the lift motor room

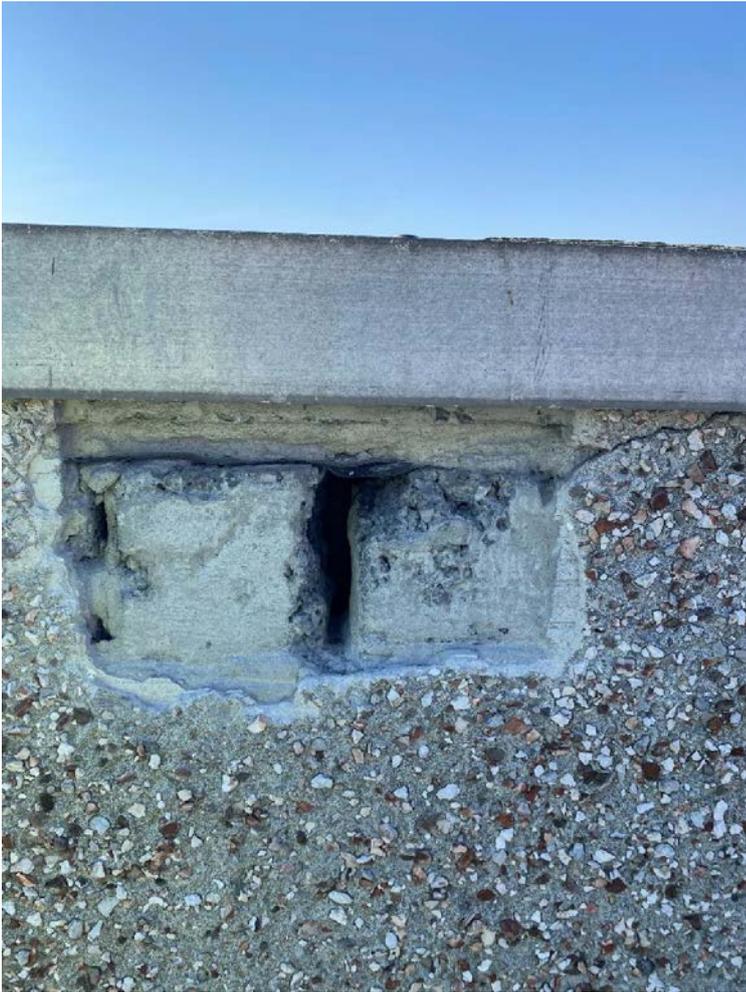
Figure 2.3: Construction at the coping

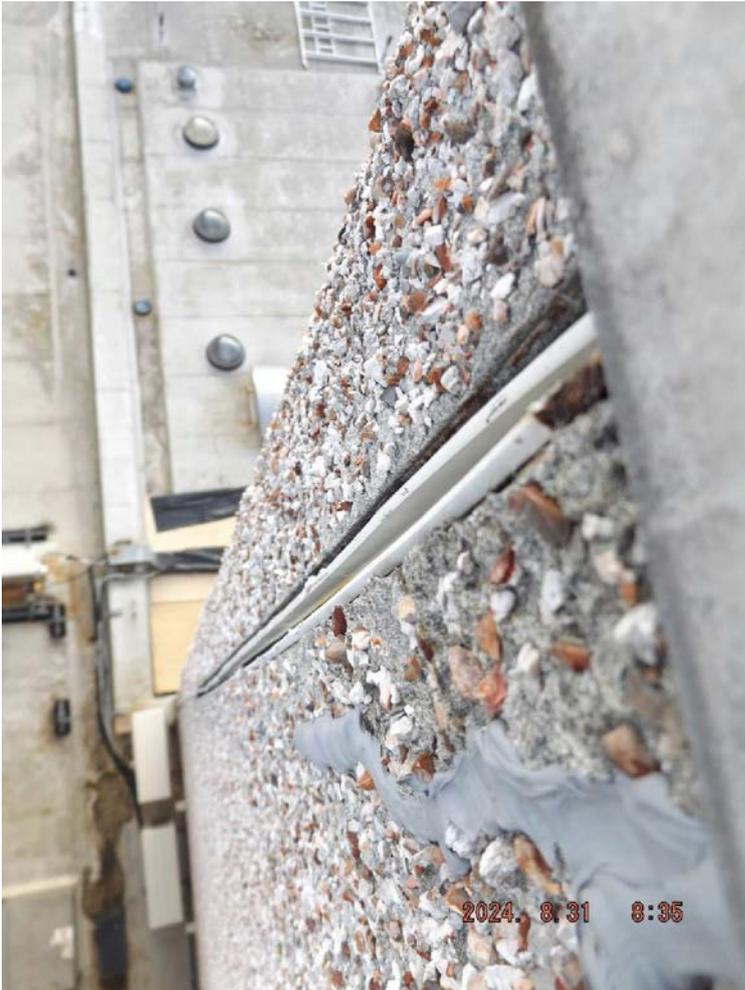
Figure 2.4: Outward lean of the east elevation wall from roof level

In addition to the east wall head projecting outward by approx. 20mm as noted in Section 2.1 above the north elevation wall was also seen to be leaning outward by approx. 10mm at the wall head at the north-east corner of the 4 Storey block. Photographs of horizontal cracking at parapet level are included in Figures 2.5 to 2.8, with Figures 2.5 and 2.6 showing cracking at the south elevation and Figures 2.7 and 2.8 showing cracking at the east elevation.

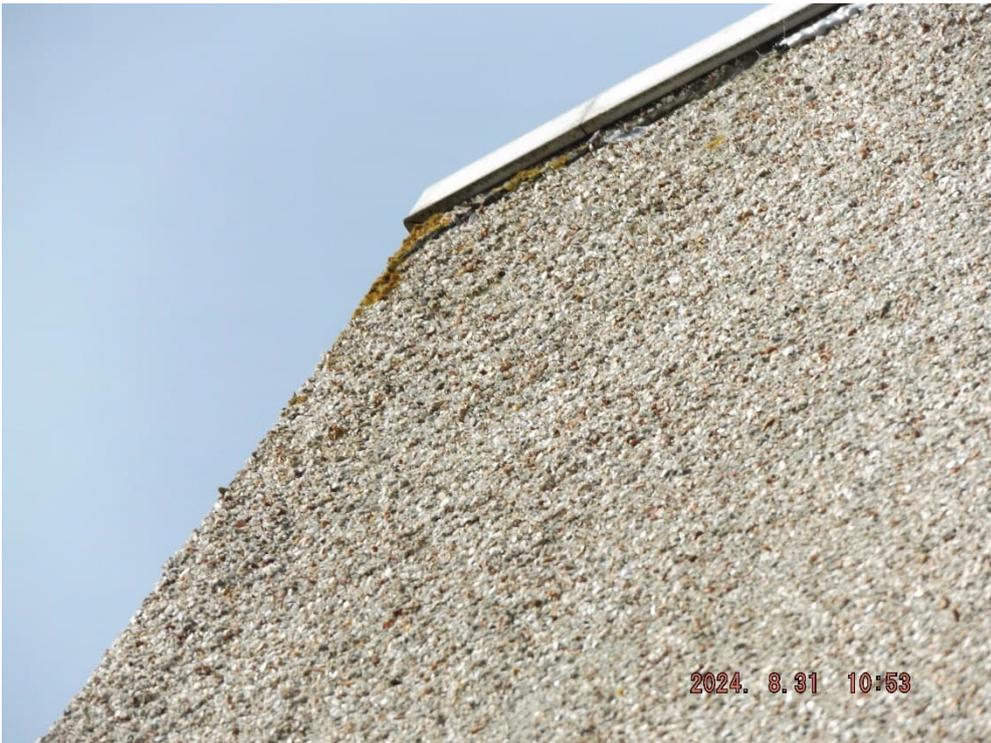
Figure 2.5: Cracking at south elevation

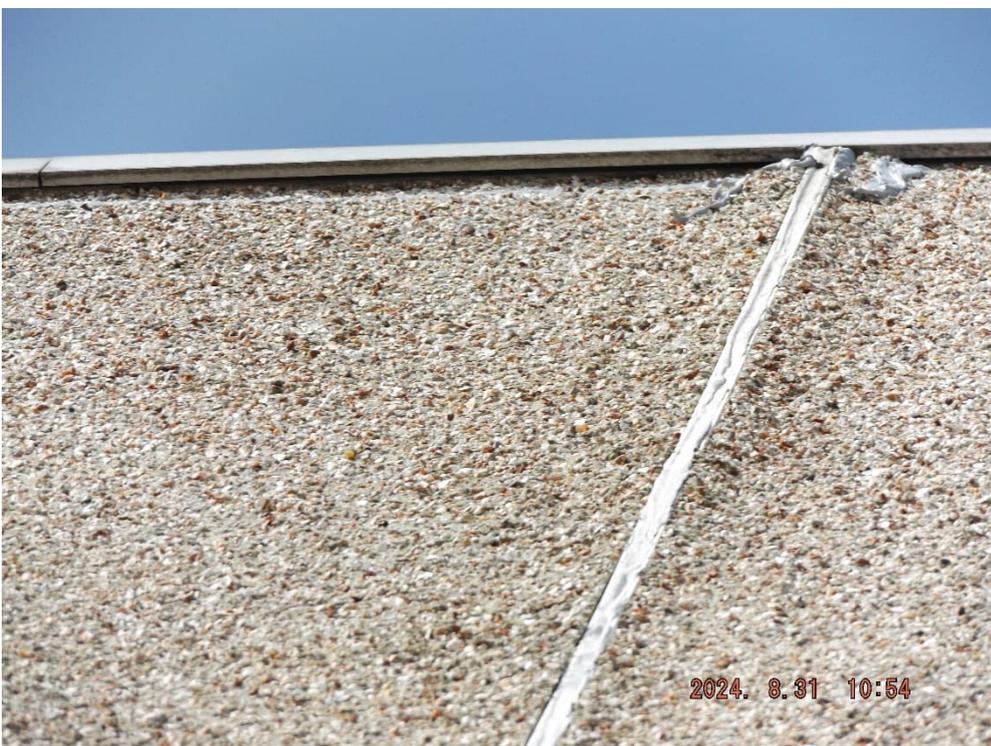
Figure 2.6: Cracking at south elevation

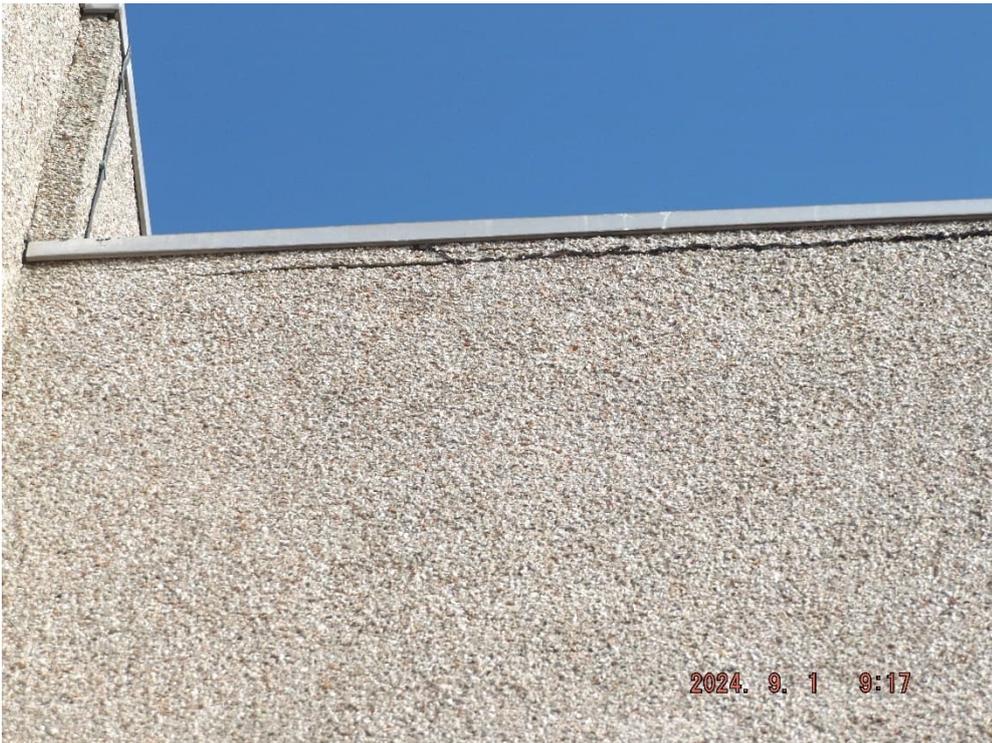
Figure 2.7: Cracking at the east elevation

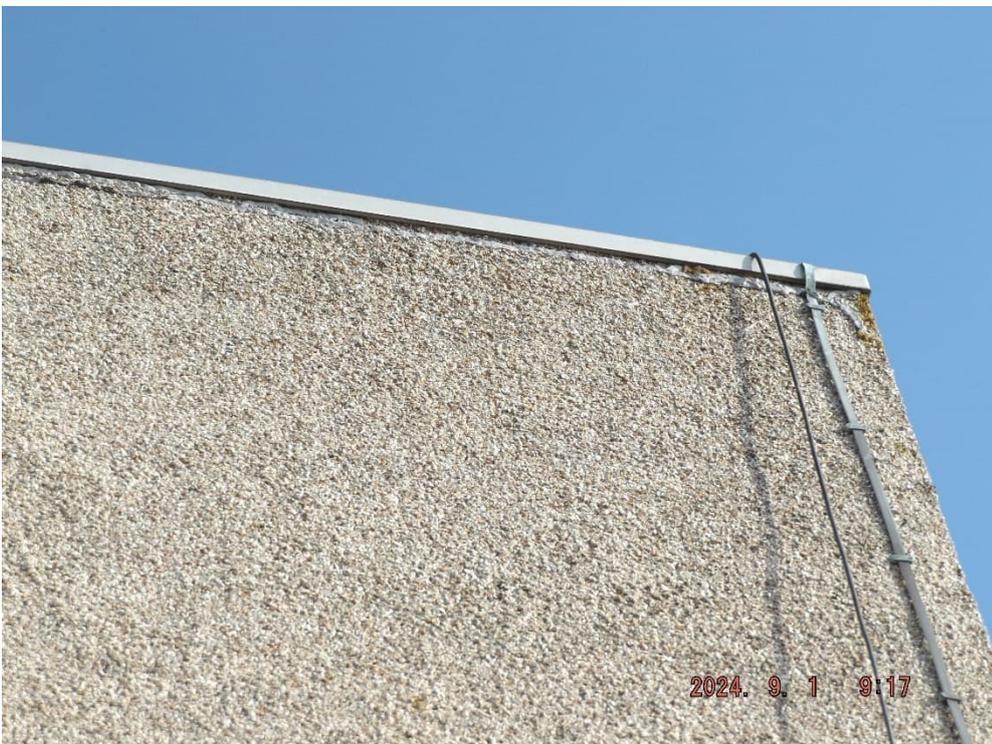
Figure 2.8: Cracking at the east elevation

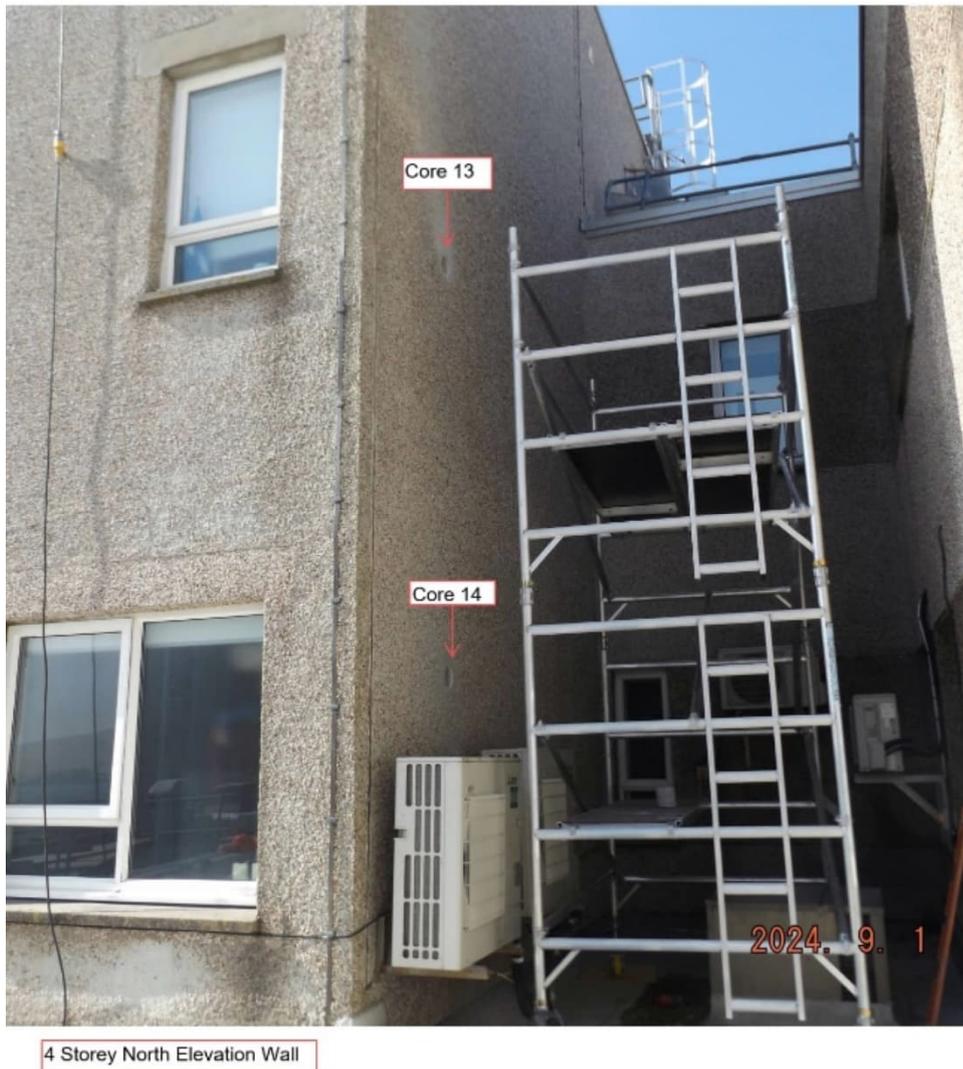
Figure 2.9: 2 no cores at the 4 Storey north elevation wall

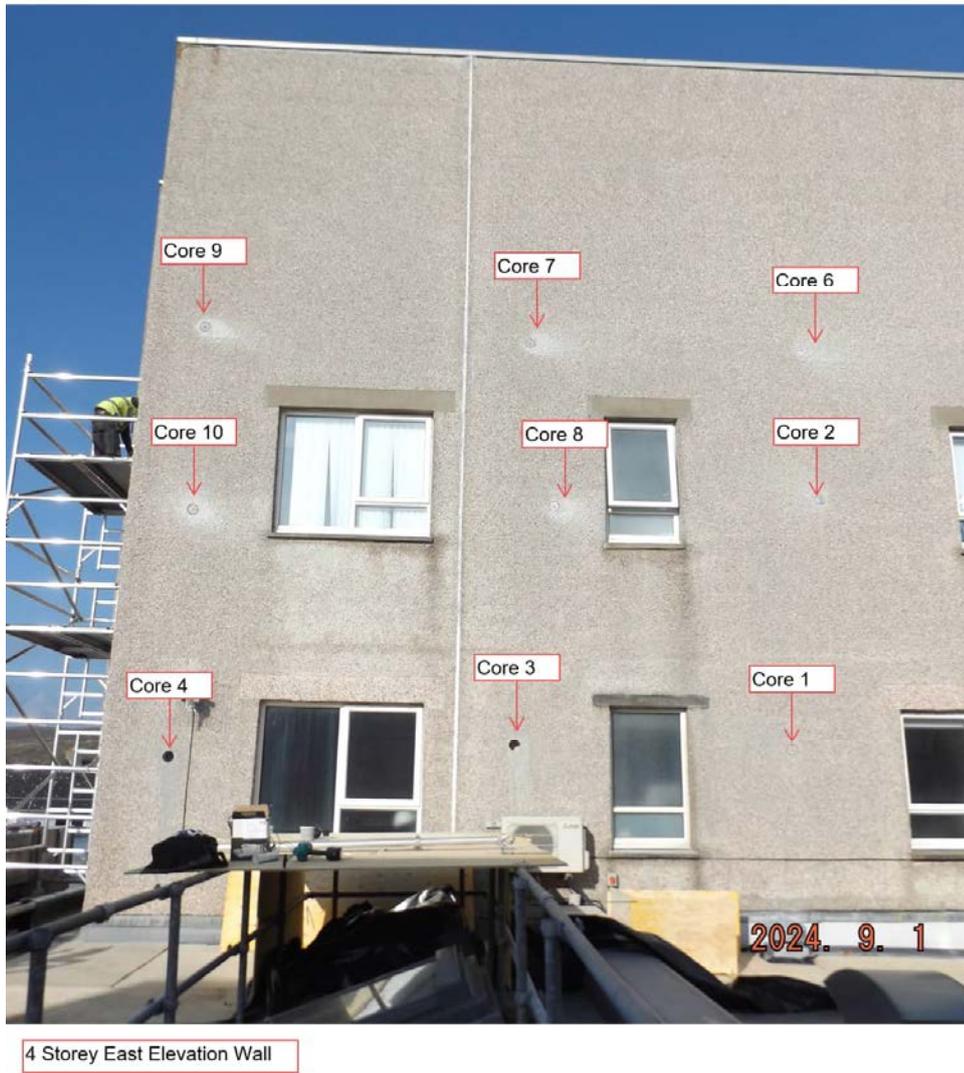
Figure 2.10: 9 no cores at the 4 Storey east elevation wall

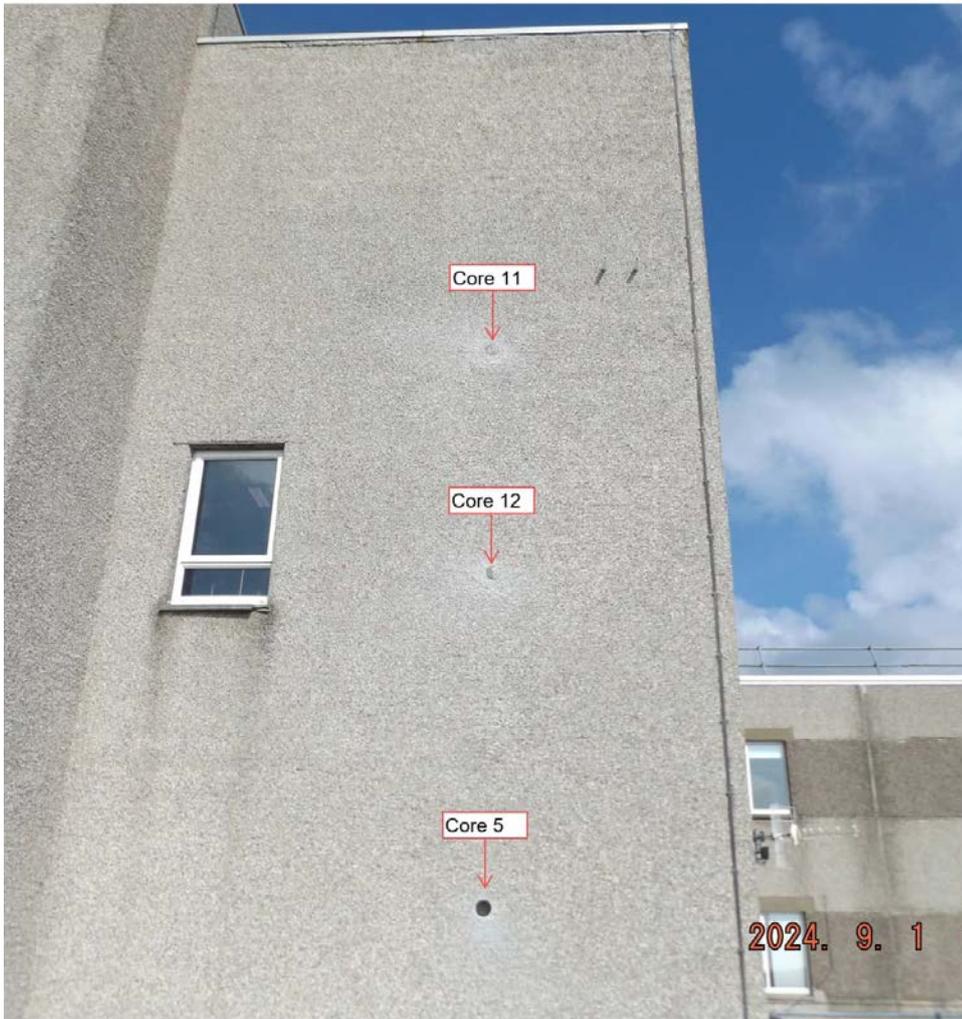
4 Storey South Elevation Wall

Figure 2.11: 3 no cores at the 4 Storey south elevation wall

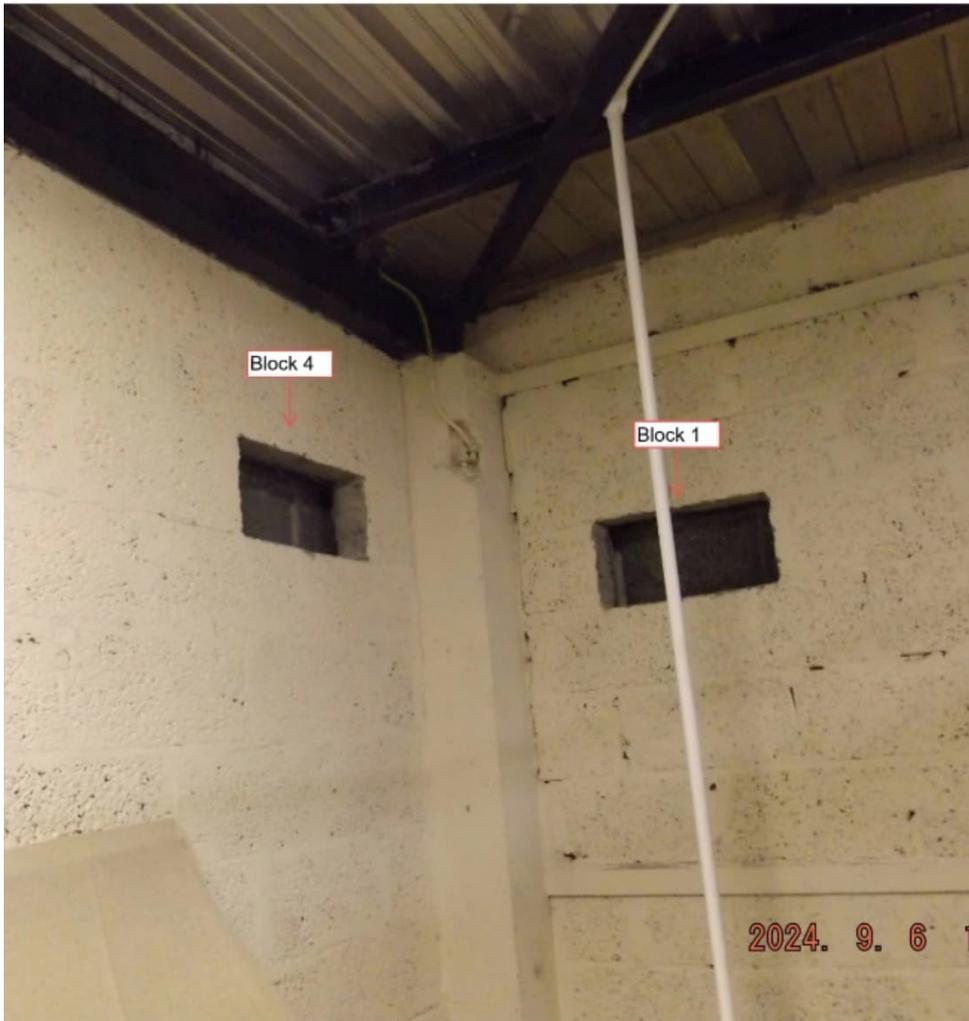
Water Tank Room NE corner

Figure 2.12: Blocks removed at NE corner of Water Tank Room

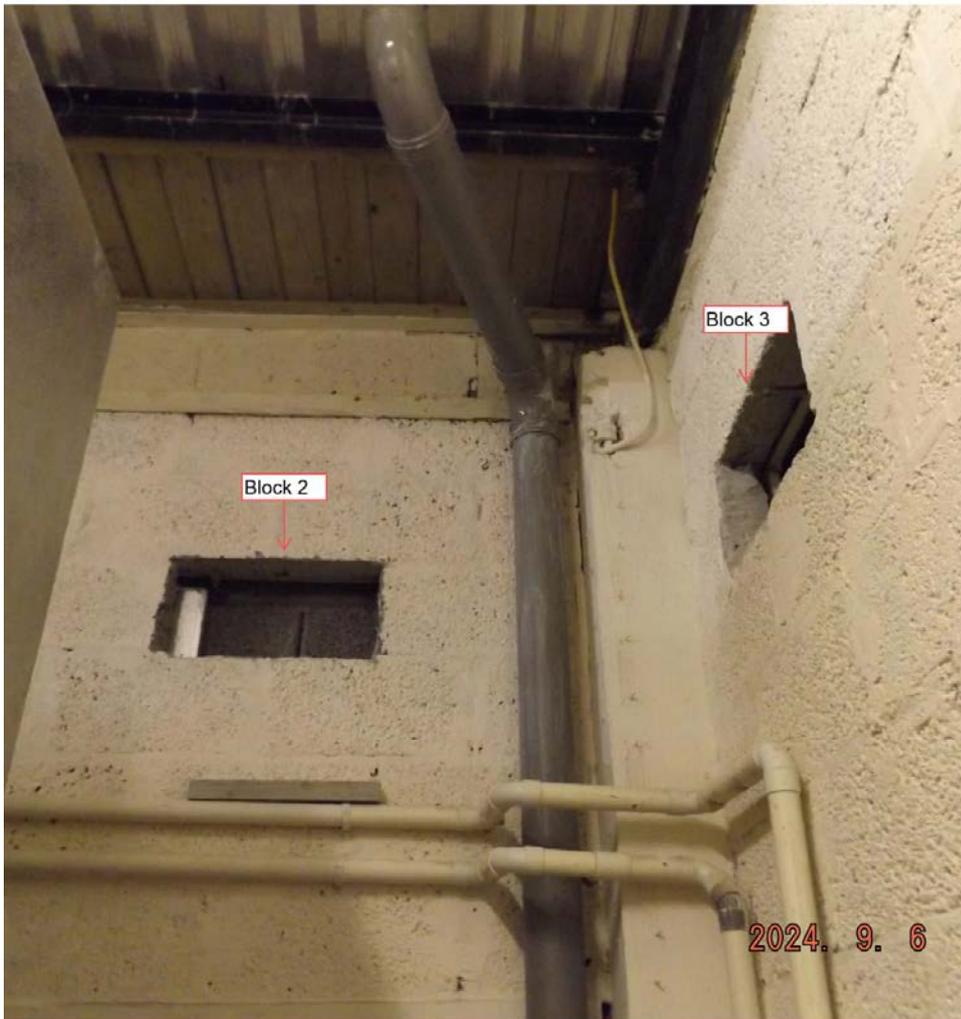
Water Tank Room SE corner

Figure 2.13: Blocks removed at SE corner of Water Tank Room

Wall ties were seen to be loose at the south-east corner of the water tank room and it is possible that under high wind suction loading the outer leaf could have displaced relative to the inner leaf with the wall ties sliding in the mortar beds. The mortar test report confirms that the original mix of the mortar included designation (iv), which is equivalent to 2N/mm² compressive strength at 28 days. This is an unusually weak mix and it is compounded by the high amount of voids found in the samples giving a very weak and friable mortar over most of the 4 Storey

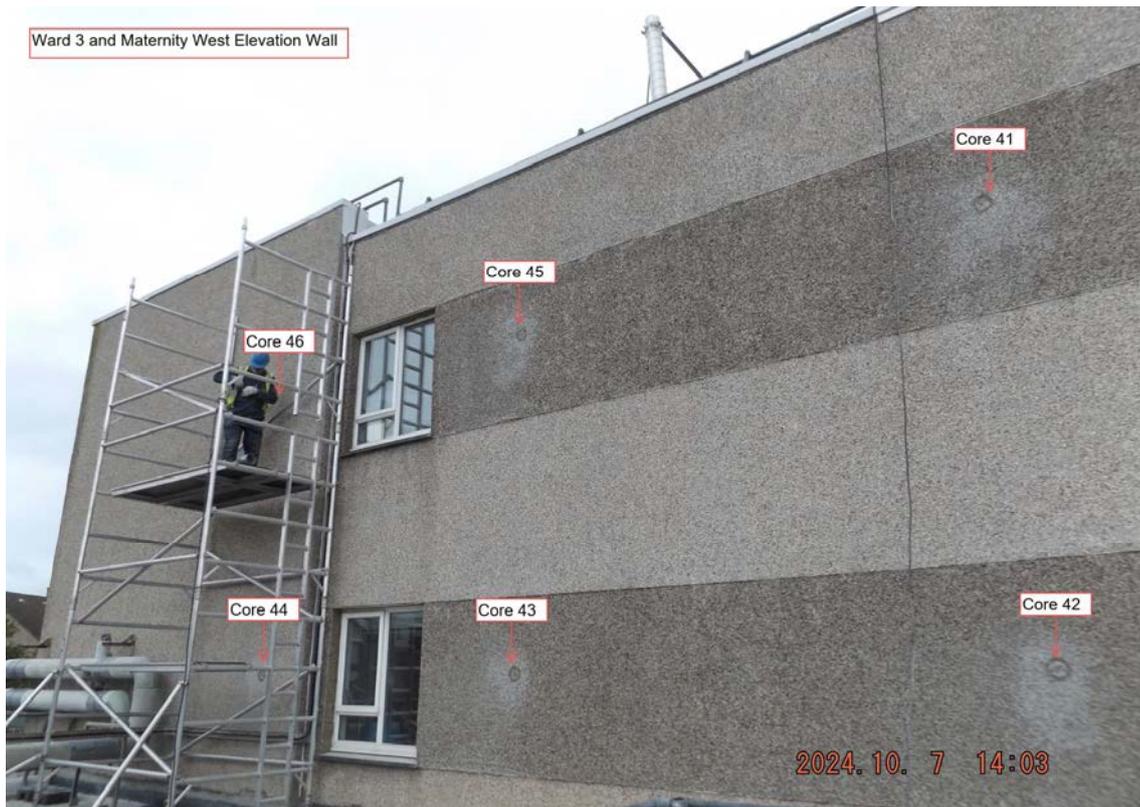
100mm diameter cores were removed from the west elevation of the 3 Storey building including Ward 3 at the top floor and Maternity on the first floor. The core locations are included in Figure 2.20. Sample photographs of extracted cores, the exposed cavity and wall ties located with an endoscope inspection are included in Appendix G. Notes of key findings at each core location are also included in Appendix G. The core inspections confirmed that the outer leaf was of good quality dense concrete blocks with some poor and generally more reasonable mortar jointing. Wall ties were present in the cavity but were difficult to locate due to the narrow cavity and significant amount of mortar droppings in the cavity. The wall ties were of the vertical twist type and where they could be inspected closely appeared to be in good condition.

Figure 2.20: Cores at the west elevation of Ward 3 and Maternity

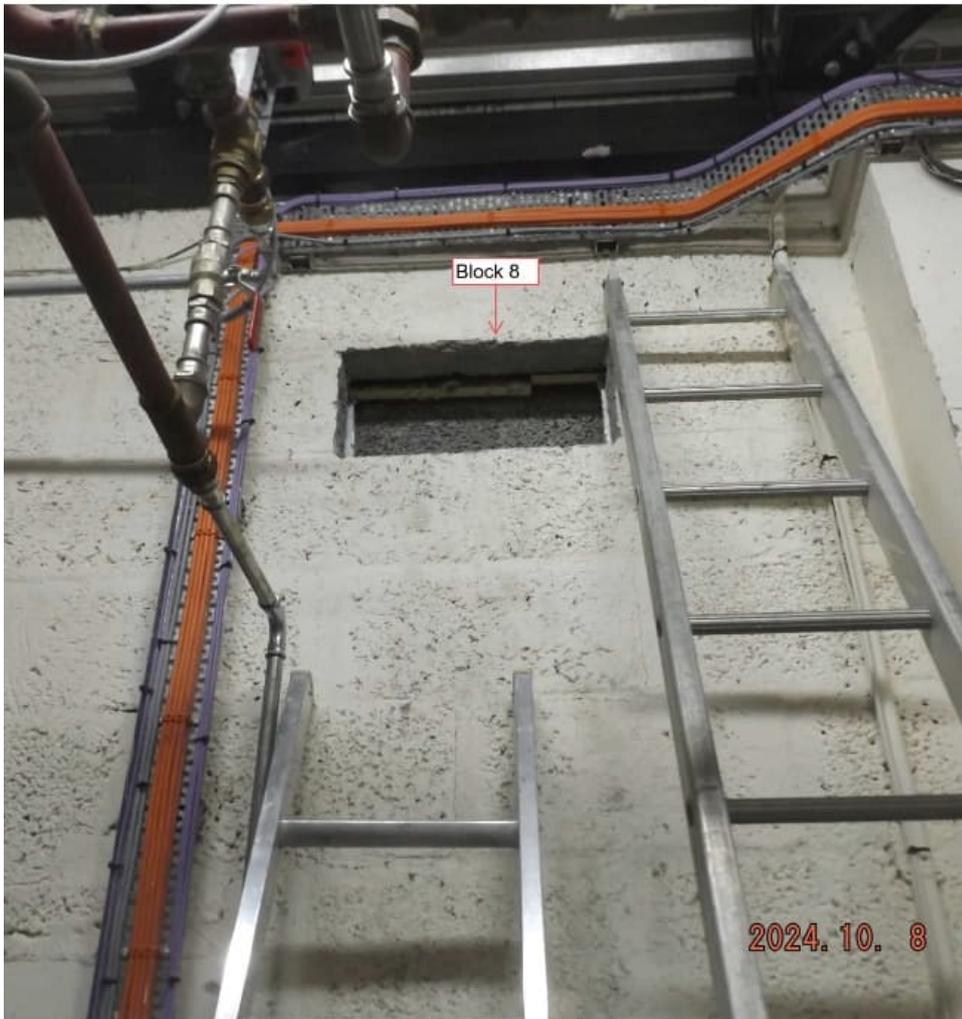
Plant Room north wall

Figure 2.21: Block removed at north wall of Plant Room

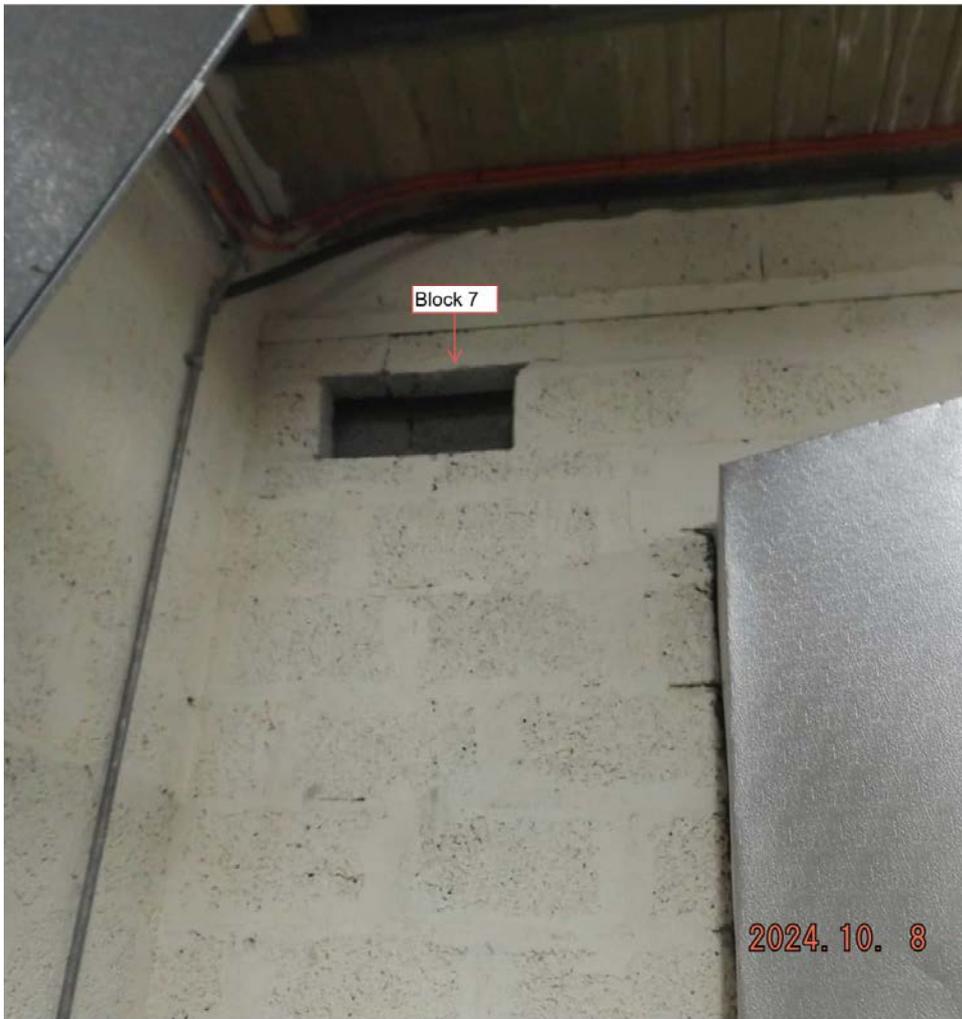
Plant Room west wall

Figure 2.22: Block removed at west wall of Plant Room

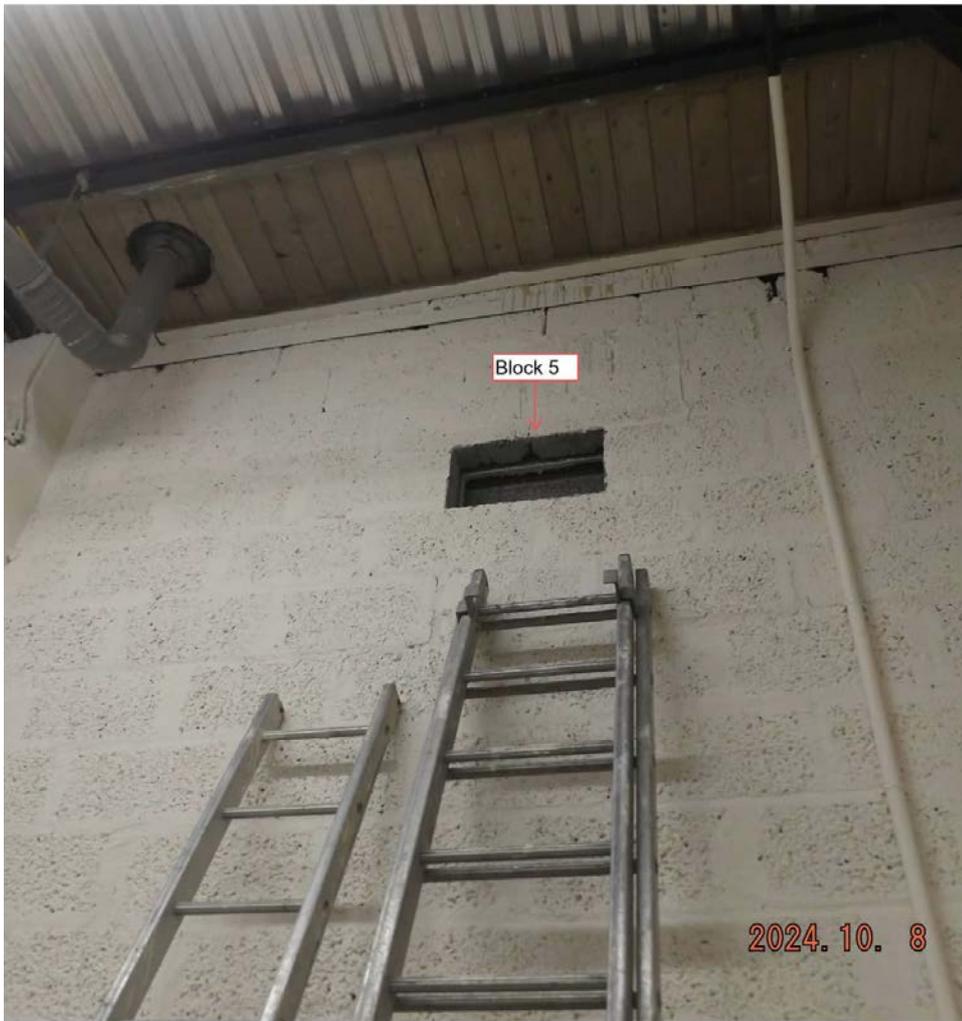
Lift Motor Room west wall

Figure 2.23: Block removed at west wall of Lift Motor Room

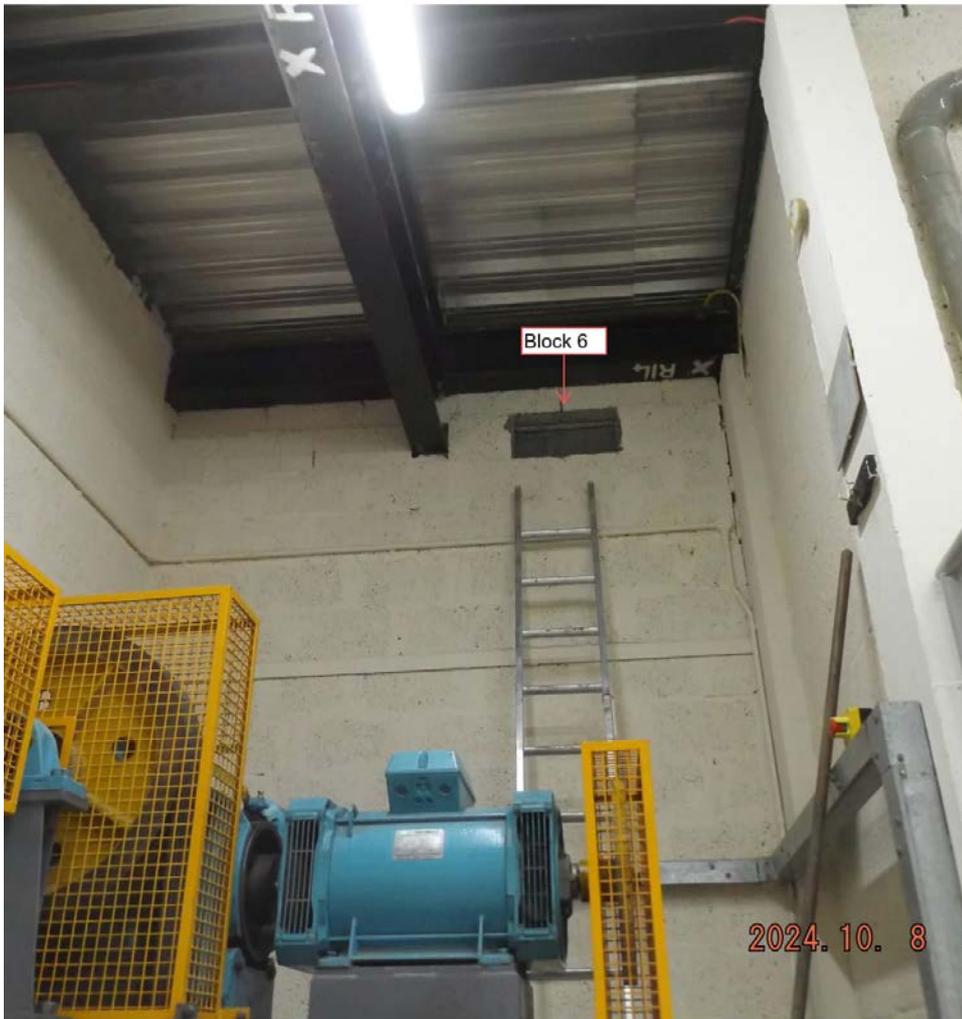
Lift Motor Room south wall

Figure 2.24: Block removed at south wall of Lift Motor Room

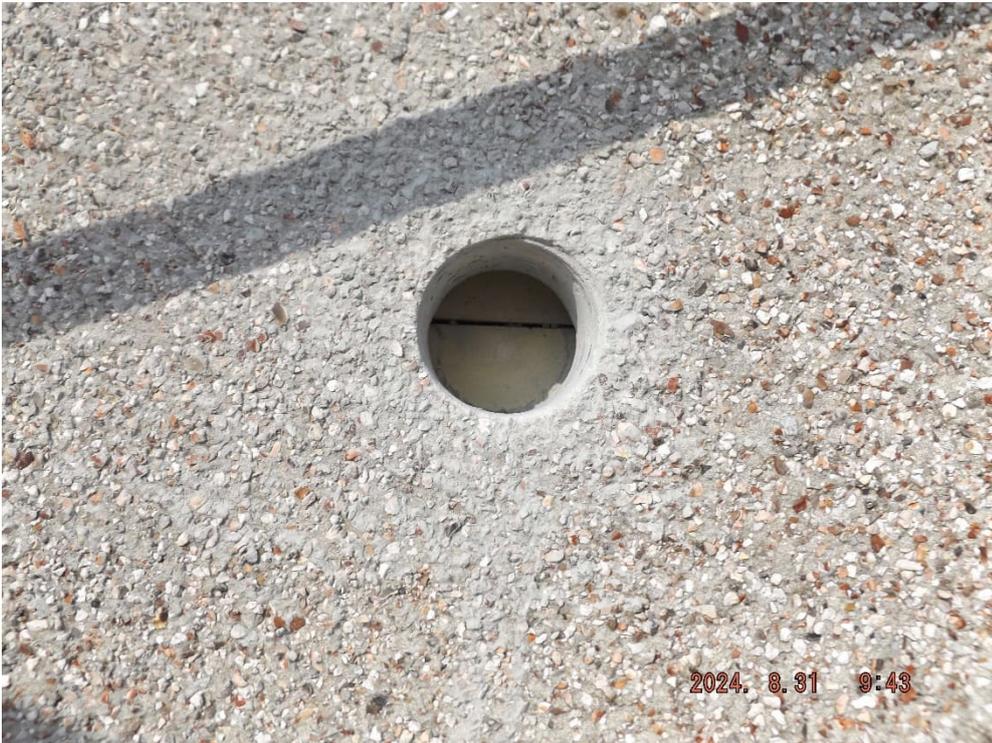
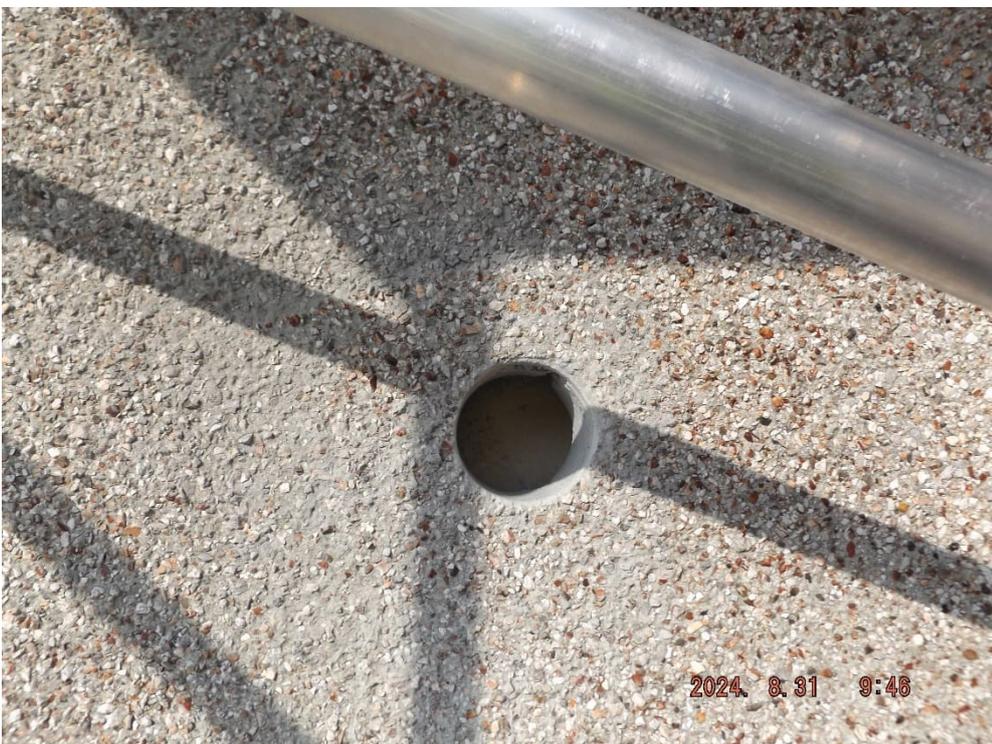
Cores 1 and 2

Core reference	Block condition	Mortar condition	No of Wall Ties found and condition	Comments
Core 1 (east wall)	100mm thick dense concrete in good condition	Poor – weak and friable	1 no 300mm to right lower of core/covered with mortar	25mm cavity to 25mm insulation board. Lot of mortar droppings in cavity
Core 2 (east wall)	100mm thick dense concrete in good condition	Poor – weak and friable	None	35mm cavity to 25mm insulation board. Lot of mortar droppings in cavity. Mortar sample taken
Core 3 (east wall)	100mm thick dense concrete in good condition	Poor – very weak and friable	1 no 250mm to right upper of core/good	35mm cavity to 25mm insulation board. Lot of mortar droppings in cavity
Core 4 (east wall)	100mm thick dense concrete in good condition	Poor – very weak, friable and damp mortar with void joint 30mm to left of core hole	1 no 250mm to right upper of core/good. 1 no 400mm to left lower of core/covered with mortar	30mm cavity to 25mm insulation board. Lot of mortar droppings in cavity

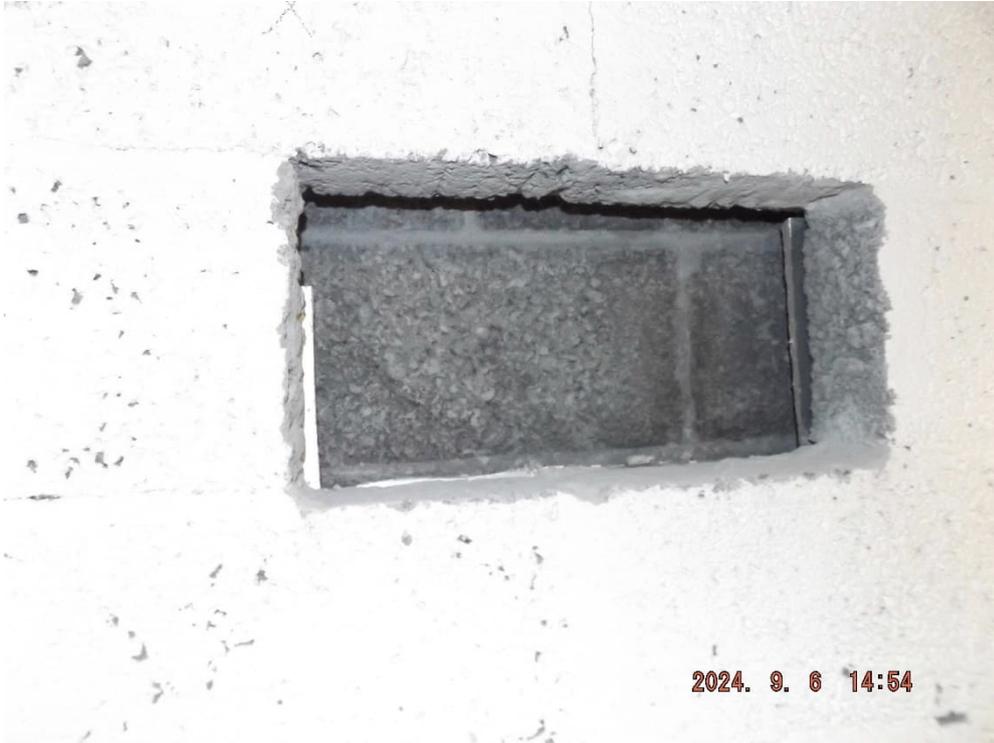
Block reference	Block condition	Mortar condition	No of Wall Ties found and condition	Comments
Block 1 (east wall)	100mm thick dense concrete in good condition	Poor – inner leaf weak and friable; outer leaf very weak and friable	3no to upper, lower and right side of block within 450mm and 2 no adjacent to RC column to left of block/good	105mm cavity overall with 25mm insulation board displaced 20mm off inner leaf wall. Insufficient wall tie embedment in outer leaf.
Block 2 (east wall)	100mm thick dense concrete in good condition	Poor – inner leaf weak and friable; outer leaf very weak and friable	4no to top of block, upper right, lower left and lower right side of block within 900mm/good	90mm cavity overall with 25mm insulation board displaced 20mm off inner leaf wall. Wall tie at top of block slightly loose. Insufficient wall tie embedment in outer leaf.
Block 3 (south wall)	100mm thick dense concrete in good condition	Poor – inner leaf very weak and friable; outer leaf very weak and friable	4no to top of block, upper, upper right and lower right side of block within 450mm and 2 no adjacent to RC column to left of block/good	95mm cavity overall with 25mm insulation board displaced 20mm off inner leaf wall. Wall tie at top of block loose. Insufficient wall tie embedment in outer leaf. Mortar sample taken

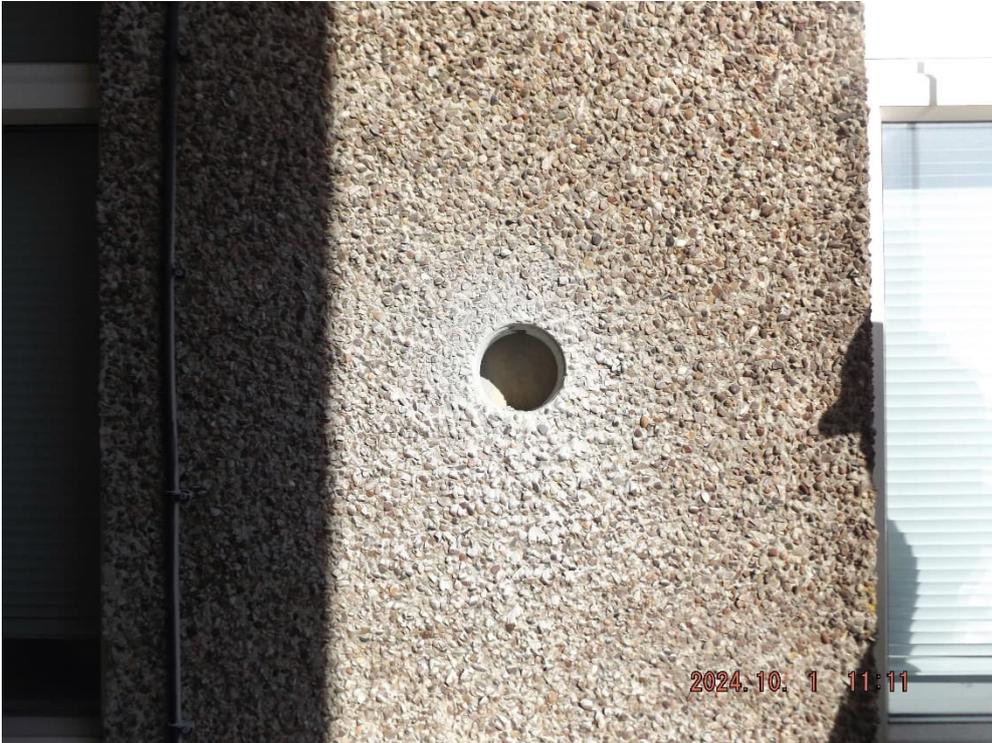
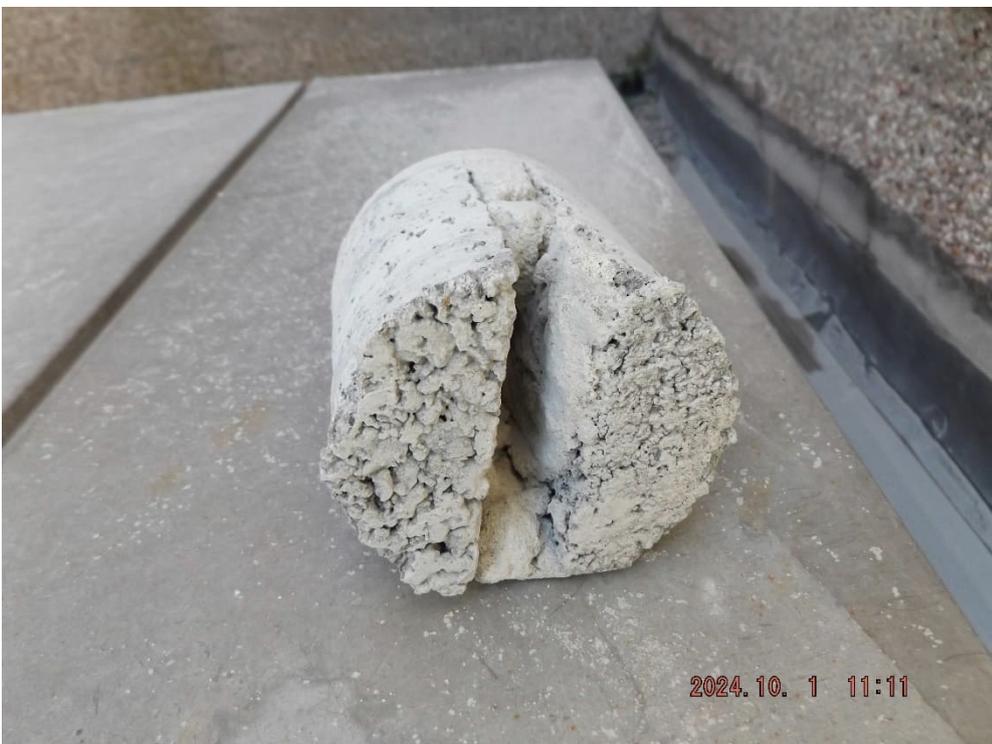
Core reference	Block condition	Mortar condition	No of Wall Ties found and condition	Comments
Core 15	100mm thick dense concrete in good condition	Poor – satisfactory strength but 50% voided joint at core	Suspected ties 300mm and 1200mm above and 600mm below core/covered with mortar	20mm cavity to 25mm insulation board. Lot of mortar droppings in cavity
Core 16	100mm thick dense concrete in good condition	Poor – weak and friable	1no 1200mm to right of core/good. 2no suspected 450mm below and 900mm to left lower of core/covered with mortar	20mm cavity to 25mm insulation board. Lot of mortar droppings in cavity
Core 17	100mm thick dense concrete in good condition	Reasonable – strength of mortar satisfactory	1 no at core/good. 2no suspected 600mm above and 600mm to left lower of core/covered with mortar	25mm cavity to 25mm insulation board. Lot of mortar droppings in cavity
Core 18	100mm thick dense concrete in good condition	Reasonable – strength of mortar satisfactory	3no suspected 900mm to left, 600mm to left upper and 600mm to left lower of core/covered with mortar	20mm cavity to 25mm insulation board. Lot of mortar droppings in cavity

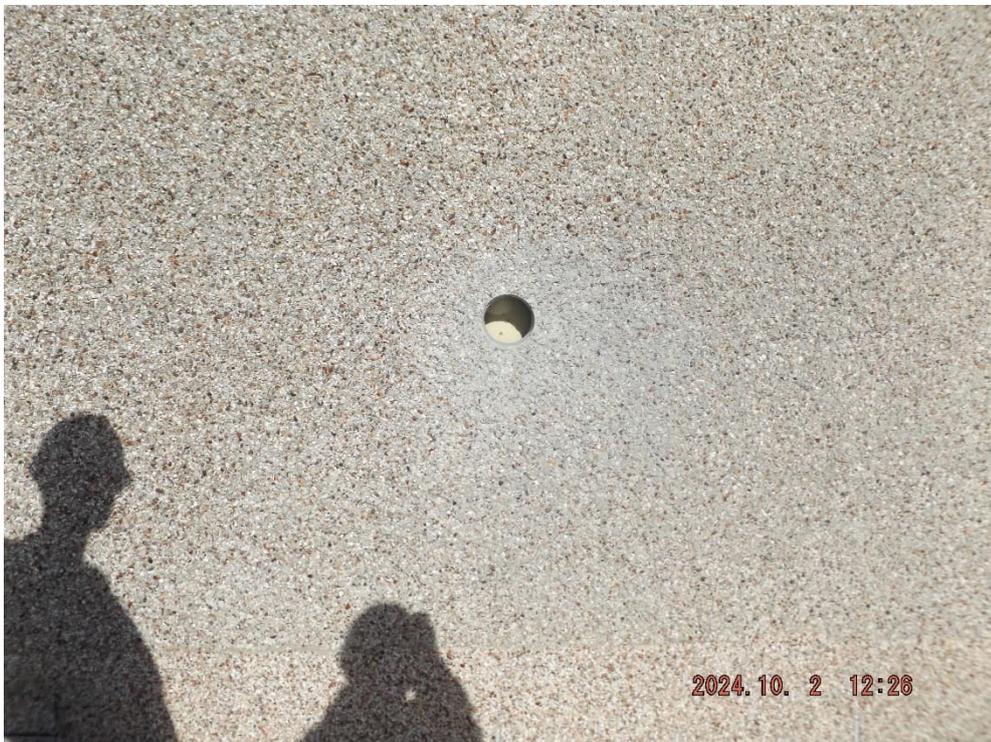
Core reference	Block condition	Mortar condition	No of Wall Ties found and condition	Comments
Core 21 (south wall)	100mm thick dense concrete in good condition	Reasonable - mortar satisfactory	2no 600mm above core and 450mm to right of core /good. 1no 1200mm below core/covered with mortar	30mm cavity to 25mm insulation board. Lot of mortar droppings in cavity
Core 22 (south wall)	100mm thick dense concrete in good condition	Poor – weak and friable	1no 300mm to right upper of core/good. 1no 900mm below core/covered with mortar	25mm cavity to 25mm insulation board. Lot of mortar droppings in cavity.
Core 23 (south wall)	100mm thick dense concrete in good condition	Poor – weak and friable	3 no 250mm to left upper of core, 1200mm to right lower of core and 900mm below core/covered in mortar	30mm cavity to 25mm insulation board. Lot of mortar droppings in cavity
Core 24 (south wall)	100mm thick dense concrete in good condition	Poor - weak and friable	2 no 600mm to right upper of core and at core/covered with mortar. 1 no 900mm to right of core/good	35mm cavity to 25mm insulation board. Lot of mortar droppings in cavity

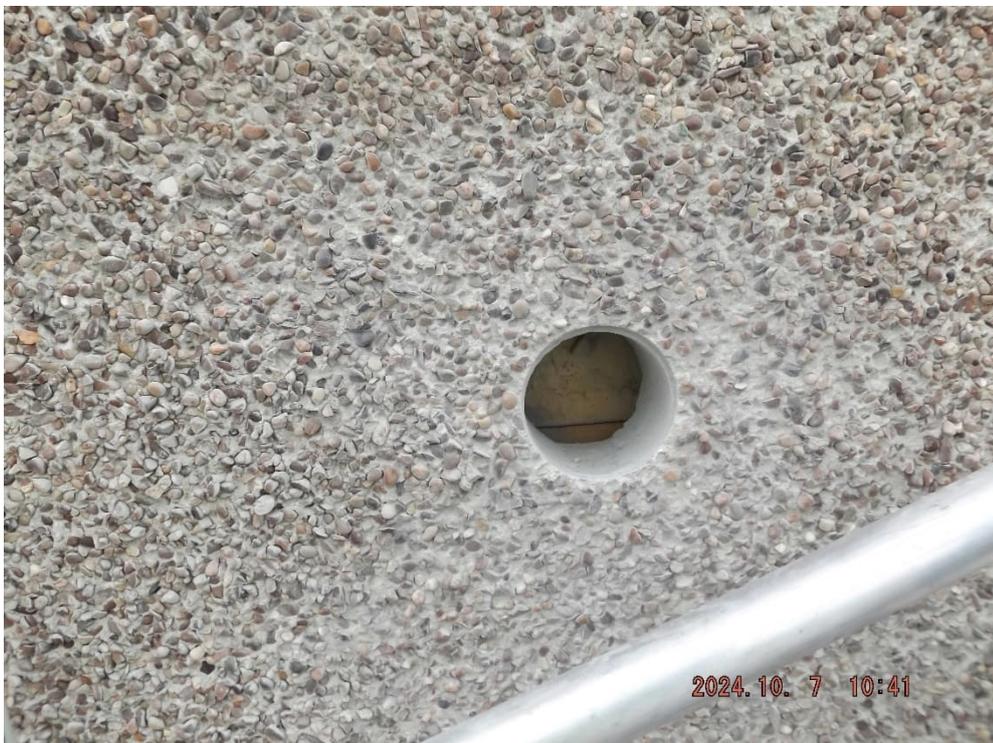
Core reference	Block condition	Mortar condition	No of Wall Ties found and condition	Comments
Core 41 (west wall)	100mm thick dense concrete in good condition	Reasonable – strength adequate	2 no 150mm to left lower and 1200mm to right upper of core /good. 1 no 1350mm to left upper of core/covered with mortar	40mm cavity to 25mm insulation board. Lot of mortar droppings in cavity
Core 42 (west wall)	100mm thick dense concrete in good condition	Poor – weak and friable	1no 250mm to left of core/good. 1no 650mm to right of core/covered with mortar	25mm cavity to 25mm insulation board. Lot of mortar droppings in cavity.
Core 43 (west wall)	100mm thick dense concrete	Poor – very weak and friable. 50%	1no 750mm to right upper of core/good. 1no	30mm cavity to 25mm insulation
