Gilbert Bain Hospital Phase 1 Construction

Report on Condition of External Walls

December 2024

Document reference: 100106891NH03 | 01 | A |

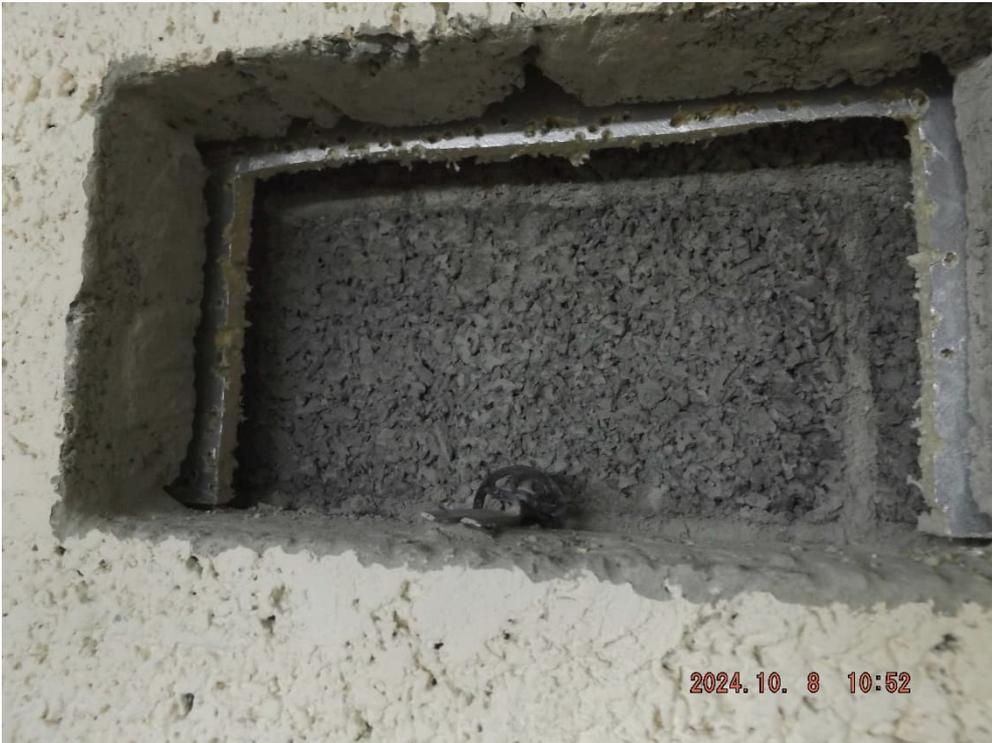
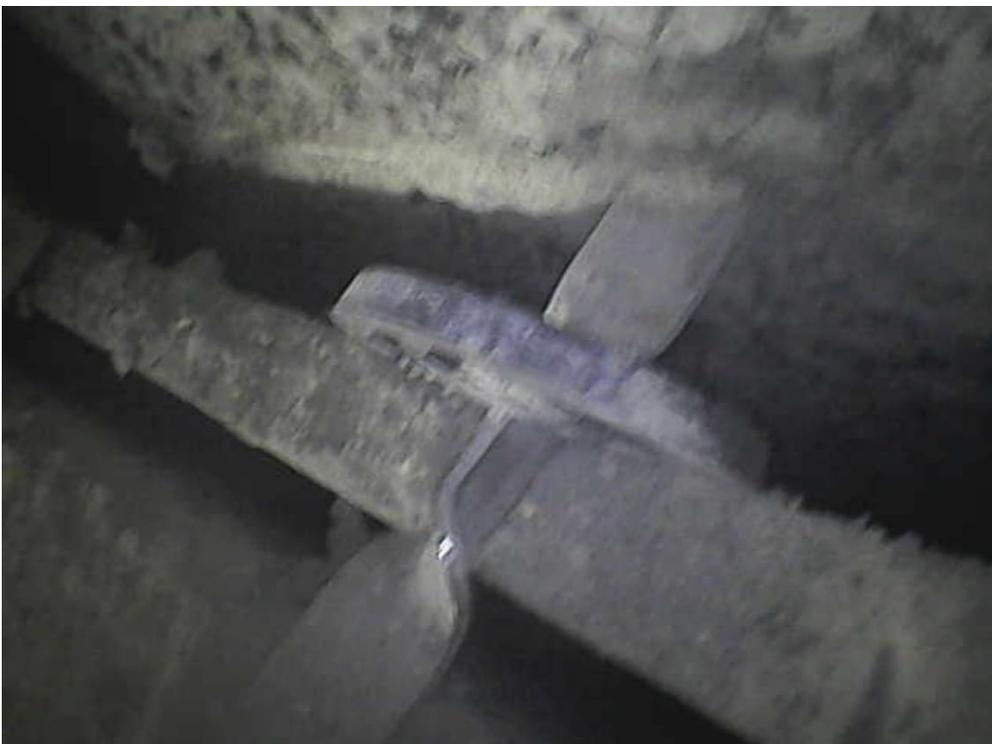
Block reference	Block condition	Mortar condition	No of Wall Ties found and condition	Comments
Block 5 (west wall)	100mm thick dense concrete in good condition	Poor – inner leaf weak and friable; outer leaf weak and friable	1no at bottom of block/good; 2 no 600mm to right lower of block and 900mm below block/covered in mortar	80mm cavity overall with 25mm insulation board displaced 25mm off inner leaf wall.
Block 6 (south wall)	100mm thick dense concrete in good condition	Reasonable – adequate strength mortar to both inner and outer leaf	2no at top left of block and 450mm to right of block/good; 1 no 500mm to left lower of block/covered in mortar	80mm cavity overall with 25mm insulation board displaced 25mm off inner leaf wall.
Block 7 (west wall)	100mm thick dense concrete in good condition	Poor – inner leaf very weak and friable; outer leaf very weak and friable	3no 300mm to upper right of block, 200mm to upper left of block and 225mm below block/good	90mm cavity overall with no insulation board.

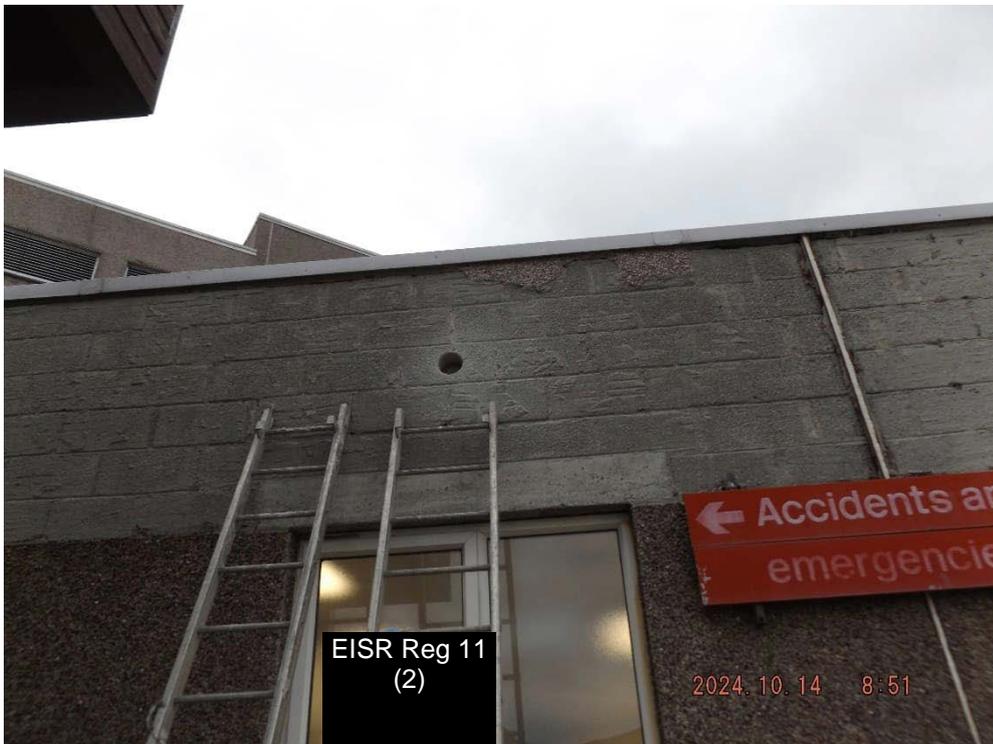
Core reference	Block condition	Mortar condition	No of Wall Ties found and condition	Comments
Core 61 (west wall, single storey)	100mm thick dense concrete in good condition.	Poor – weak and friable	2 no 200mm above and 900mm to right upper of core/good.	20mm cavity to 25mm insulation board. Lot of mortar droppings in cavity. Boss render has been removed previously due to proximity to main entrance.
Inner leaf block removed (3 Storey building stairwell north elevation wall)	140mm thick dense concrete inner leaf block in good condition	Poor to reasonable – low strength mortar in both inner and outer leafs	1 no at top of block/good. 1 no 600mm to left lower of block/covered with mortar	15mm gap to 25mm insulation board. Lot of mortar droppings in cavity. Cavity width is 60mm overall.
