# **Gilbert Bain Hospital Phase 1 Construction**

Report on Condition of External Walls

December 2024

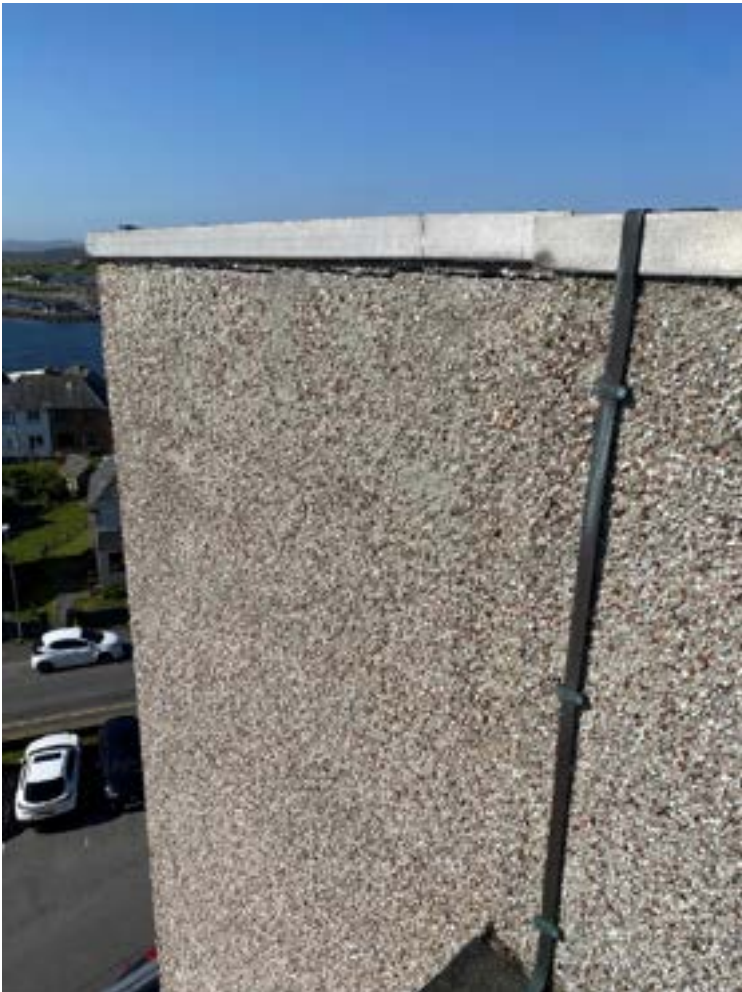
A typical 3 to 5mm wide crack below the coping had been chased out to allow inspection of the construction at the coping. This included a precast or insitu concrete coping on 30mm of soft mortar on DPC. The crack at the wall head coincided with the DPC location.

**Figure 2.2: Cracking along the east wall head of the lift motor room**

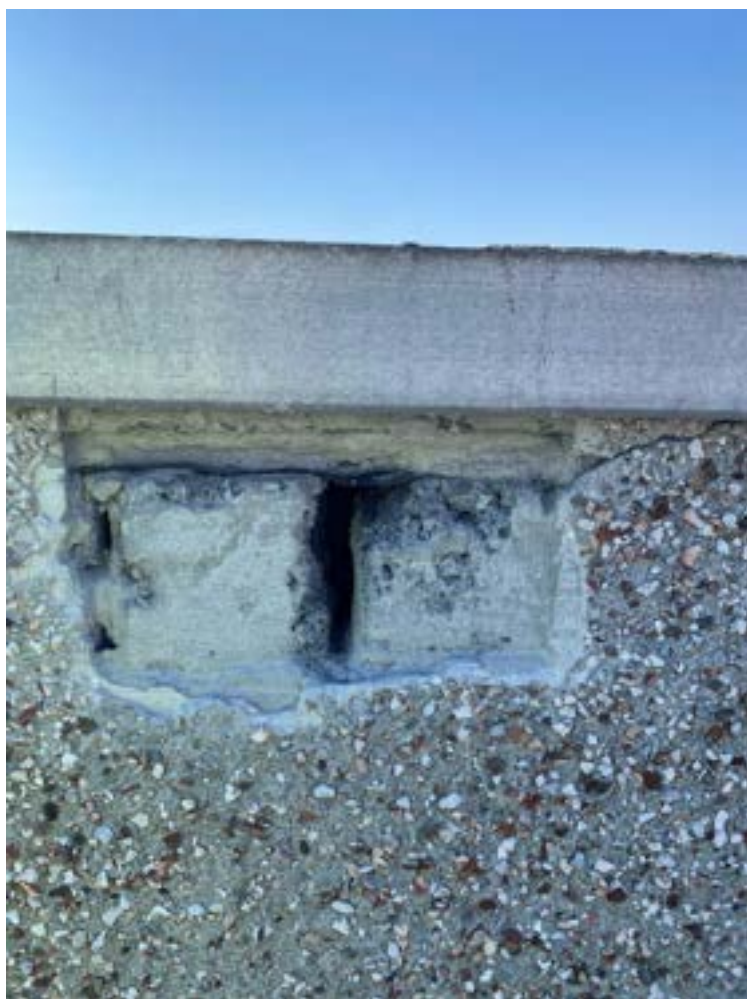
**Figure 2.3: Construction at the coping**

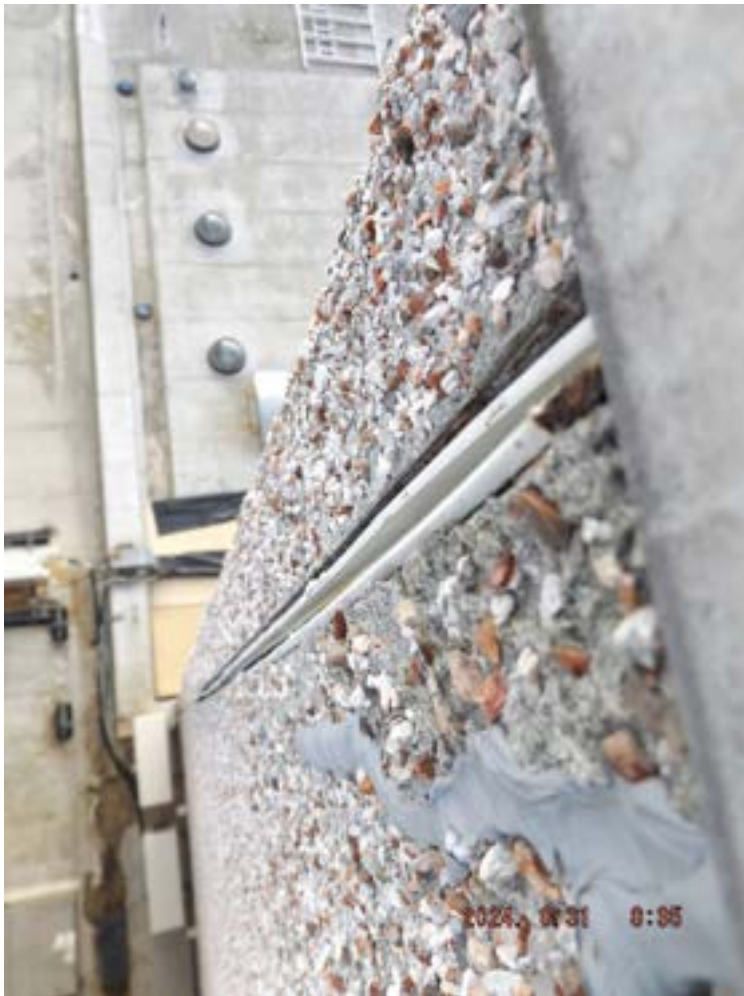
**Figure 2.4: Outward lean of the east elevation wall from roof level**

In addition to the east wall head projecting outward by approx. 20mm as noted in Section 2.1 above the north elevation wall was also seen to be leaning outward by approx. 10mm at the wall head at the north-east corner of the 4 Storey block. Photographs of horizontal cracking at parapet level are included in Figures 2.5 to 2.8, with Figures 2.5 and 2.6 showing cracking at the south elevation and Figures 2.7 and 2.8 showing cracking at the east elevation.

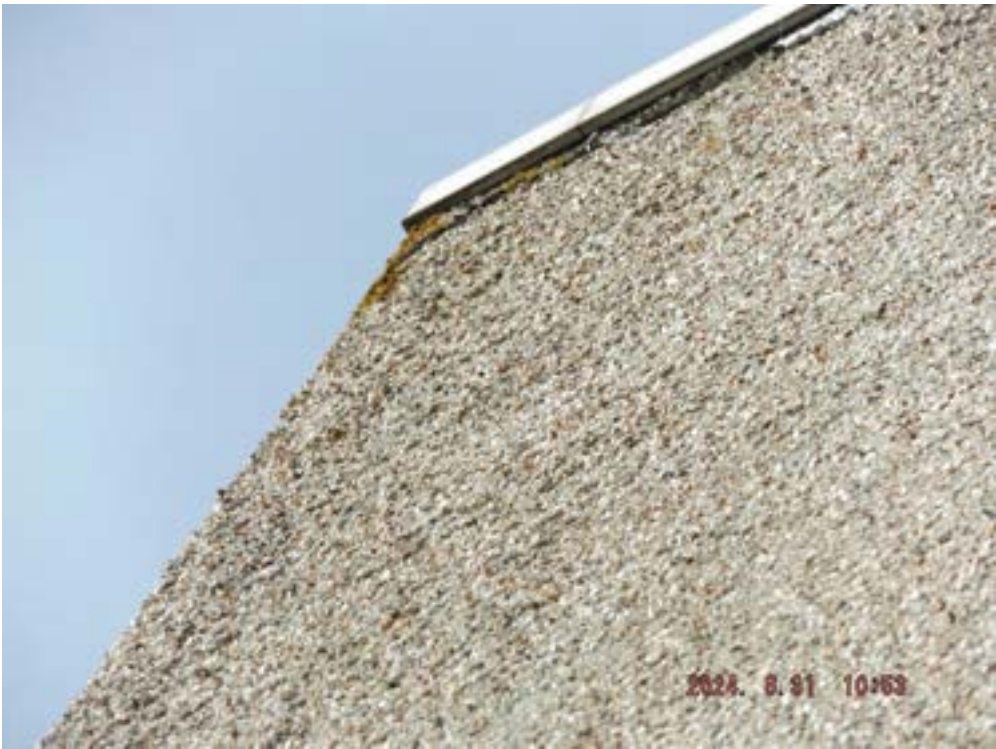
Figure 2.5: Cracking at south elevation

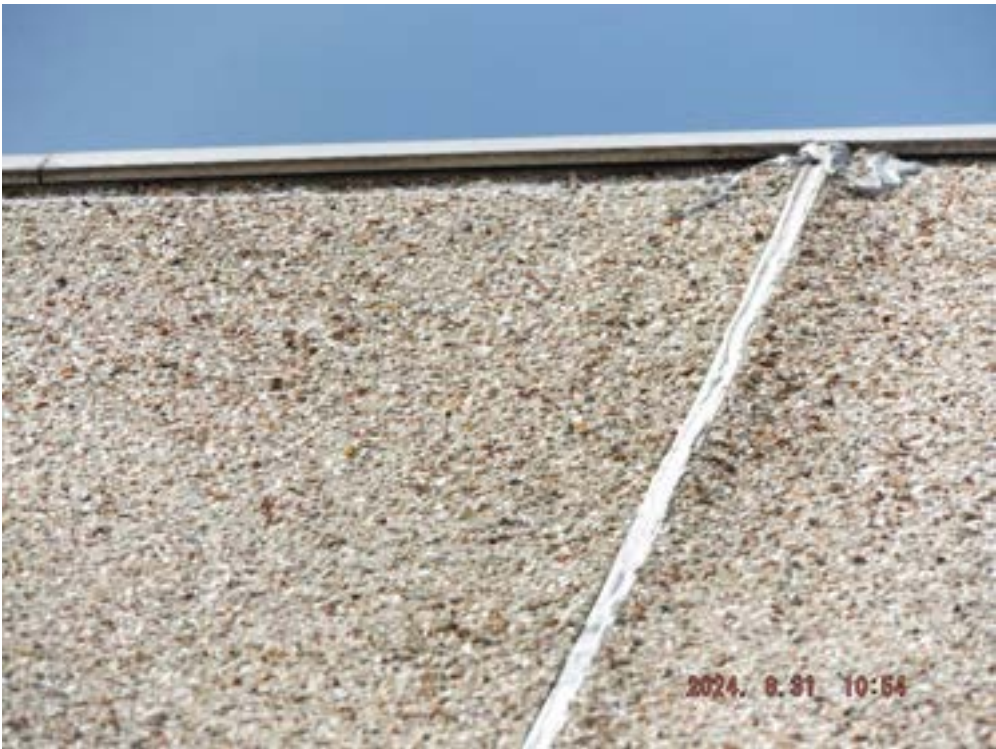
Figure 2.6: Cracking at south elevation

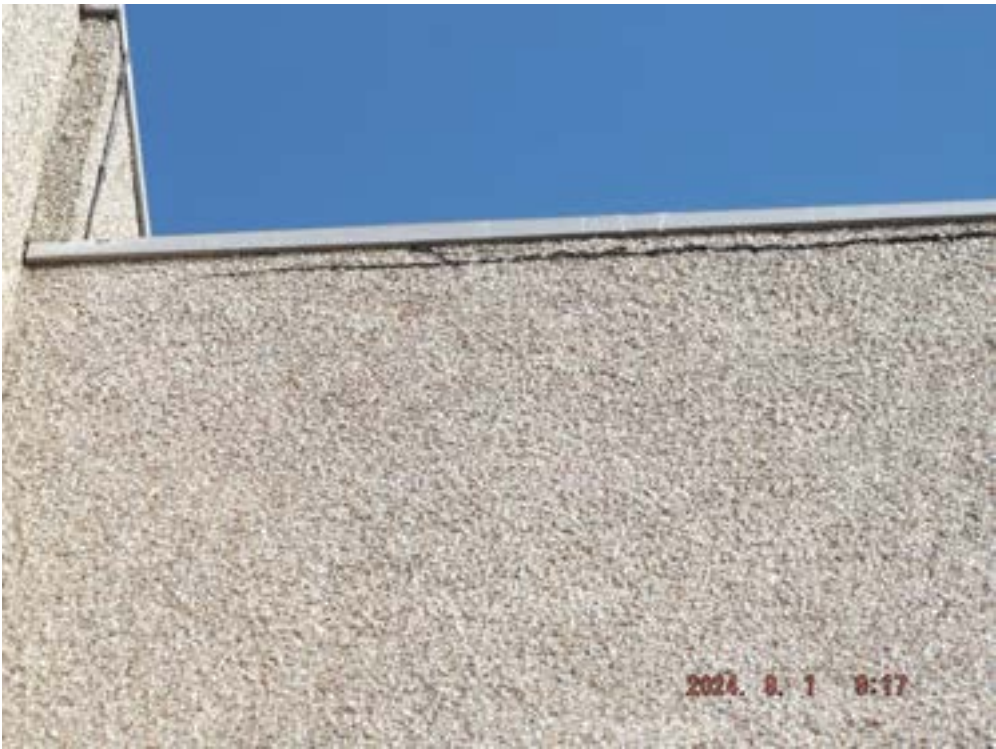
Figure 2.7: Cracking at the east elevation

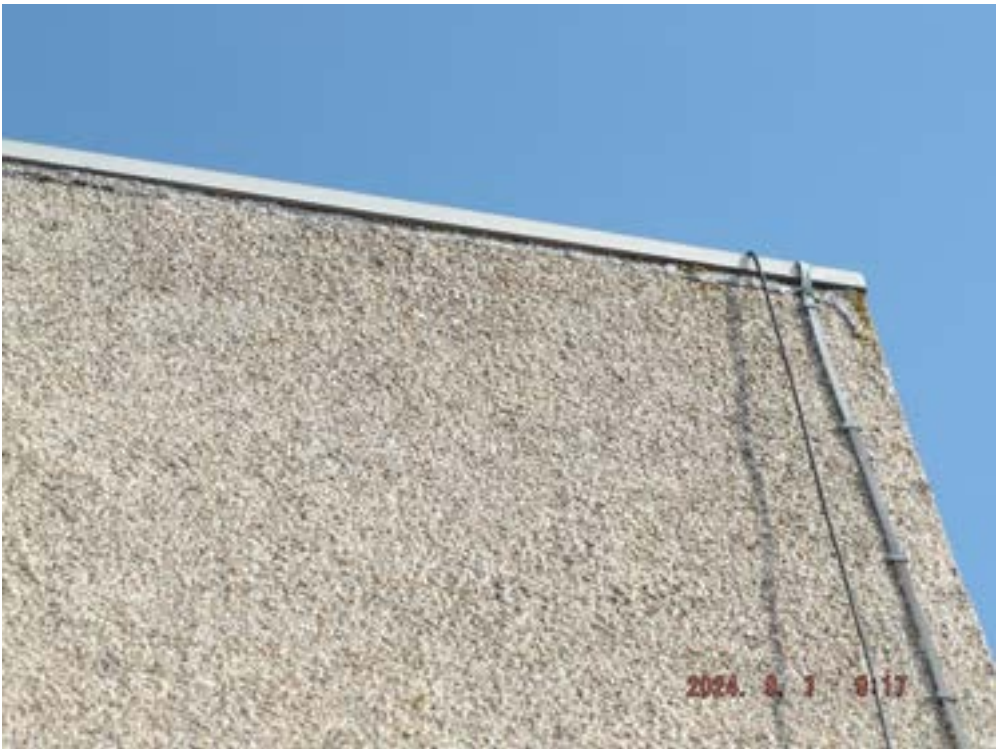
Figure 2.8: Cracking at the east elevation

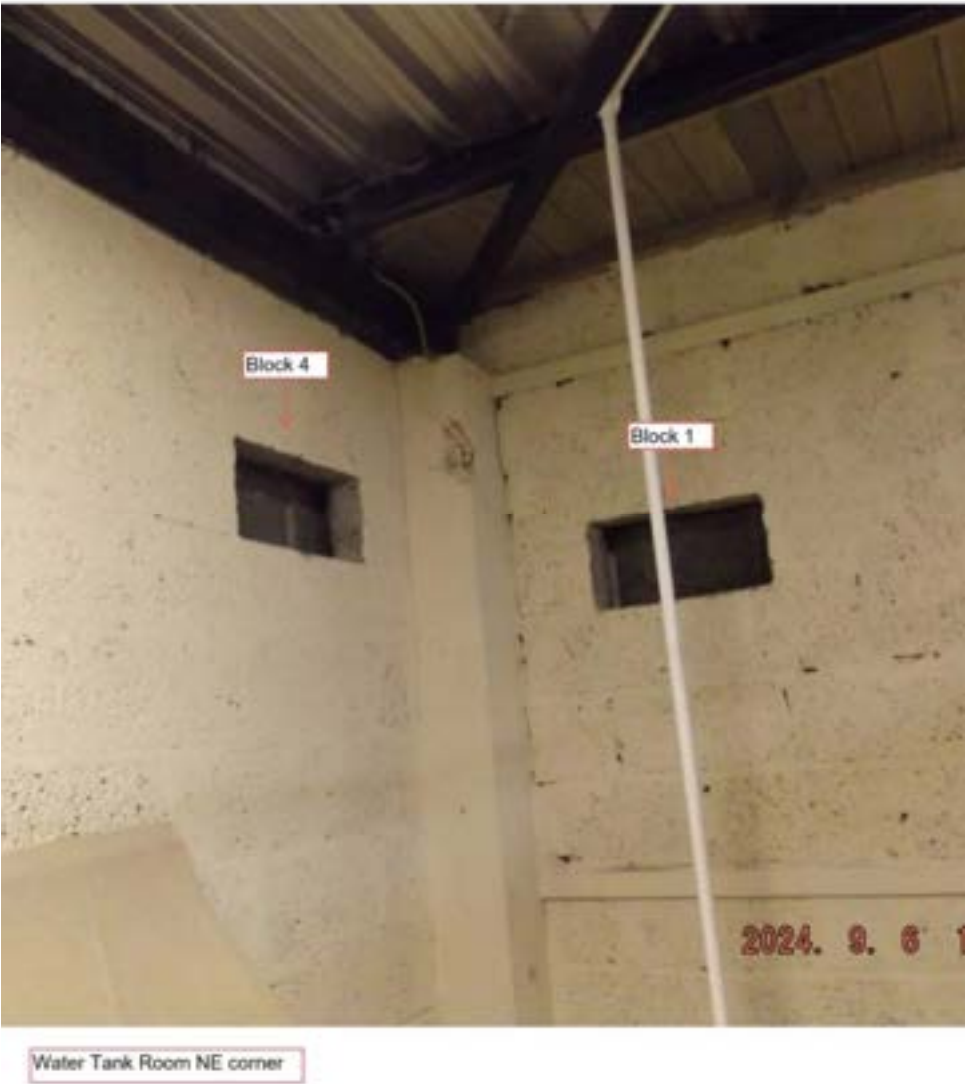
Figure 2.12: Blocks removed at NE corner of Water Tank Room

Photographs and notes of key findings are included in Appendix C. The block inspections confirmed that the inner leaf was of good quality dense concrete blocks with weak to very weak mortar jointing. Wall ties were present in the cavity but where closely inspected were found to be slightly loose to loose and some ties had inadequate embedment in the outer leaf blockwork. The wall ties were of the vertical twist type and where they could be inspected closely appeared to be in good condition. The cavity was wider than expected varying from 75mm at the north elevation to 90 to 105mm at the east elevation and 95mm at the south elevation. The width of the cavity would suggest that the outer leaf blockwork has displaced over time increasing the

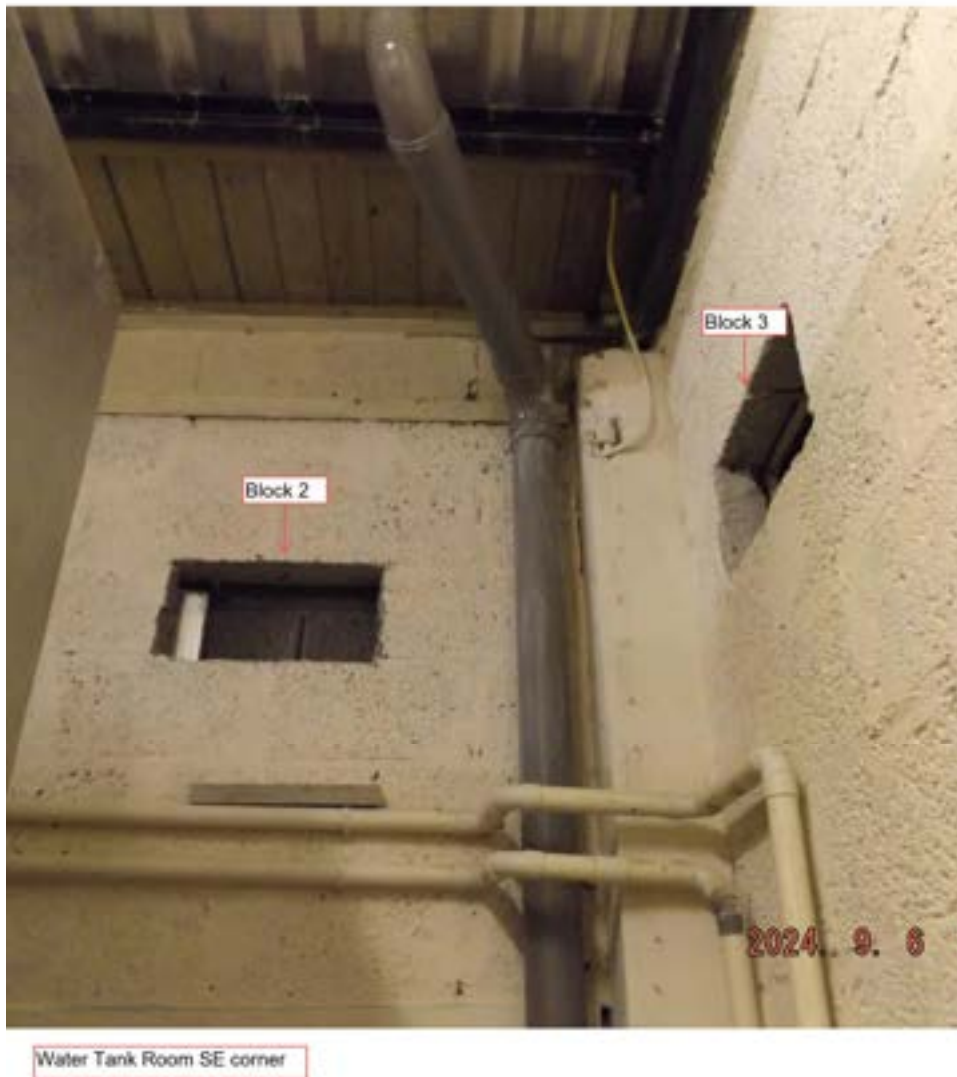
**Figure 2.13: Blocks removed at SE corner of Water Tank Room**

Wall ties were seen to be loose at the south-east corner of the water tank room and it is possible that under high wind suction loading the outer leaf could have displaced relative to the inner leaf with the wall ties sliding in the mortar beds. The mortar test report confirms that the original mix of the mortar included designation (iv), which is equivalent to 2N/mm<sup>2</sup> compressive strength at 28 days. This is an unusually weak mix and it is compounded by the high amount of voids found in the samples giving a very weak and friable mortar over most of the 4 Storey

At the inner leaf inspection locations in the plant room, water tank room and lift motor room the mortar was found to be weak. Accordingly, a remedial solution which avoids tying a new outer leaf to the existing inner leaf blockwork should be avoided. Instead, it is recommended that the outer leaf blockwork walls at the 4 storey building and the south wall of the 3 storey building including Ward 3 and Renal are dismantled and replaced with a cladding system spanning between the reinforced concrete columns. A new cladding system could include cladding rails spanning horizontally between the reinforced concrete columns and supporting a lightweight composite cladding system or similar. Architectural input is required in respect of energy performance and aesthetic appearance of any new cladding system. The time frame for this work should be as soon as possible with scaffolding erected and the existing outer leaf walls taken down in the Spring/Summer of 2025.

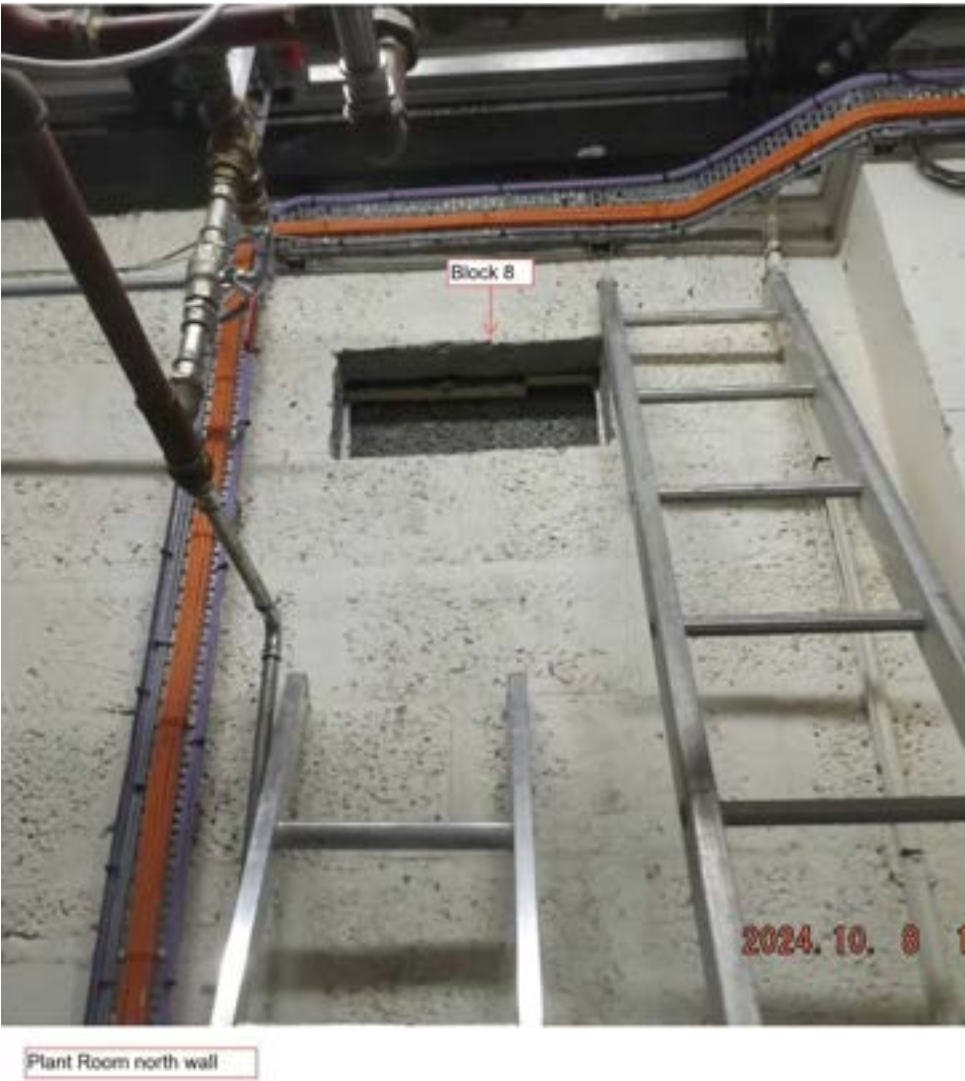
Figure 2.21: Block removed at north wall of Plant Room

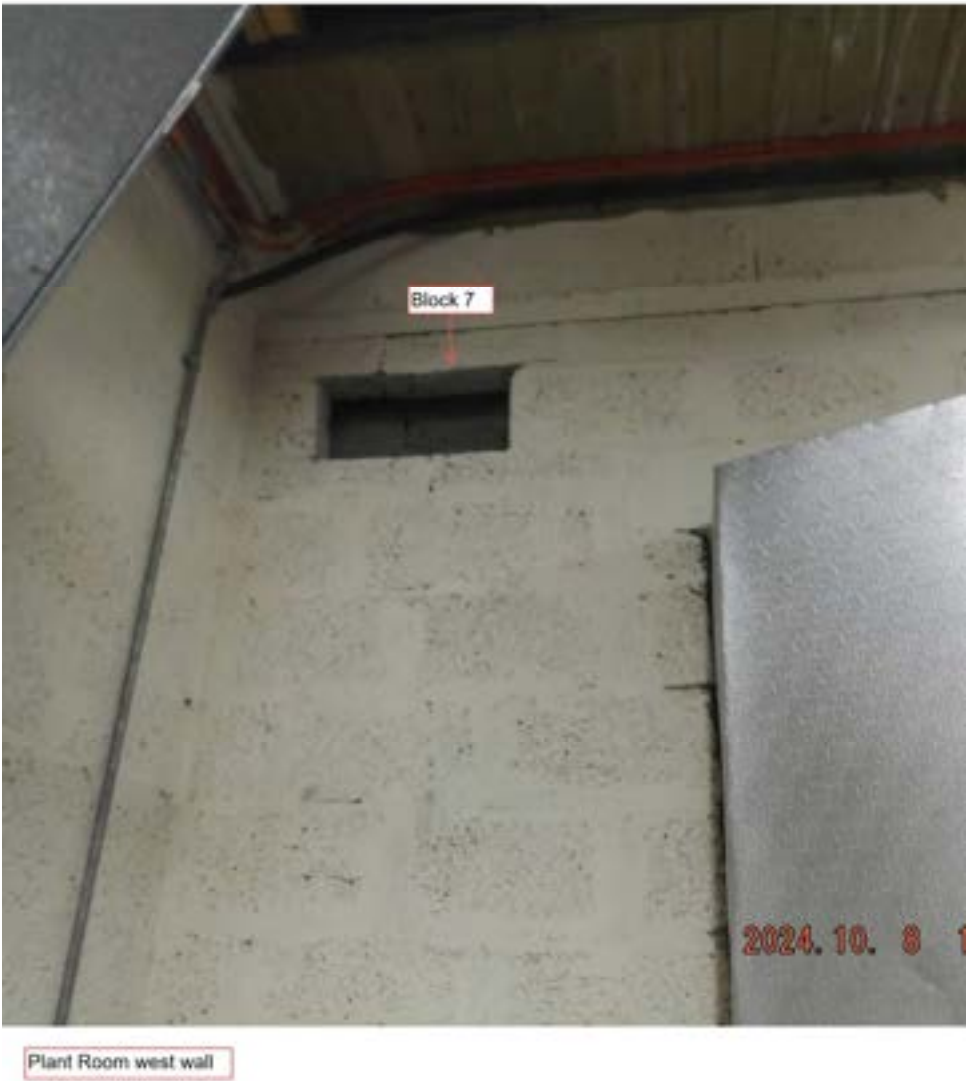
Figure 2.22: Block removed at west wall of Plant Room

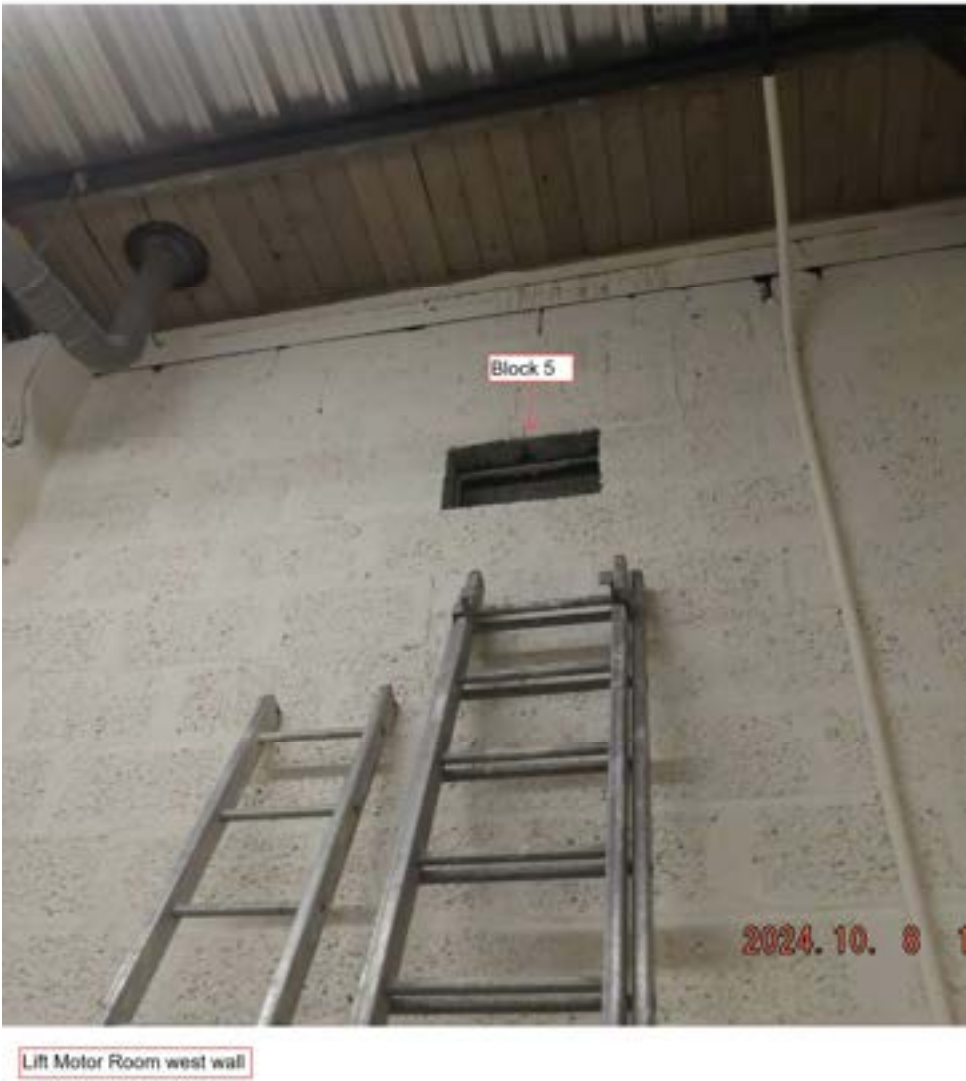
Figure 2.23: Block removed at west wall of Lift Motor Room

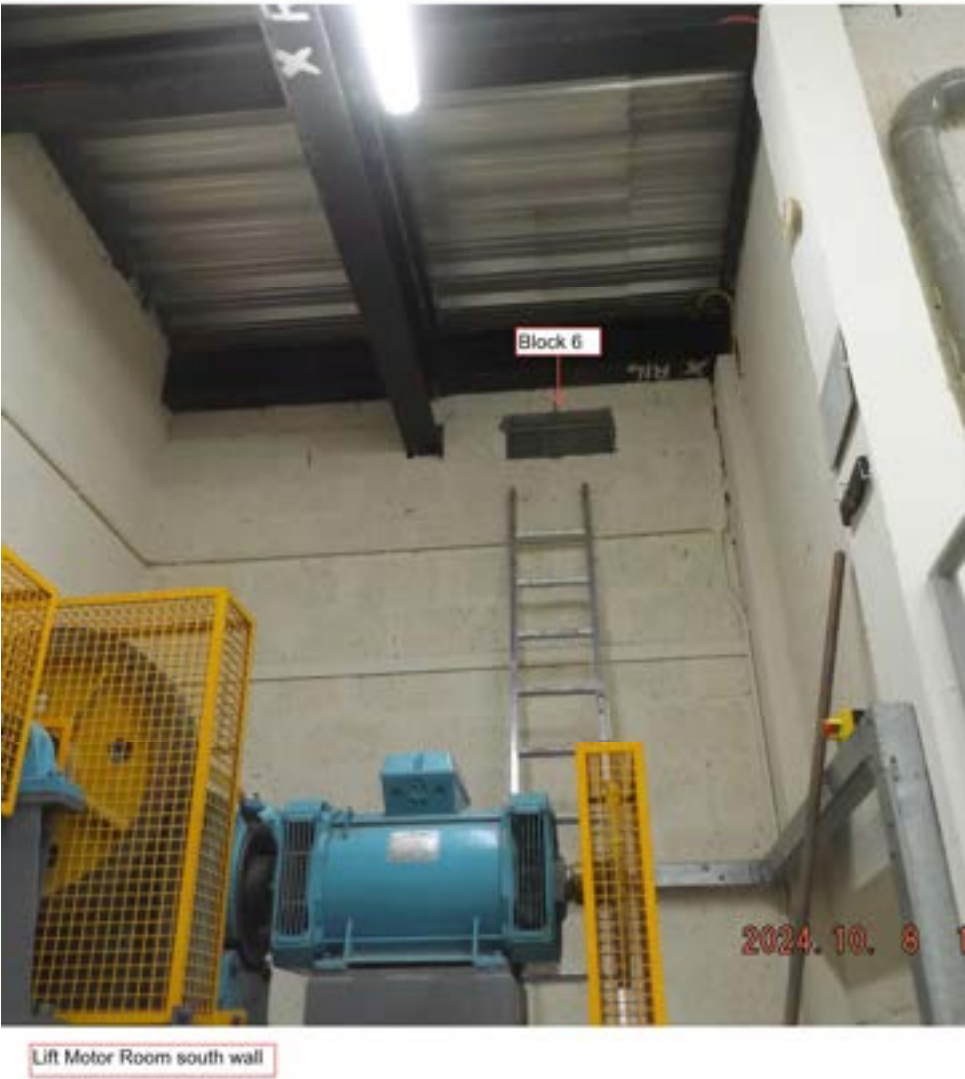
Figure 2.24: Block removed at south wall of Lift Motor Room

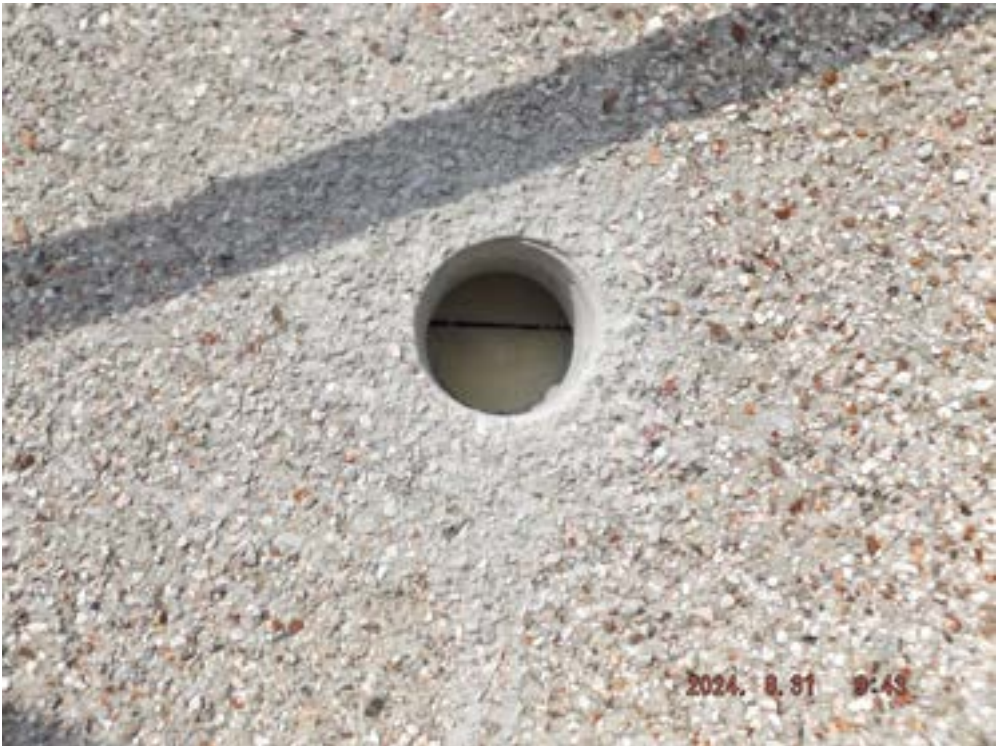
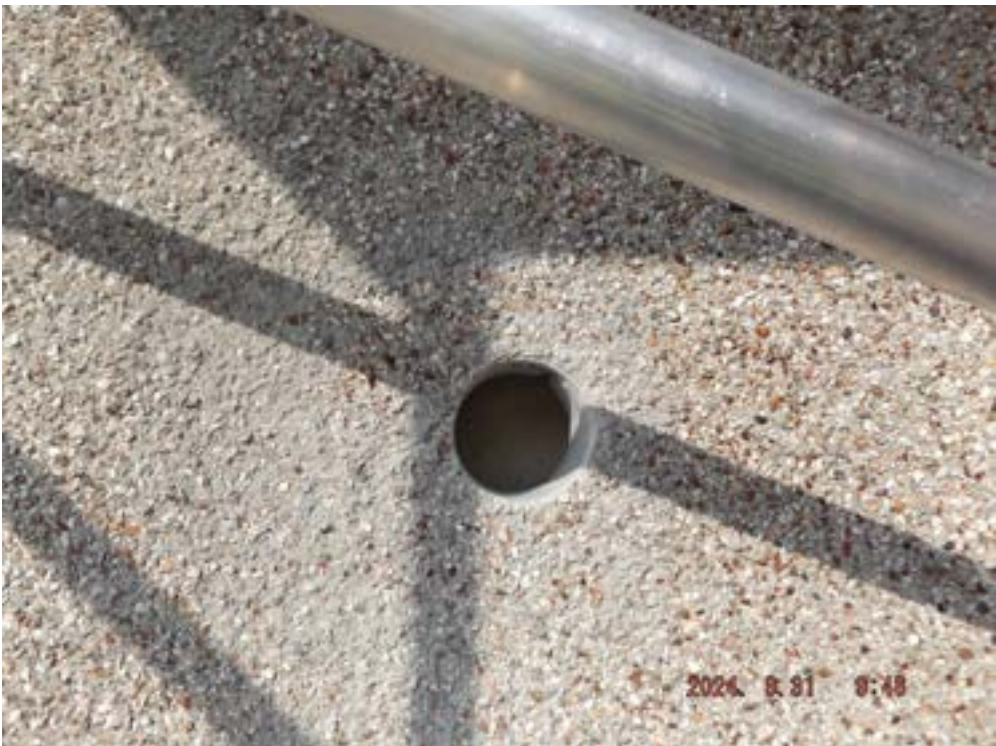
Cores 1 and 2

| Core reference | Block condition | Mortar condition | No of Wall Ties found and condition | Comments |
|---|---|---|---|---|
| Core 1<br>(east wall) | 100mm thick dense concrete in good condition | Poor – weak and friable | 1 no 300mm to right lower of core/covered with mortar | 25mm cavity to 25mm insulation board. Lot of mortar droppings in cavity |
| Core 2<br>(east wall) | 100mm thick dense concrete in good condition | Poor – weak and friable | None | 35mm cavity to 25mm insulation board. Lot of mortar droppings in cavity. Mortar sample taken |

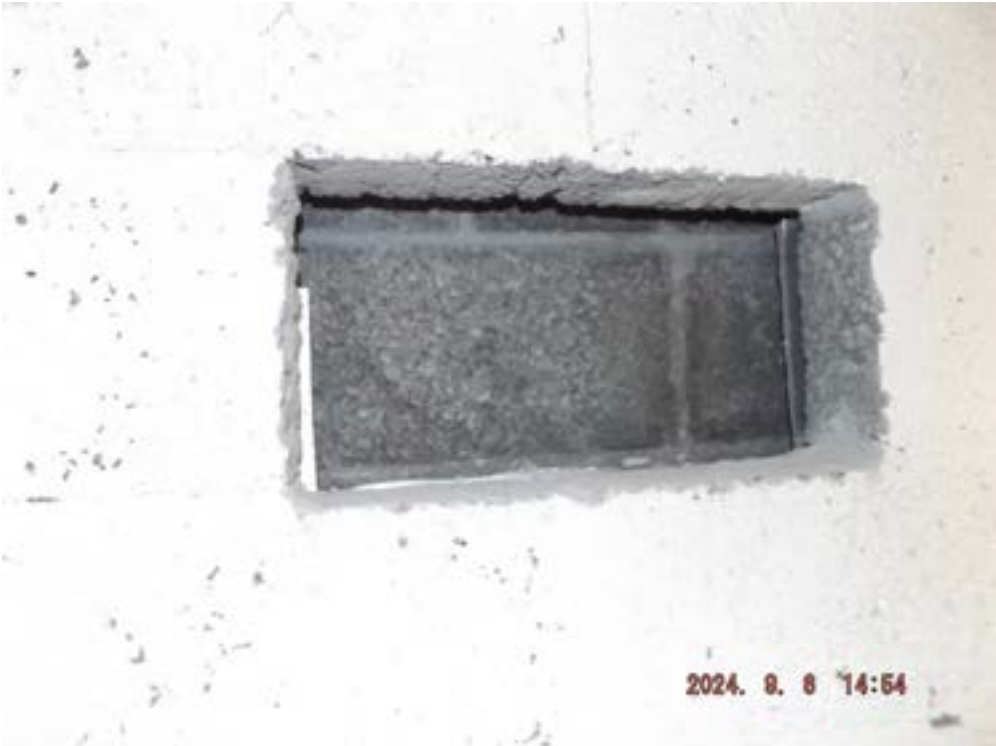
Block 1

| Block reference | Block condition | Mortar condition | No of Wall Ties found and condition | Comments |
|---|---|---|---|---|
| Block 1<br>(east wall) | 100mm thick dense concrete in good condition | Poor – inner leaf weak and friable; outer leaf very weak and friable | 3no to upper, lower and right side of block within 450mm and 2 no adjacent to RC column to left of block/good | 105mm cavity overall with 25mm insulation board displaced 20mm off inner leaf wall. Insufficient wall tie embedment in outer leaf. |
