Gilbert Bain Hospital Cladding Remedials

Planning Design Statement - July 2025

This supporting design document has been prepared by Threesixty Architecture to accompany a Planning Application on behalf of NHS Shetland. The application is to replace the façades of selected elevations of the Gilbert Bain Hospital.

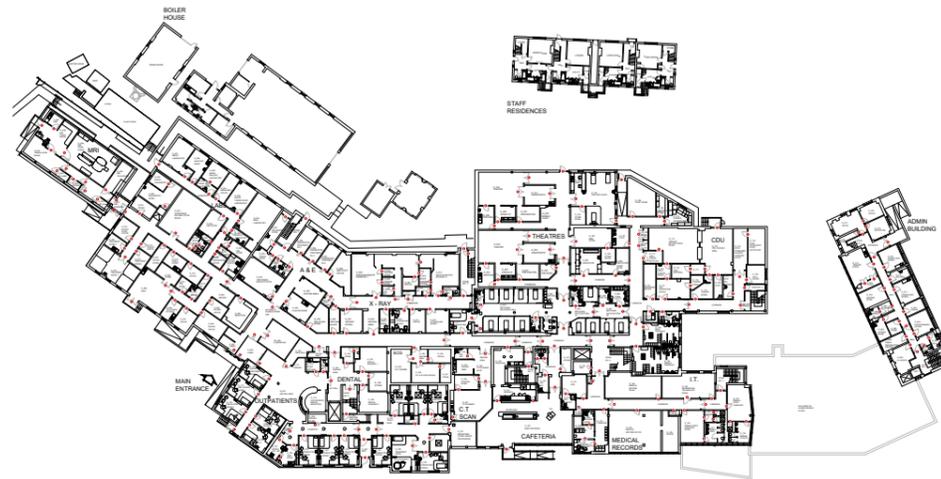
Ground Floor Plan

The new Gilbert Bain Hospital was first opened in 1961 comprising the furthest east four storey admin block, the Theatres, with wards 1 and Ronas ward above. The Phase 1 extension was built in 1989 comprising a 4 storey block containing key departments including A&E, Xray, Dental, and the main access corridor at ground floor, with wards located on the first and second floors above, with plant rooms on the top floor all connected to the original building via a two-storey link corridor. In 2001, a ground floor extension was built to wrap around the original Phase 1 building and this accommodates the current Outpatients Department. Most recently in 2023, a single storey extension containing a new MRI Facility was installed at the far western end of the clinics' corridor.

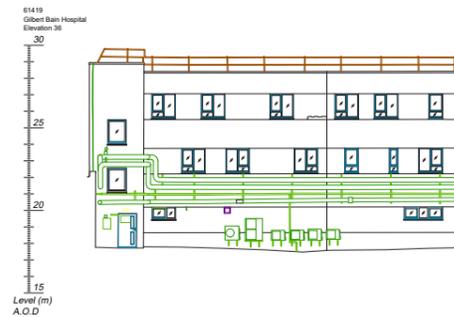
Elevation 36

Elevations 36 and 37 require some areas of bossed render to be identified and replaced.

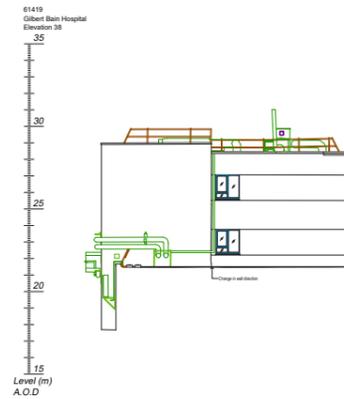
Elevation 38

Elevations 38 and 39 require all existing render to be removed from the outer leaf of blockwork, and a new rainscreen cladding system is to be installed, spanning between reinforced columns with replacement of cills and lintels throughout.

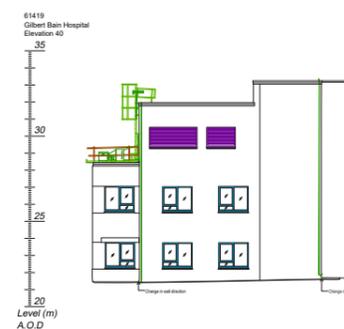
Elevation 40

Elevations 40 to 44 require the complete dismantling of the outer leaf of the cavity walls and removal of existing windows. Replacement cladding spanning between the reinforced concrete columns with new insulation is to be installed. As part of the recladding works we are taking the opportunity to replace all windows to elevations 38 to 44.

In Mott MacDonald's condition report Elevations 40-44 have been identified in need of remedial work. As such the outer leaf of blockwork to Elevations 40-44 must be dismantled and replaced with a lightweight insulated cladding system.

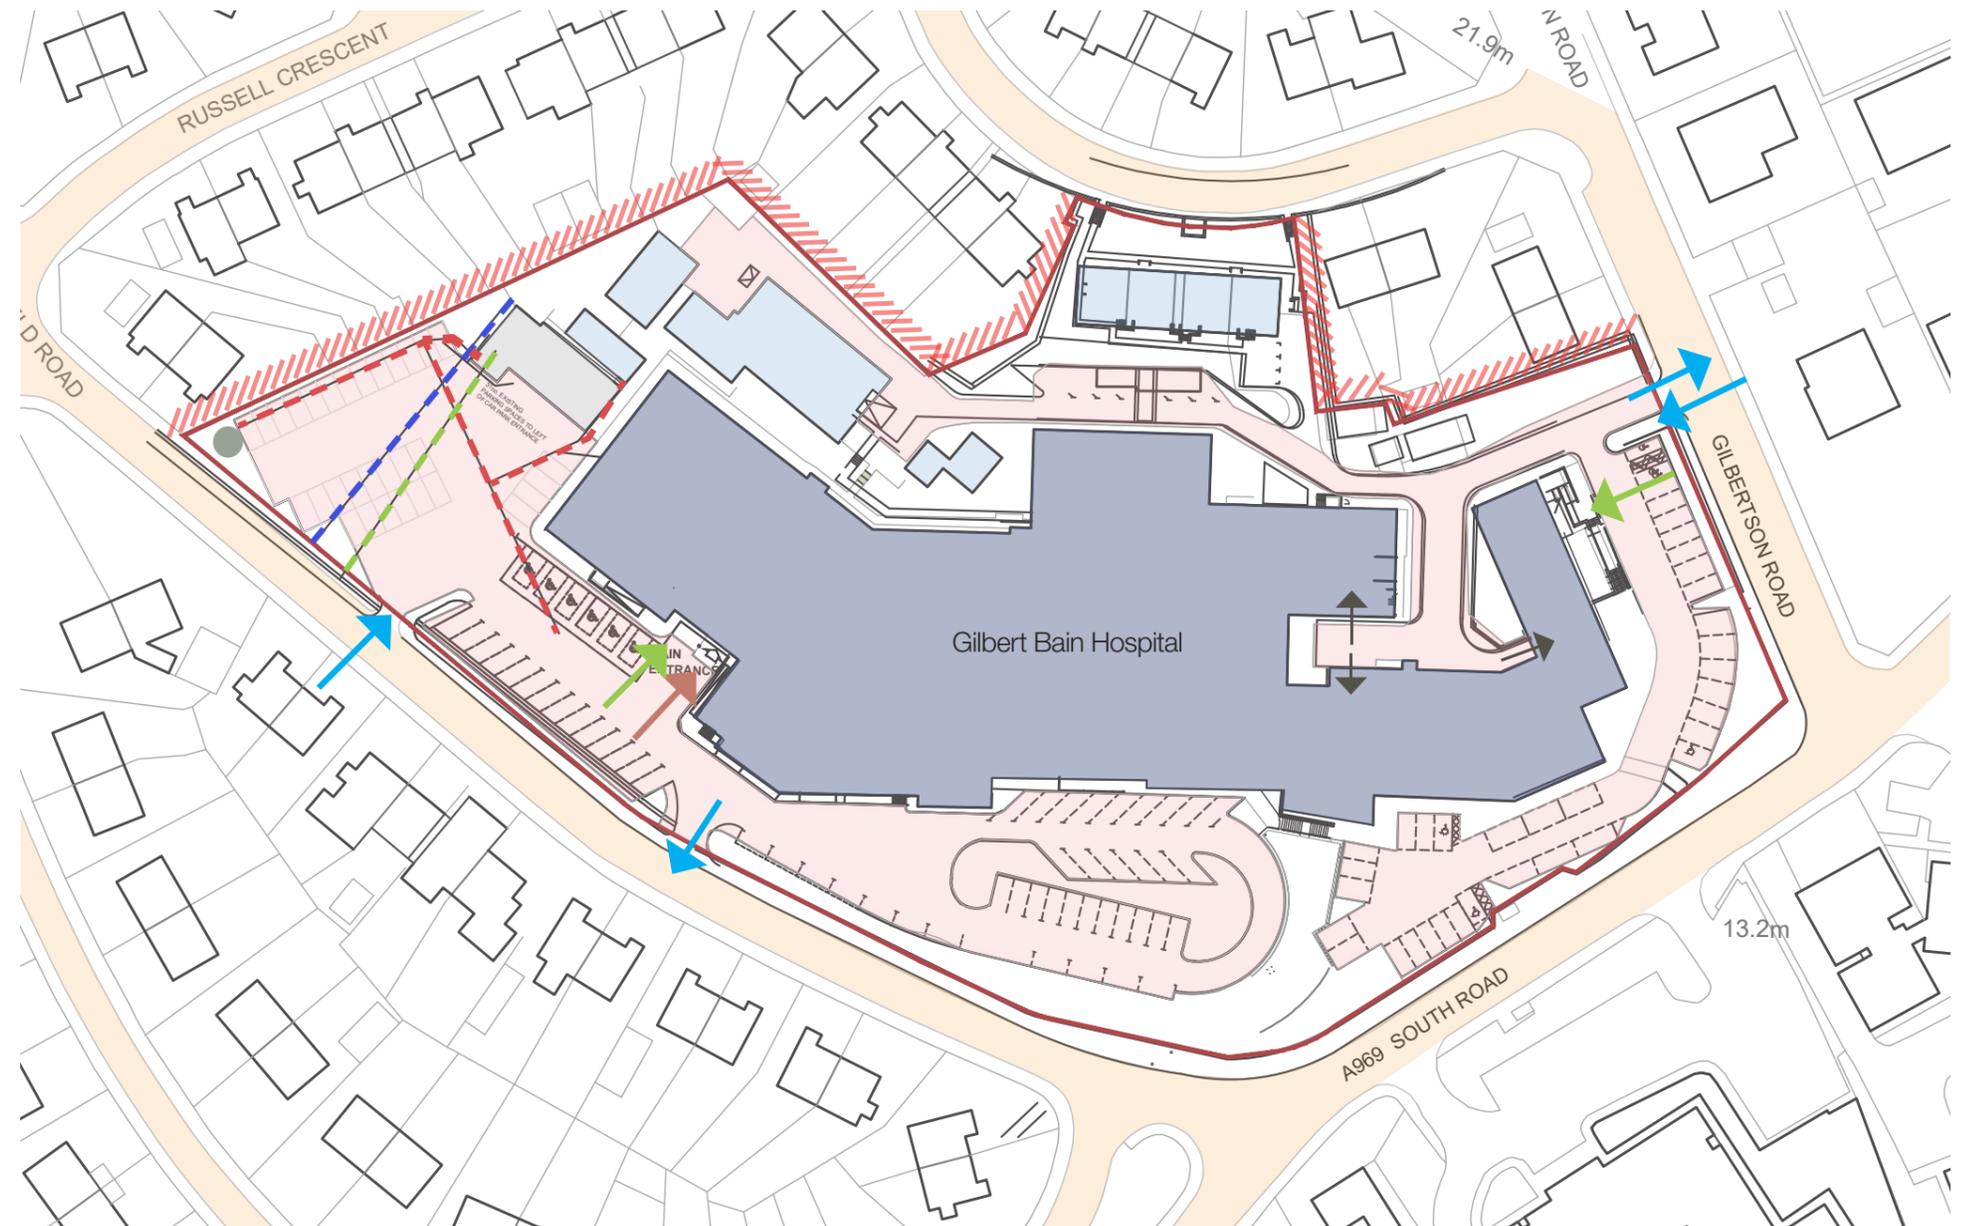
There are HV cables and district heating pipework running below the carpark in the far western part of the site.

The hospital site is very constrained with low rise housing backing onto the rear boundaries. Various services outbuildings pepper the rear service access road with pedestrian escape routes threading through these areas. The site falls away from west to east, dropping a storey in height across the site, with split level parking to all available land wrapping around the main building. Blue light vehicular access is required to be maintained at all times at the front of the hospital.

As noted previously there are 2 existing access points to the site, and 1 exit only point. The one way vehicular access and route around the upper car park will be maintained throughout.

All 3 points must remain available throughout the duration of the works with emergency vehicles able to drop off / pick up at the main entrance and A+E.

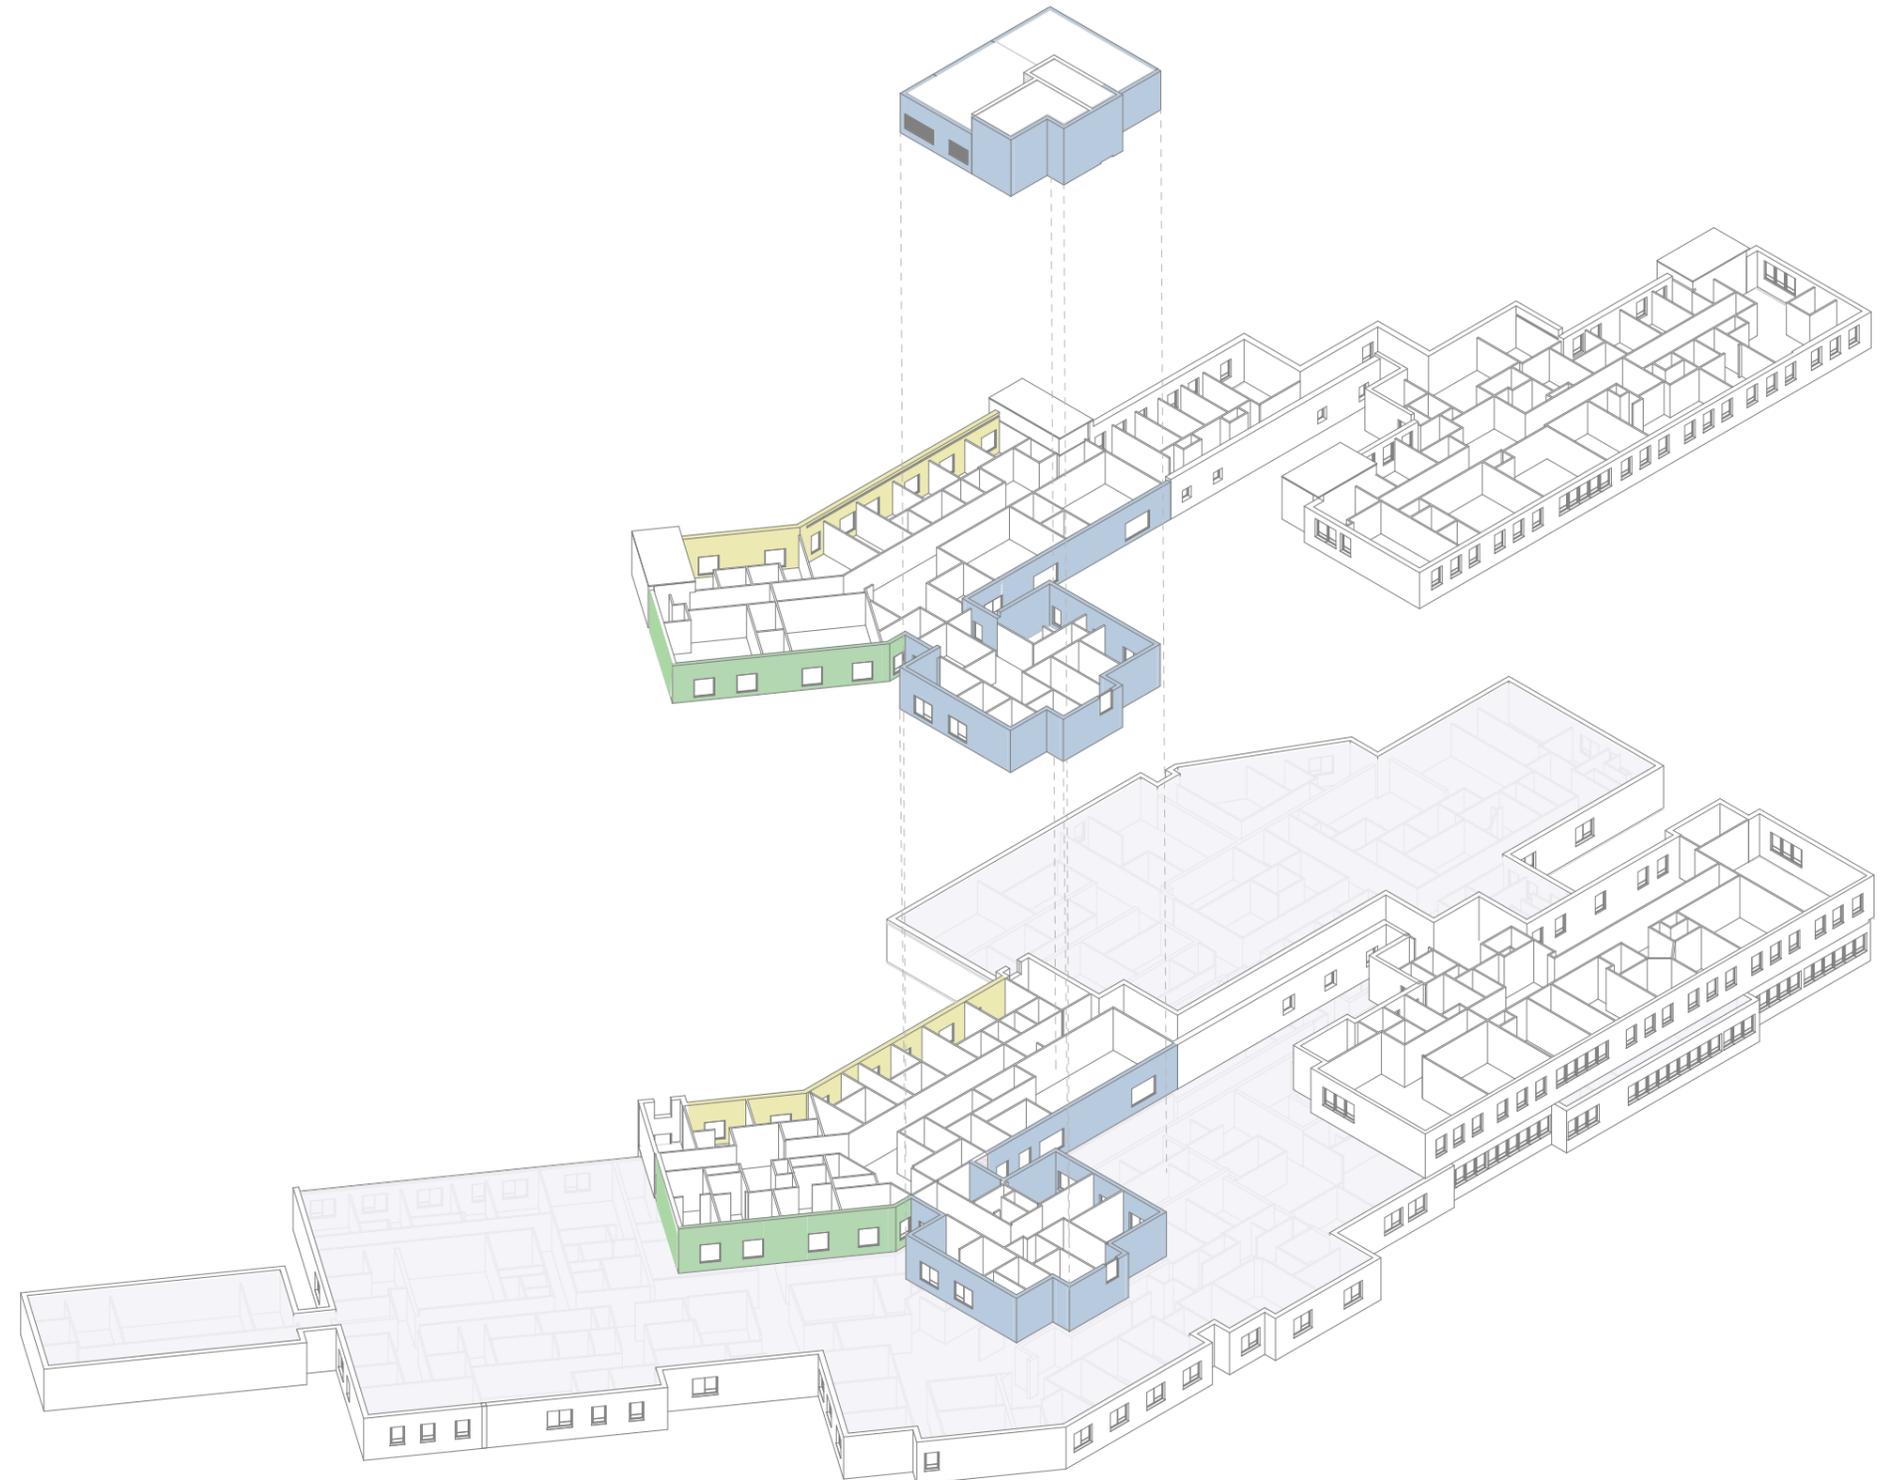
Extent of Works	
	REMEDIAL WORK - Strip external blockwork leaf (including external render) and remove windows. Internal blockwork leaf to be made good to accept new cladding supporting structure.
	REPAIR WORKS - Assess condition of render, locally repair or replace as required. Windows to be retained and made good as required.
	REMEDIAL WORK - Strip external render and make good to accept new cladding supporting rails. Cavity wall retained. replace windows, lintels & cills

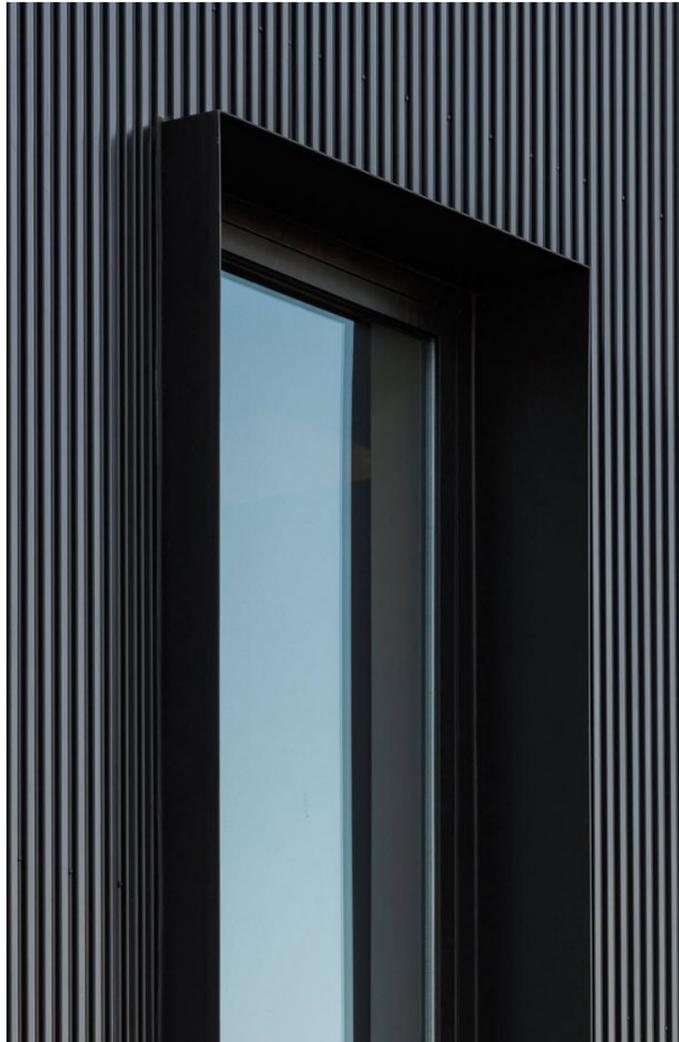
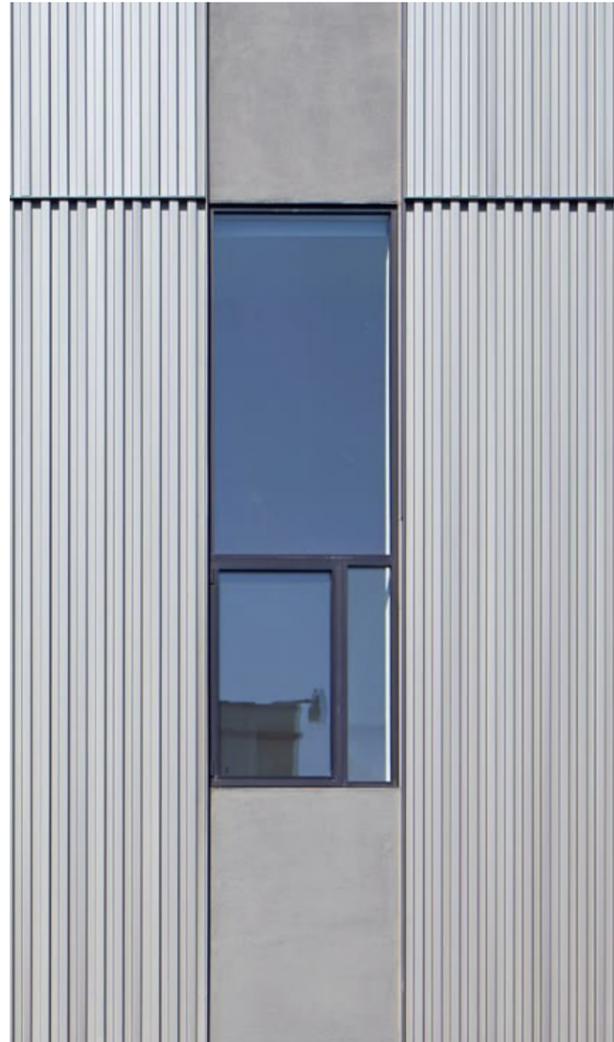
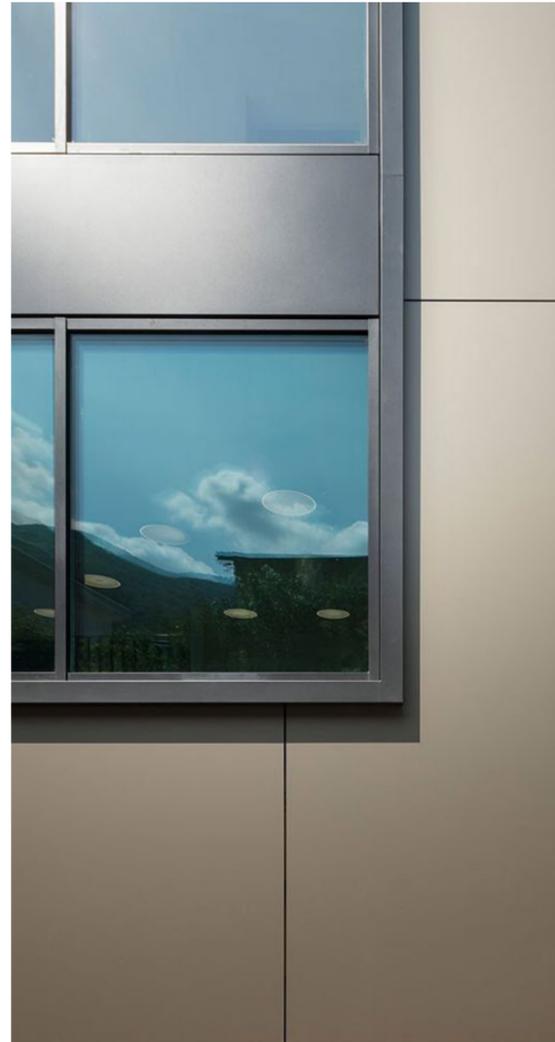
Precedents

The proposed aluminium cladding introduces a slim panel arrangement with vertical banding created for the window zones; rationalising the existing layout and creating an overall architectural rhythm on the facade. Elegant flashing details will add a sense of structure and formation to the existing facade.

We have chosen to use a non-combustible aluminium rainscreen cladding due to its following characteristics:

- Classified A1* fire rating in accordance with BS EN 13501-1
- Environmental exposure class
- Lightweight
- High quality and durability
- Ease of installation
- Availability

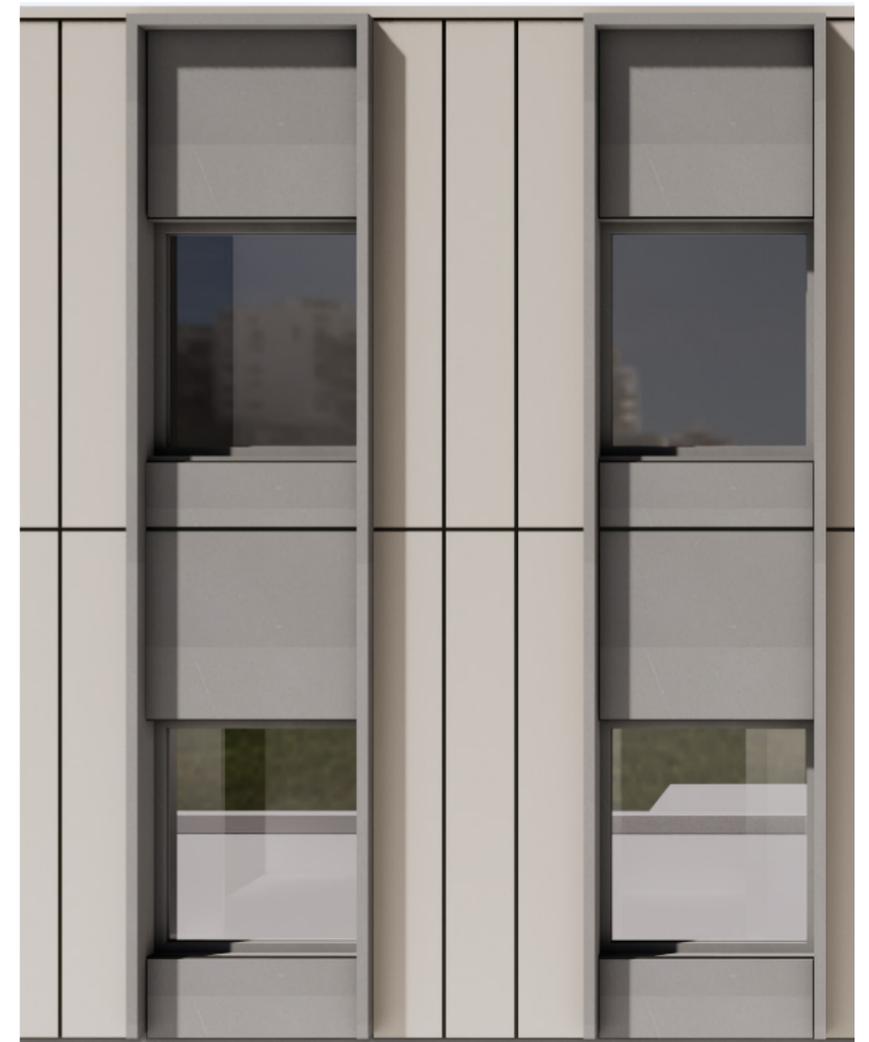
Proposal

Additionally, visual interest will be carefully balanced by ensuring that the louvres are integrated discreetly within the elevations, avoiding their emphasis whilst maintaining a cohesive appearance.
