Gilbert Bain Hospital Phase 1 Construction

Report on Condition of External Walls

December 2024

Document reference: 100106891NH03 | 01 | A |

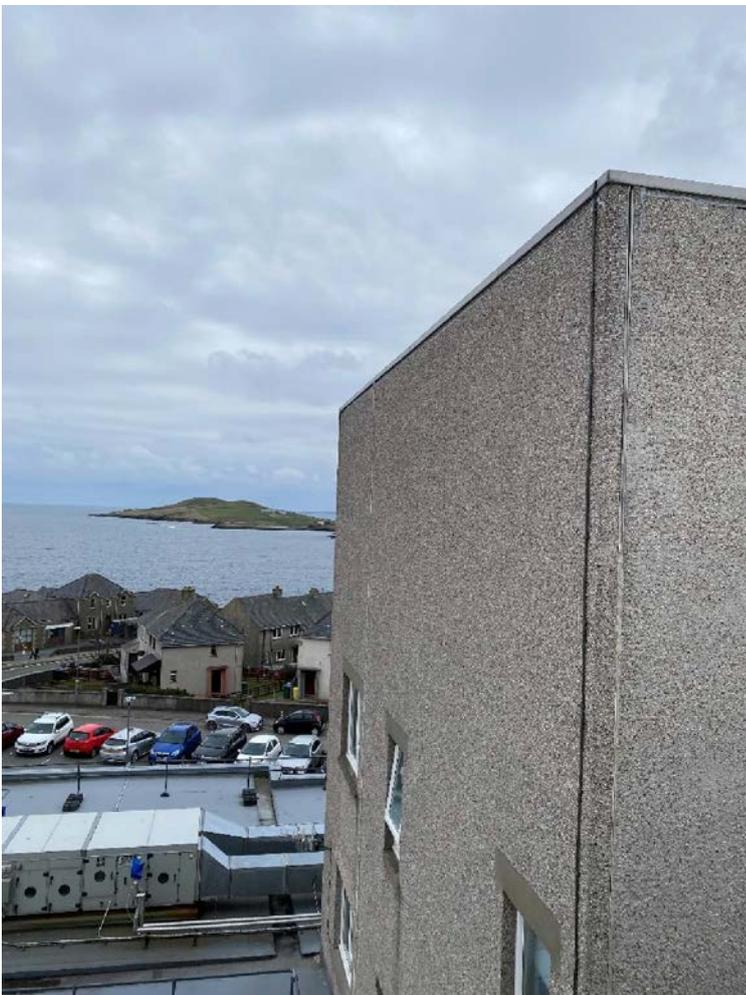
Figure 2.1: View of the east elevation wall from the north

At this visit the walls were inspected visually and an estimate of the outward movement of the upper two metres of the 4 Storey building east elevation wall was made with a theodolite sited on the adjacent roof to the north. It was estimated that the wall had moved 20mm outward at the head with the outward lean springing from a point 2m below the top of the wall. The north elevation movement joint was void of sealant over this height of the wall. Figure 2.1 includes a view of the east elevation wall from the north.

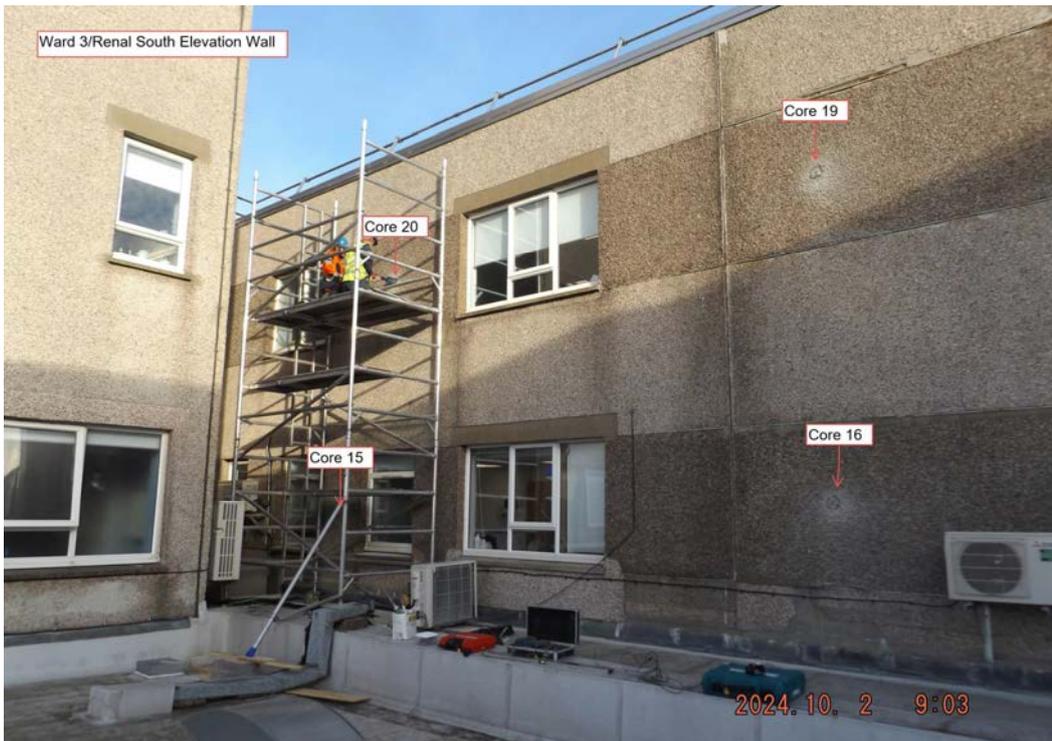
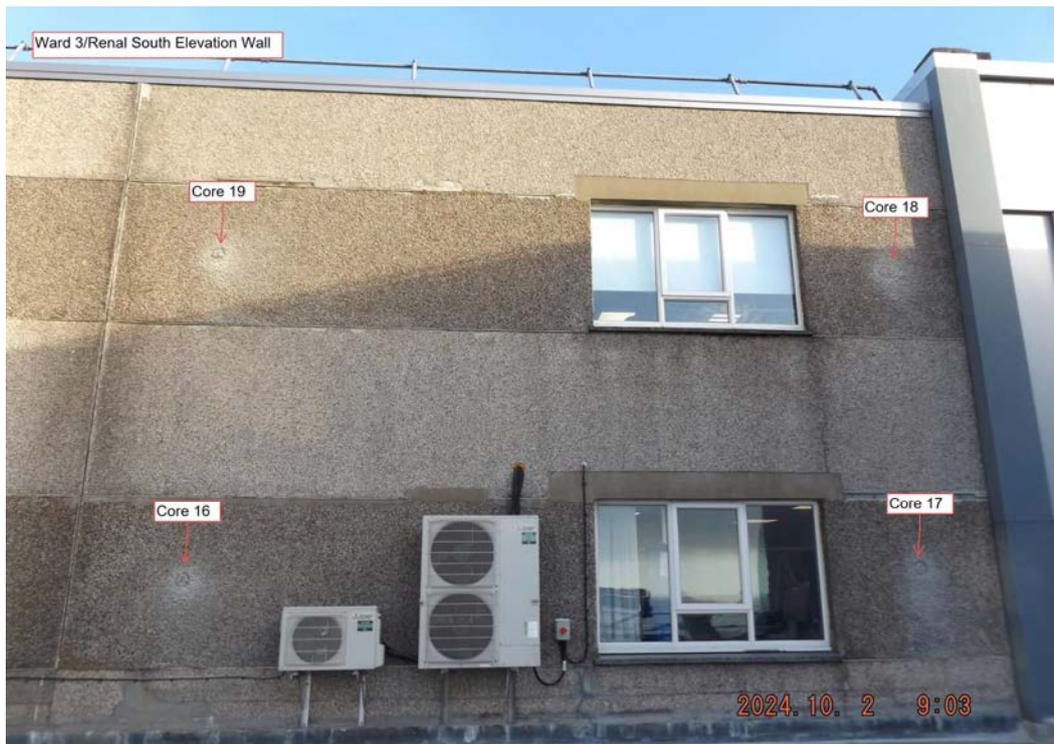
100mm diameter cores were removed from the south elevation of the 3 Storey building including Ward 3 at the top floor and Renal on the first floor. The core locations are included in Figures 2.14 and 2.15.

Figure 2.14: Cores at the south elevation of Ward 3 and Renal 1 of 2

Figure 2.15: Cores at the south elevation of Ward 3 and Renal 2 of 2

Sample photographs of extracted cores, the exposed cavity and wall ties located with an endoscope inspection are included in Appendix D. Notes of key findings at each core location are also included in Appendix D. The core inspections confirmed that the outer leaf was of good quality dense concrete blocks with some weak and some reasonable mortar jointing. Wall ties were present in the cavity but were difficult to locate due to the narrow cavity and significant amount of mortar droppings in the cavity. The wall ties were of the vertical twist type and where they could be inspected closely appeared to be in good condition.

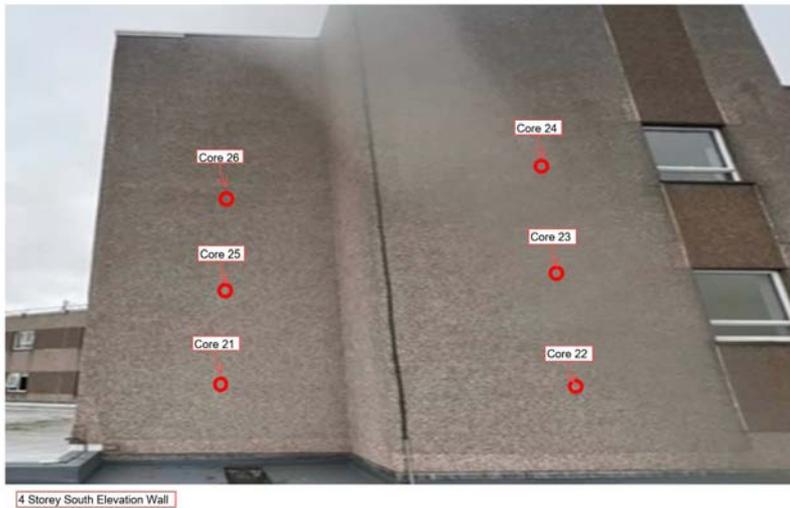
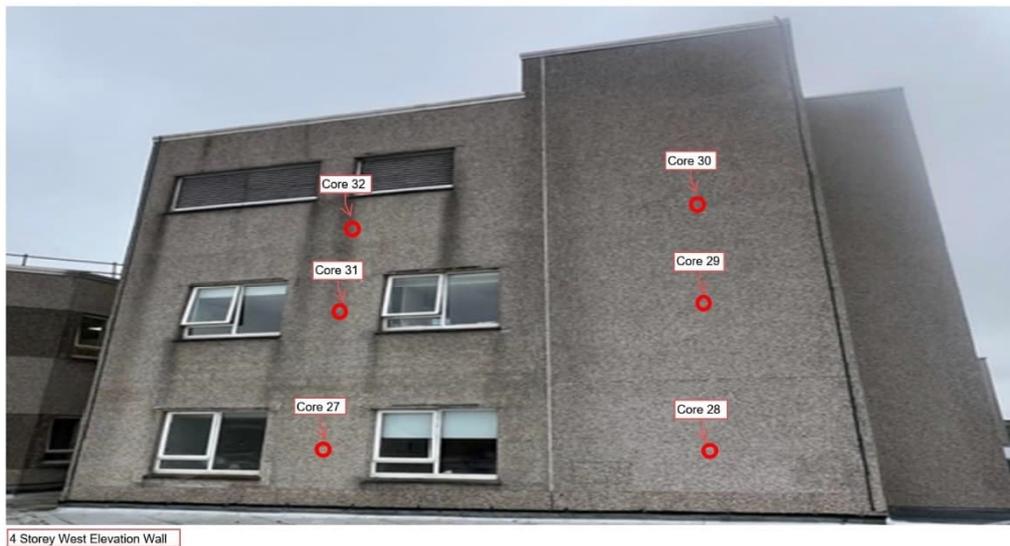
100mm diameter cores were removed from the south and west elevations of the 4 Storey building. The core locations are included in Figures 2.16 and 2.17. Sample photographs of extracted cores, the exposed cavity and wall ties located with an endoscope inspection are included in Appendix E. Notes of key findings at each core location are also included in Appendix E. The core inspections confirmed that the outer leaf was of good quality dense concrete blocks with weak mortar jointing. Wall ties were present in the cavity but were difficult to locate due to the narrow cavity and significant amount of mortar droppings in the cavity. The wall ties were of the vertical twist type and where they could be inspected closely appeared to be in good condition.

Figure 2.16: 4 Storey south wall cores – 6 no cores at the 4 Storey south elevation wall

Figure 2.17: 4 Storey west wall cores – 6 no cores at the 4 Storey west elevation wall

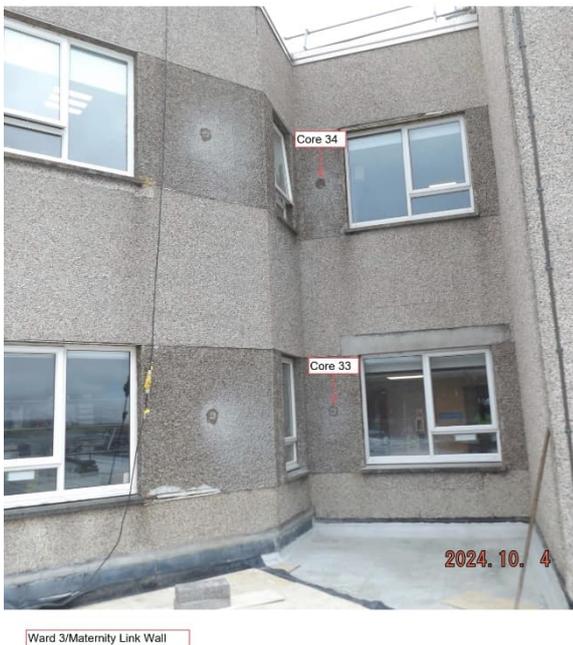
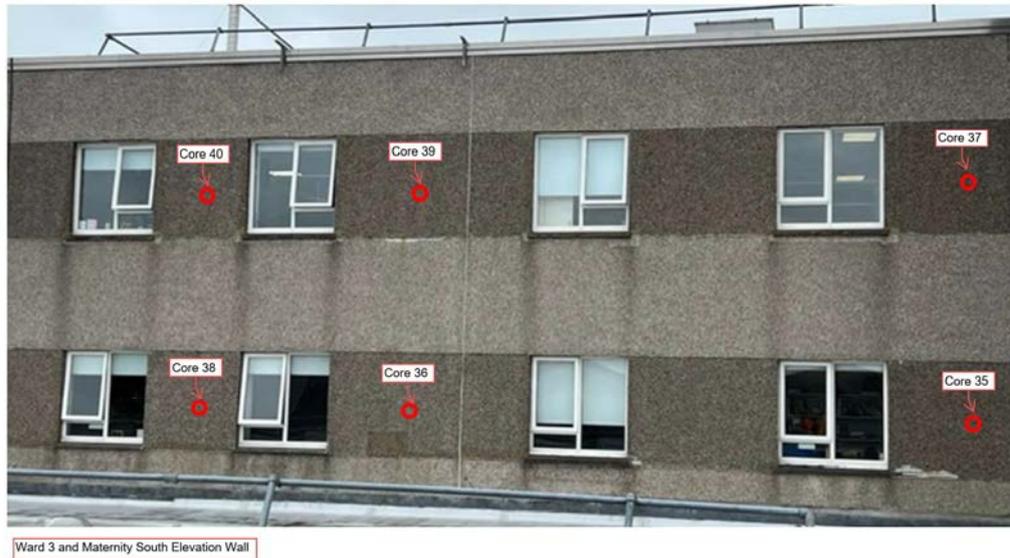
100mm diameter cores were removed from the link between the 3 and 4 Storey buildings and from the south elevation of the 3 Storey building including Ward 3 at the top floor and Maternity on the first floor. The core locations are included in Figures 2.18 and 2.19. Sample photographs of extracted cores, the exposed cavity and wall ties located with an endoscope inspection are included in Appendix F. Notes of key findings at each core location are also included in Appendix F. The core inspections confirmed that the outer leaf was of good quality dense concrete blocks with some weak and some reasonable mortar jointing. Wall ties were present in the cavity but were difficult to locate due to the narrow cavity and significant amount of mortar droppings in the cavity. The wall ties were of the vertical twist type and where they could be inspected closely appeared to be in good condition.

Figure 2.18: Cores at the Link west elevation of Ward 3 and Maternity

Figure 2.19: 3 Storey south wall cores” – Cores at the south elevation of Ward 3 and Maternity

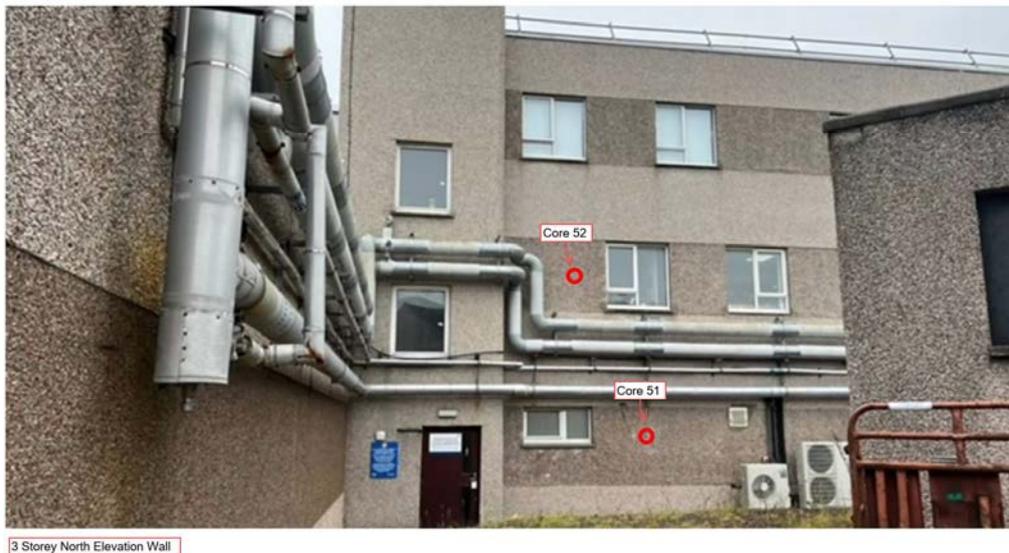
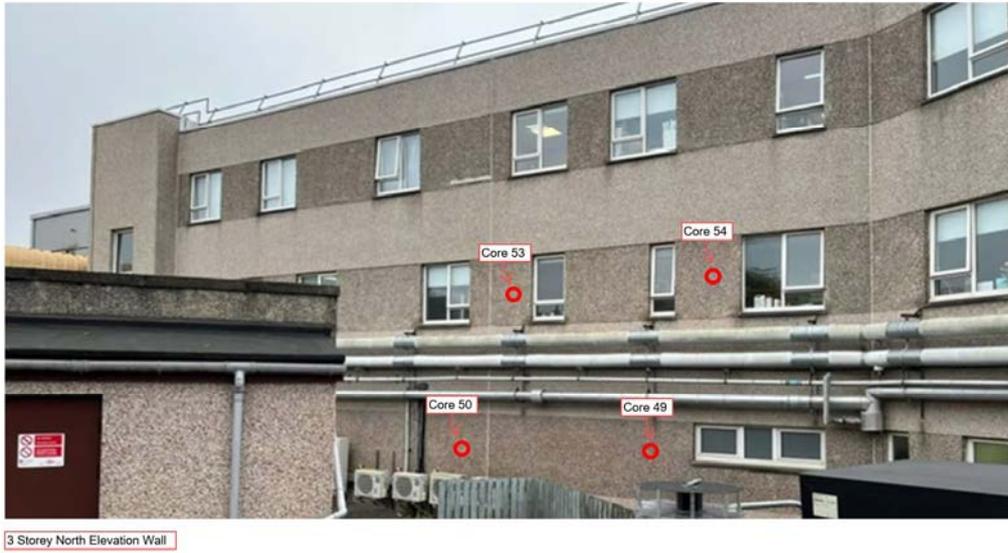
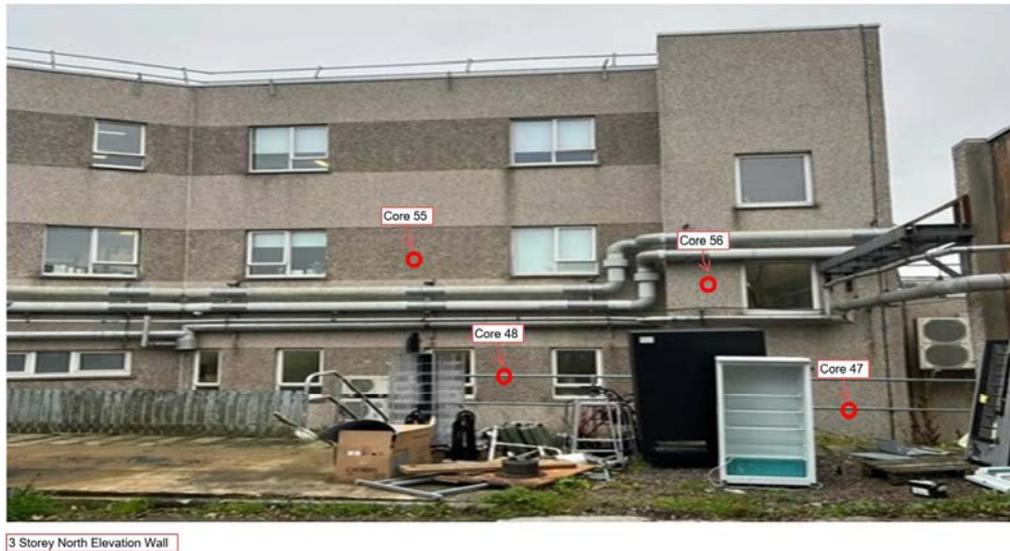
100mm diameter cores were removed from the north elevations of the 3 Storey building. The north elevation includes Ward 3 at the upper floor, Maternity and Renal at the first floor and A&E and X-Ray at the ground floor. The core locations are included in Figures 2.25 to 2.27 inclusive. Sample photographs of extracted cores, the exposed cavity and wall ties located with an endoscope inspection are included in Appendix I. Notes of key findings at each core location are also included in Appendix I. The core inspections confirmed that the outer leaf was of good quality dense concrete blocks with reasonable mortar jointing. Wall ties were present in the cavity but were difficult to locate due to the narrow cavity and significant amount of mortar droppings in the cavity. The wall ties were of the vertical twist type and where they could be inspected closely appeared to be in good condition. Dry dash render was noted to boss at the west side of the north elevation wall and boss in patches towards the east side of the wall.

Figure 2.25: Cores at the 3 Storey north elevation wall 1 of 3

Figure 2.26: Cores at the 3 Storey north elevation wall 2 of 3

Figure 2.27: Cores at the 3 Storey north elevation wall 3 of 3

We would not consider that remedial works are required to the north elevation of the 3 Storey building other than identifying and replacing areas of boss render which present a hazard of falling onto the footpath below. At the single storey Outpatients wall adjacent to the entrance area the mortar was found to be poor but from visual inspection we do not consider there to be a high risk of the outer leaf wall displacing relative to the inner leaf wall and no remedial works are recommended for this area.

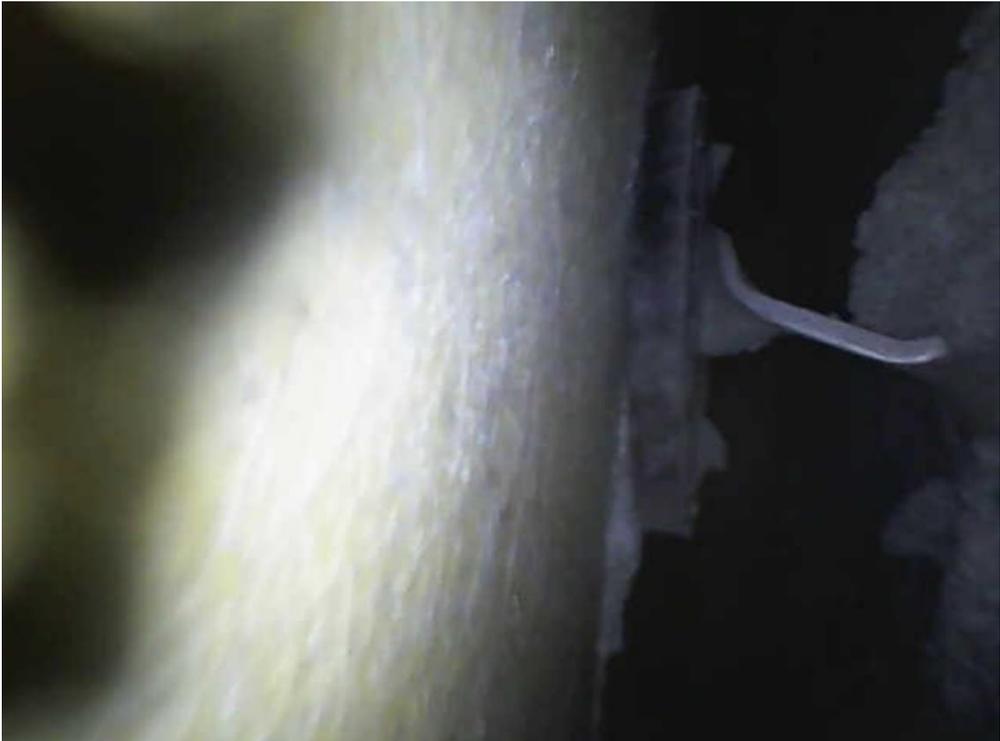
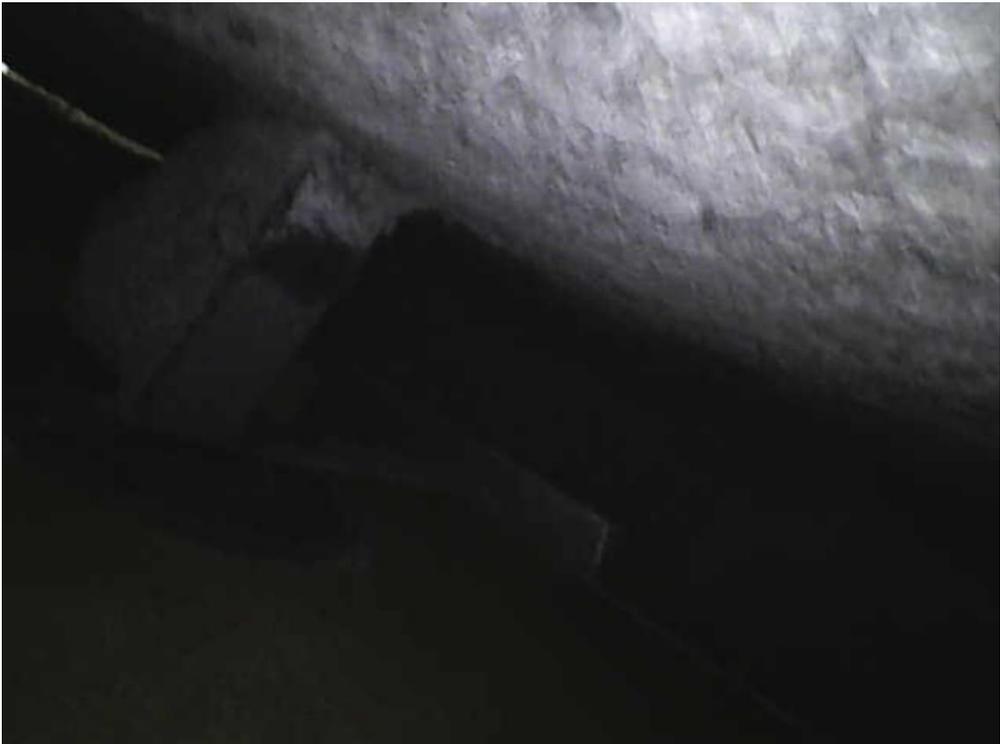
Block reference	Block condition	Mortar condition	No of Wall Ties found and condition	Comments
Block 1 (east wall)	100mm thick dense concrete in good condition	Poor – inner leaf weak and friable; outer leaf very weak and friable	3no to upper, lower and right side of block within 450mm and 2 no adjacent to RC column to left of block/good	105mm cavity overall with 25mm insulation board displaced 20mm off inner leaf wall. Insufficient wall tie embedment in outer leaf.
Block 2 (east wall)	100mm thick dense concrete in good condition	Poor – inner leaf weak and friable; outer leaf very weak and friable	4no to top of block, upper right, lower left and lower right side of block within 900mm/good	90mm cavity overall with 25mm insulation board displaced 20mm off inner leaf wall. Wall tie at top of block slightly loose. Insufficient wall tie embedment in outer leaf.
Block 3 (south wall)	100mm thick dense concrete in good condition	Poor – inner leaf very weak and friable; outer leaf very weak and friable	4no to top of block, upper, upper right and lower right side of block within 450mm and 2 no adjacent to RC column to left of block/good	95mm cavity overall with 25mm insulation board displaced 20mm off inner leaf wall. Wall tie at top of block loose. Insufficient wall tie embedment in outer leaf. Mortar sample taken

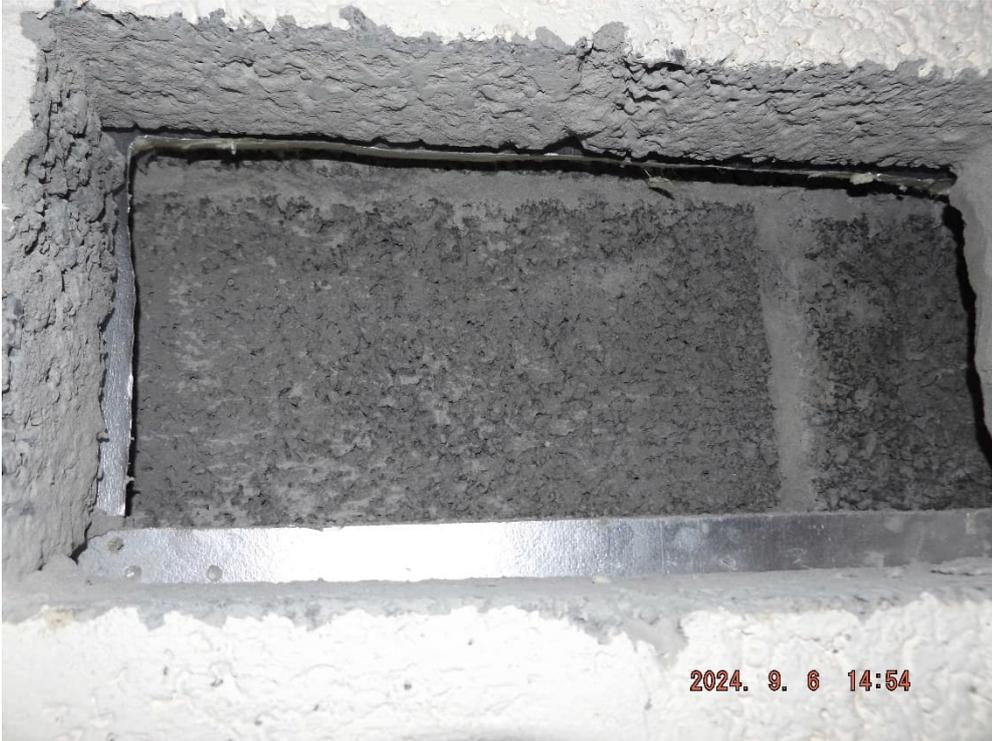
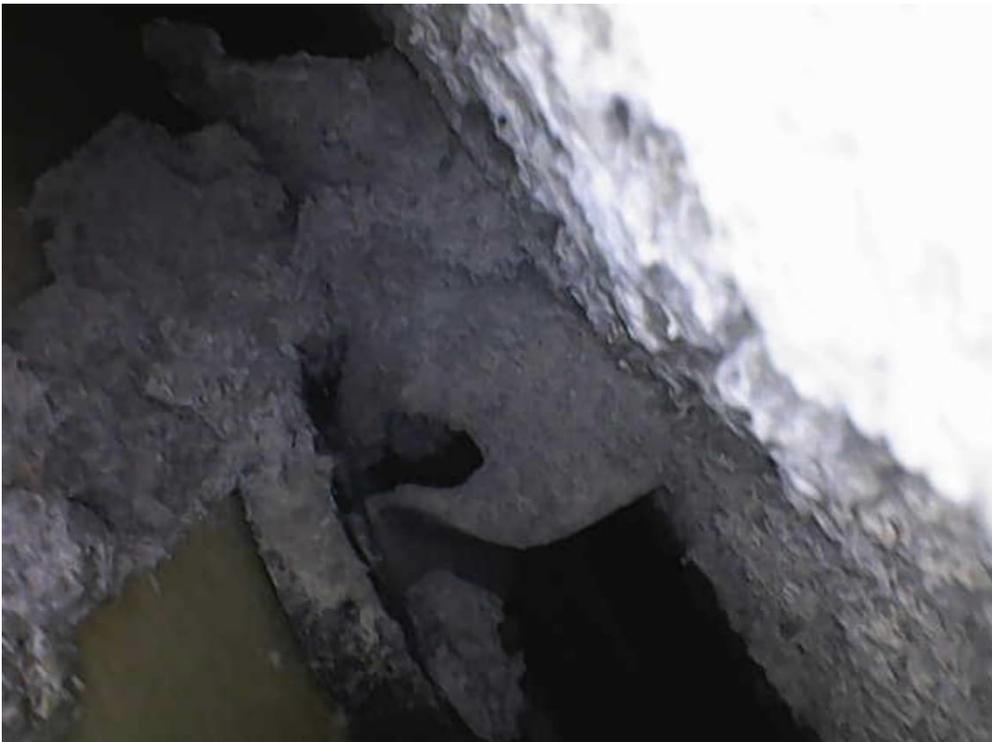
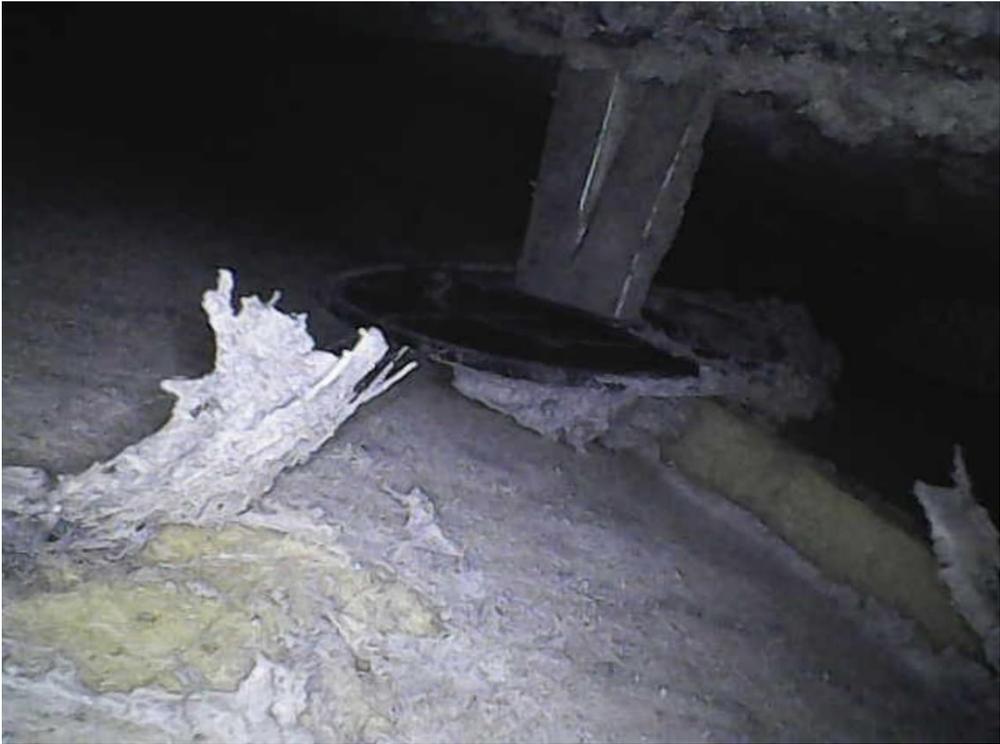
Block 4 (north wall)	100mm thick dense concrete in good condition	Poor – inner leaf very weak and friable; outer leaf very weak and friable	3no to upper, lower and left side of block within 450mm and 2 no adjacent to RC column to right of block/covered in mortar	75mm cavity overall with 25mm insulation board displaced 15mm off inner leaf wall. Insufficient wall tie embedment in outer leaf. Mortar sample taken

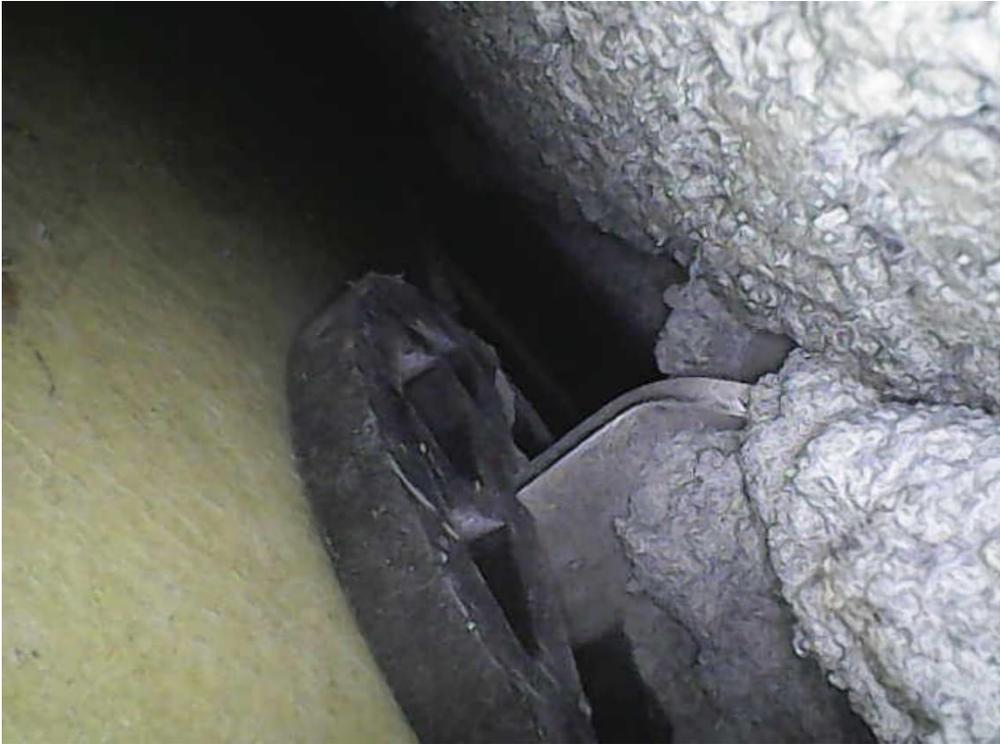
Wall tie at Core 19

Core 19	100mm thick dense concrete in good condition	Reasonable – strength of mortar satisfactory	1no at core/good. 2no suspected 900mm above and 600mm to right lower of core/covered with mortar	30mm cavity to 25mm insulation board. Lot of mortar droppings in cavity
Core 20	100mm thick dense concrete in good condition	Poor –weak and friable	2no 350mm to upper left and 250mm to lower right of core/good. 1no suspected tie 800mm to upper right/covered with mortar	30mm cavity to 25mm insulation board. Lot of mortar droppings in cavity

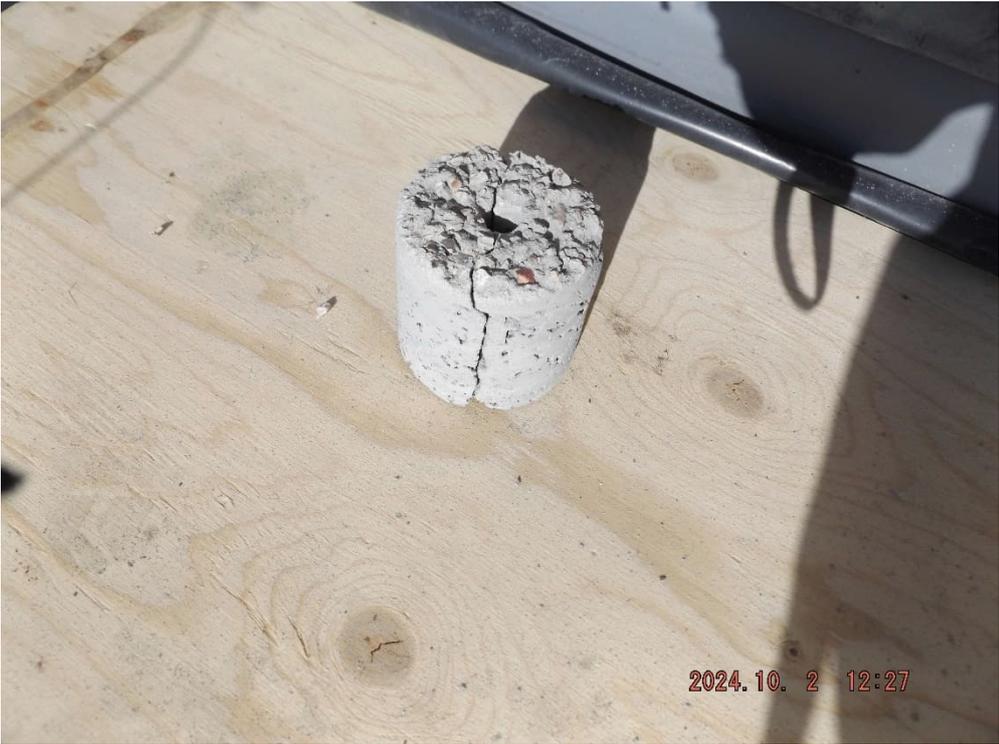
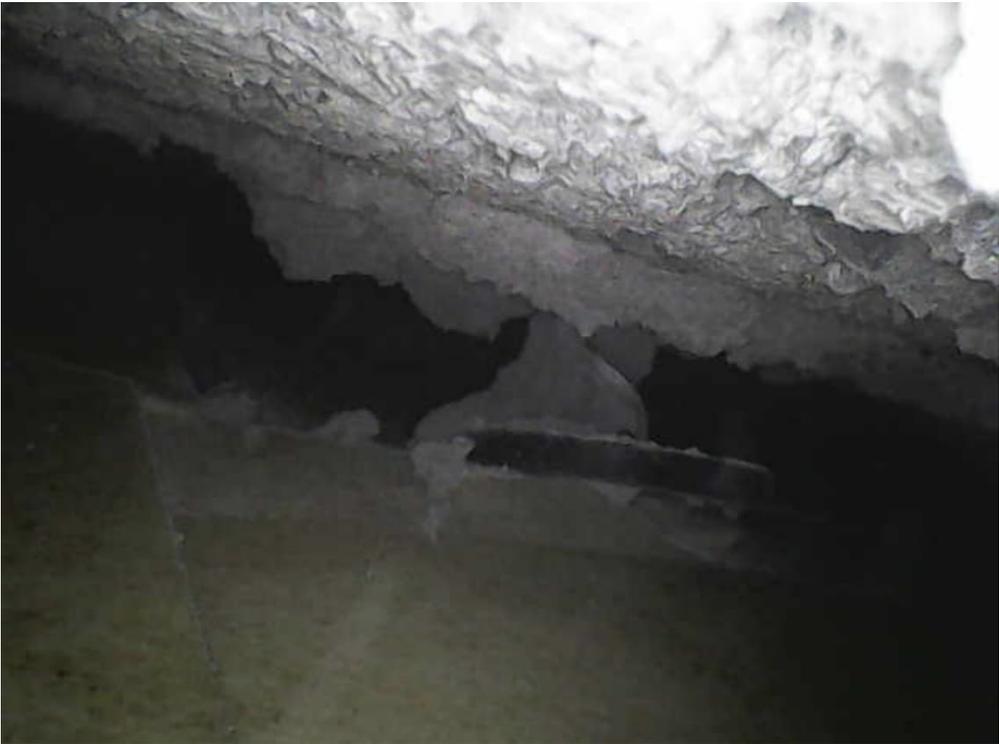
Core reference	Block condition	Mortar condition	No of Wall Ties found and condition	Comments
Core 21 (south wall)	100mm thick dense concrete in good condition	Reasonable - mortar satisfactory	2no 600mm above core and 450mm to right of core /good. 1no 1200mm below core/covered with mortar	30mm cavity to 25mm insulation board. Lot of mortar droppings in cavity
Core 22 (south wall)	100mm thick dense concrete in good condition	Poor – weak and friable	1no 300mm to right upper of core/good. 1no 900mm below core/covered with mortar	25mm cavity to 25mm insulation board. Lot of mortar droppings in cavity.
Core 23 (south wall)	100mm thick dense concrete in good condition	Poor – weak and friable	3 no 250mm to left upper of core, 1200mm to right lower of core and 900mm below core/covered in mortar	30mm cavity to 25mm insulation board. Lot of mortar droppings in cavity
Core 24 (south wall)	100mm thick dense concrete in good condition	Poor - weak and friable	2 no 600mm to right upper of core and at core/covered with mortar. 1 no 900mm to right of core/good	35mm cavity to 25mm insulation board. Lot of mortar droppings in cavity

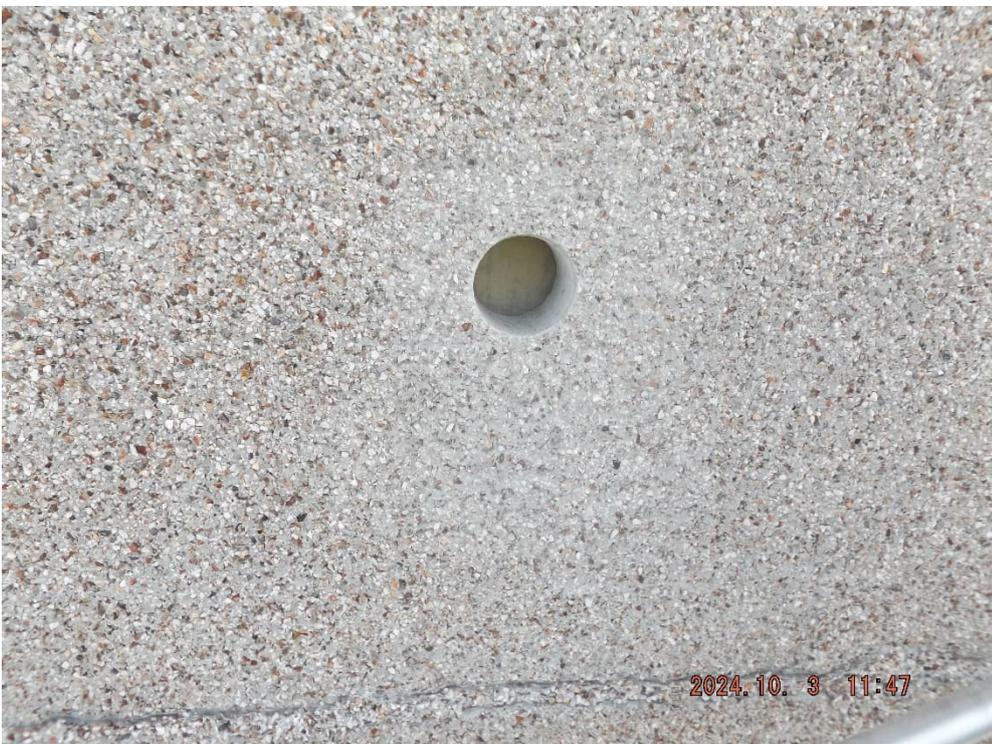
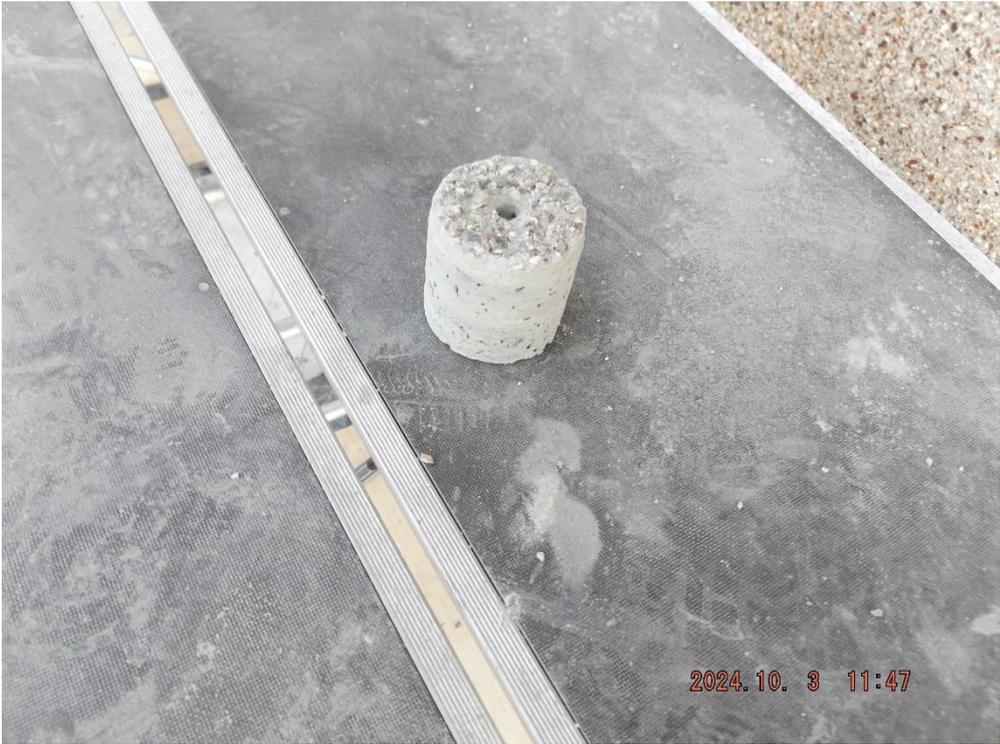
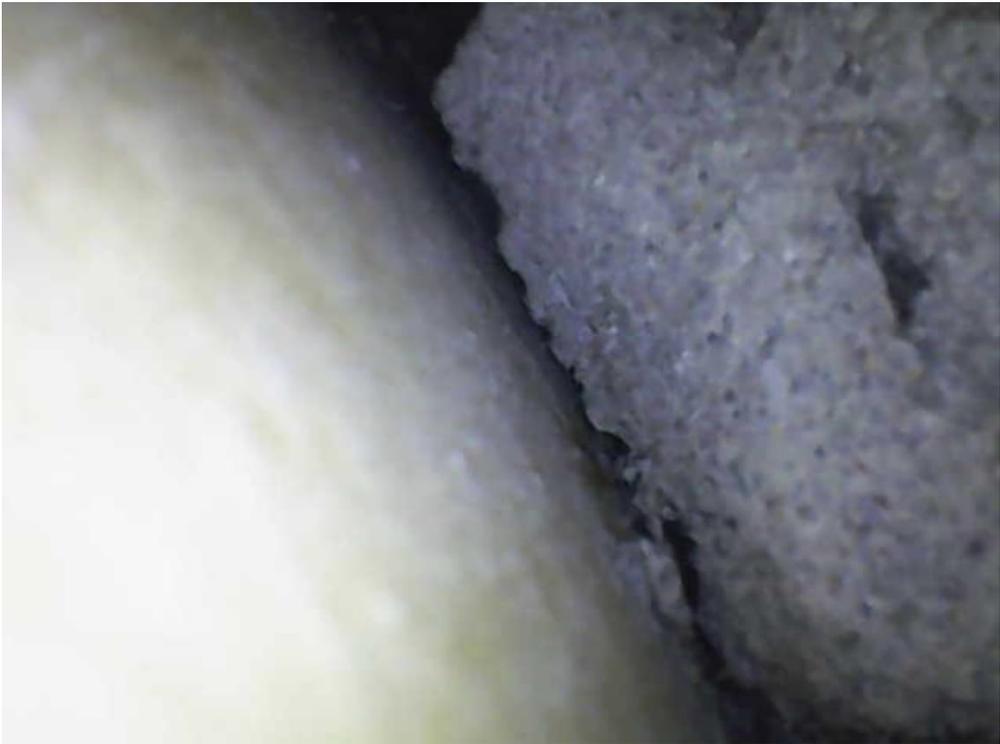
Core 29 (west wall)	100mm thick dense concrete in good condition	Poor –weak and friable	2 no suspected ties 600mm to left upper of core and 200mm to right lower of core/covered with mortar	30mm cavity to 25mm insulation board. Lot of mortar droppings in cavity
Core 30 (west wall)	100mm thick dense concrete in good condition	Poor –weak and friable	Not possible to insert endoscope in cavity as cavity full of mortar	15mm cavity to 25mm insulation board. Lot of mortar droppings in cavity
Core 31 (west wall)	100mm thick dense concrete in good condition	Poor – weak and friable	1 no suspected tie 150mm to left of core/covered with mortar. Mortar in cavity prevents further inspections	20mm cavity to 25mm insulation board. Lot of mortar droppings in cavity.
Core 32 (west wall)	100mm thick dense concrete in good condition	Poor - weak and friable.	1 no suspected tie 950mm to right upper of core/covered with mortar. Mortar in cavity prevents further inspections	35mm cavity to 25mm insulation board. Lot of mortar droppings in cavity.

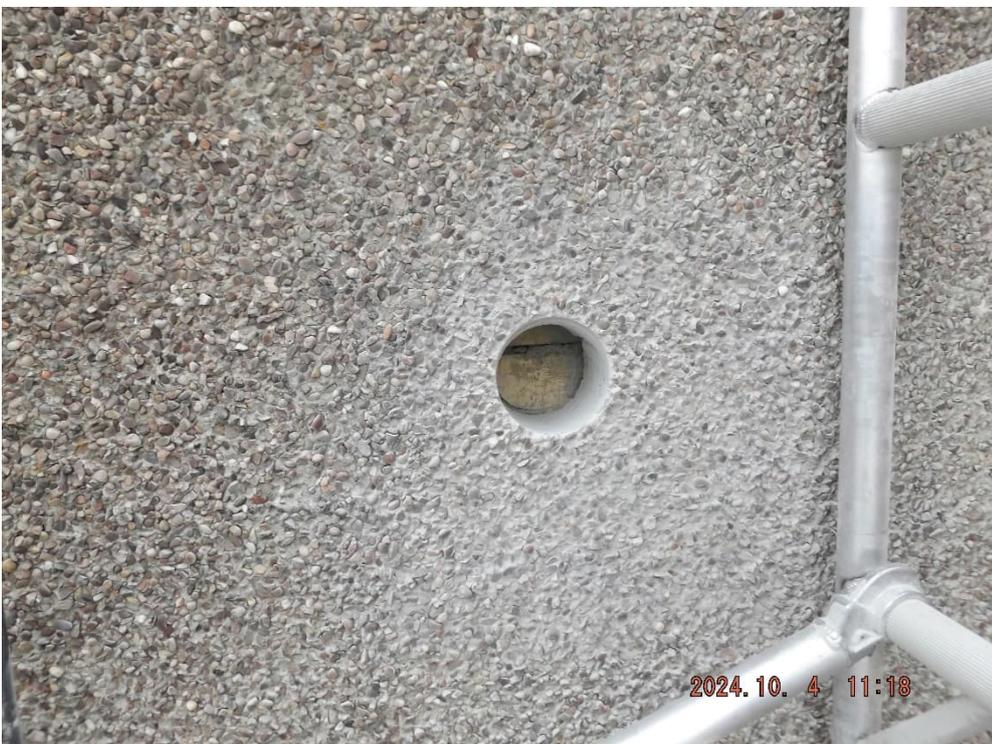
Core 37 (south wall)	100mm thick dense concrete in good condition	Reasonable – strength adequate	2 no 950mm to right upper of core and 300mm to right of core/covered with mortar	10mm cavity to 25mm insulation board. Lot of mortar droppings in cavity
Core 38 (south wall)	100mm thick dense concrete in good condition	Reasonable – strength adequate	3 no 900mm above core, 450mm to left of core and 500mm to right lower of core/good	25mm cavity to 25mm insulation board. Lot of mortar droppings in cavity
Core 39 (south wall)	100mm thick dense concrete in good condition	Reasonable – strength adequate	3 no 300mm above core, 450mm to left of core and 600mm to right lower of core/covered with mortar	10mm cavity to 25mm insulation board. Lot of mortar droppings in cavity
Core 40 (south wall)	100mm thick dense concrete in good condition	Poor to reasonable –low strength	2 no 600mm to left lower of core and 850mm to left lower of core/good	40mm cavity to 25mm insulation board. Lot of mortar droppings in cavity

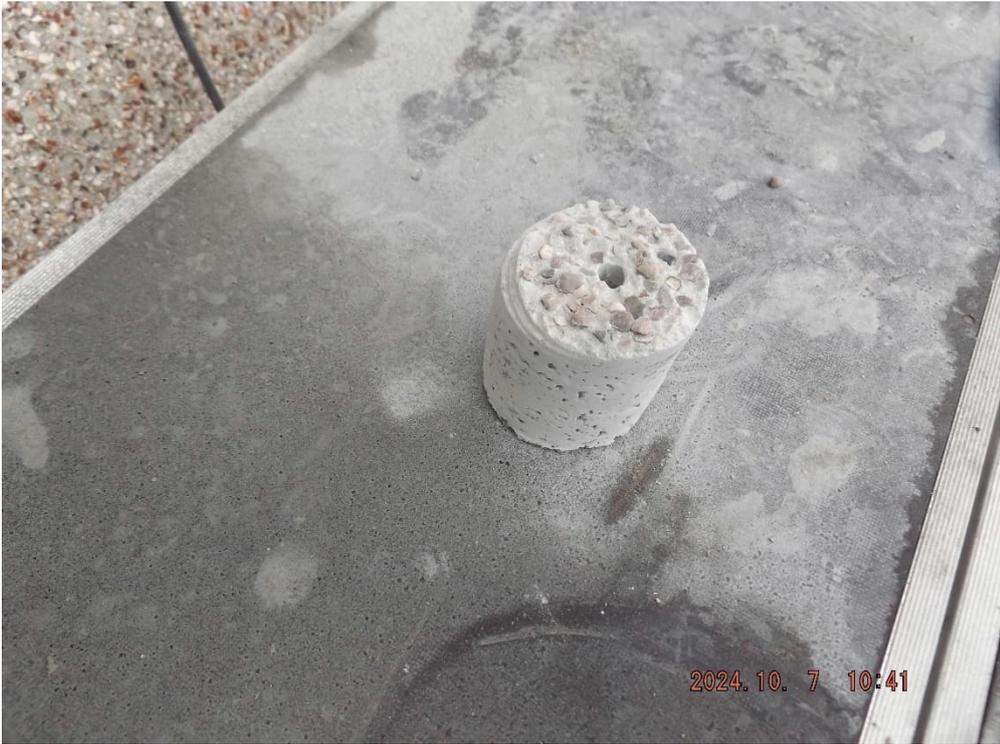
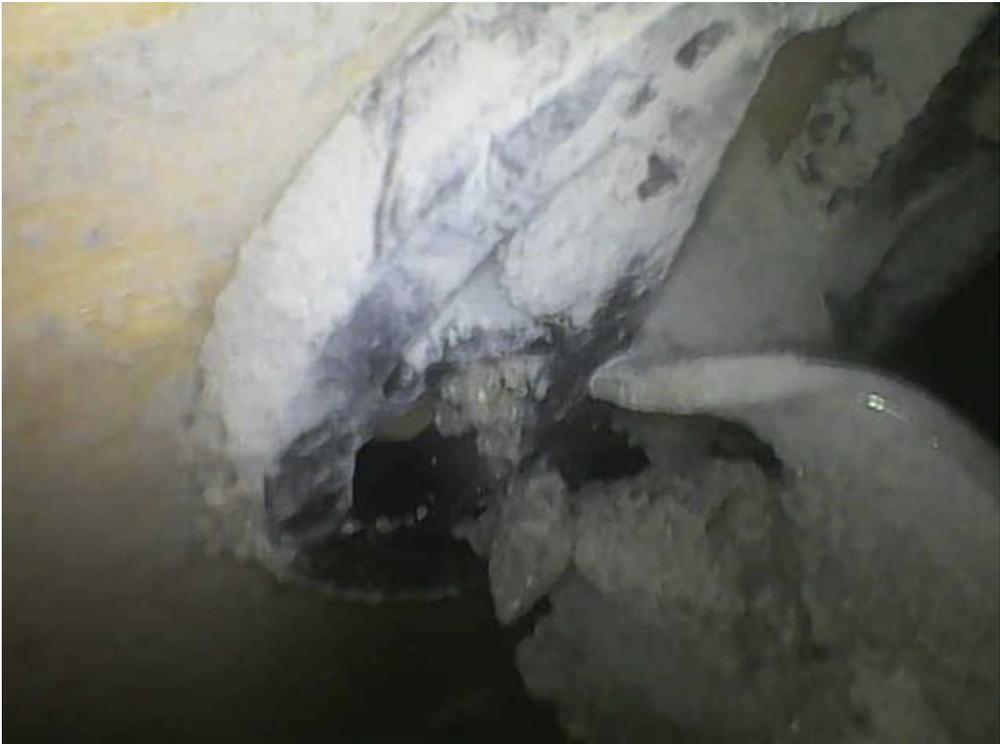
Core reference	Block condition	Mortar condition	No of Wall Ties found and condition	Comments
Core 41 (west wall)	100mm thick dense concrete in good condition	Reasonable – strength adequate	2 no 150mm to left lower and 1200mm to right upper of core /good. 1 no 1350mm to left upper of core/covered with mortar	40mm cavity to 25mm insulation board. Lot of mortar droppings in cavity
Core 42 (west wall)	100mm thick dense concrete in good condition	Poor – weak and friable	1no 250mm to left of core/good. 1no 650mm to right of core/covered with mortar	25mm cavity to 25mm insulation board. Lot of mortar droppings in cavity.
Core 43 (west wall)	100mm thick dense concrete	Poor – very weak and friable. 50%	1no 750mm to right upper of core/good. 1no	30mm cavity to 25mm insulation

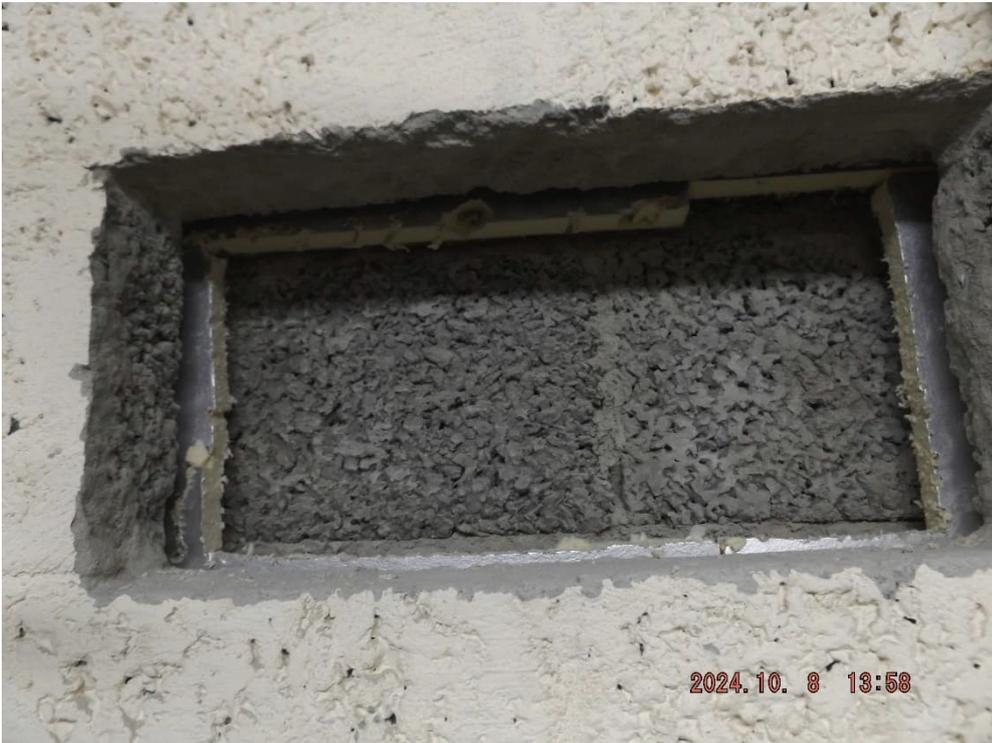
Block 8 (north wall)	100mm thick dense concrete in good condition	Poor – inner leaf very weak and friable; outer leaf very weak and friable	2no 450mm to upper right of block and 450mm to lower right of block/good	80mm cavity overall with 25mm insulation board displaced 20mm off inner leaf wall.

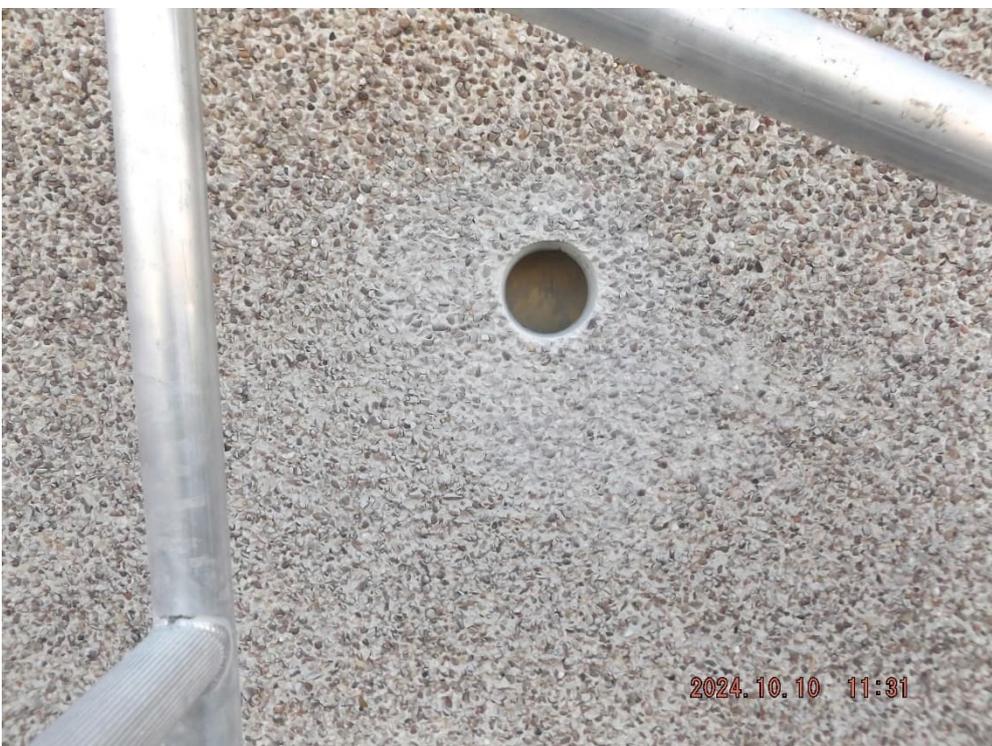
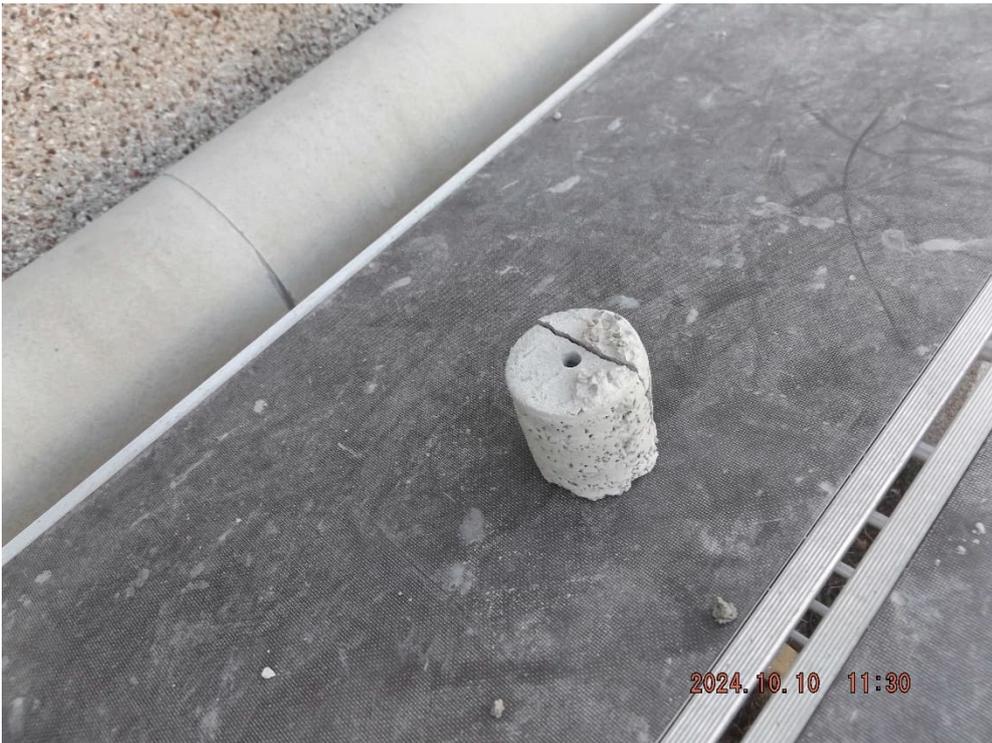
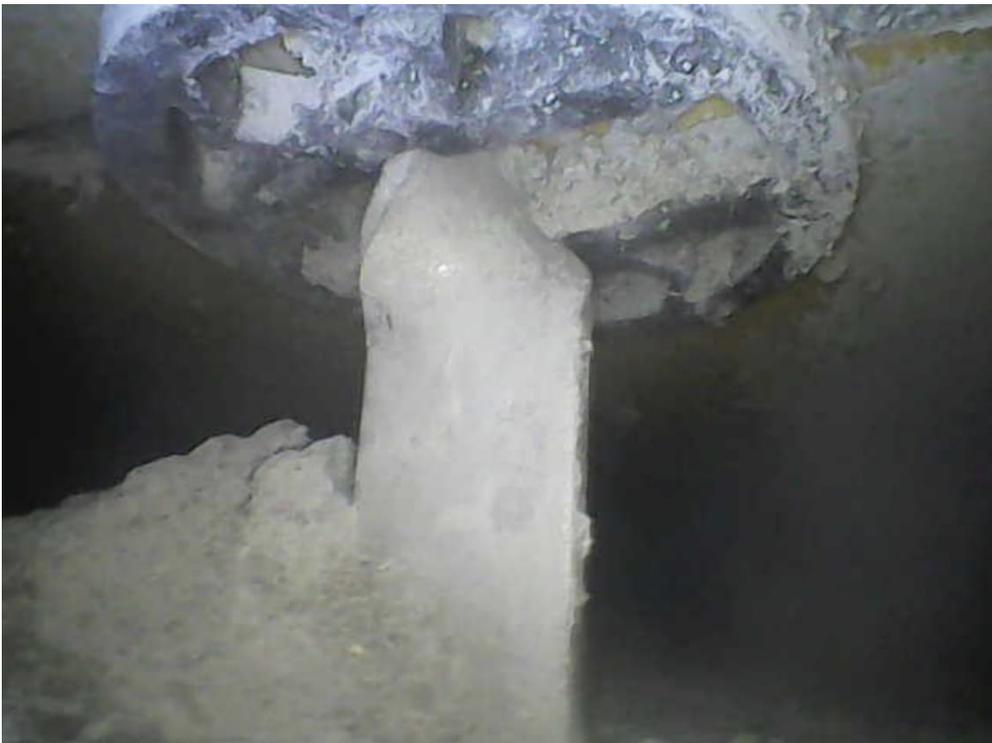
Core 54 (north wall)	100mm thick dense concrete in good condition	Reasonable – mortar strength is adequate	3 no 450mm to right of core, 250mm below core and 1150mm below core/covered with mortar	40mm cavity to 25mm insulation board. Lot of mortar droppings in cavity
Core 55 (north wall)	100mm thick dense concrete in good condition	Reasonable – mortar strength is adequate	2 no 600mm to left upper of core and 50mm below core/good. 1 no 600mm to right upper of core/covered with mortar	50mm cavity to 25mm insulation board. Lot of mortar droppings in cavity
Core 56 (north wall)	100mm thick dense concrete in good condition	Poor to reasonable – low strength	3 no 400mm to right upper, 600mm to left lower and 600mm to right lower of core/covered with mortar	30mm cavity to 25mm insulation board. Lot of mortar droppings in cavity
