Gilbert Bain Hospital Phase 1 Construction

Report on Condition of External Walls

December 2024

Document reference: 100106891NH03 | 01 | A |

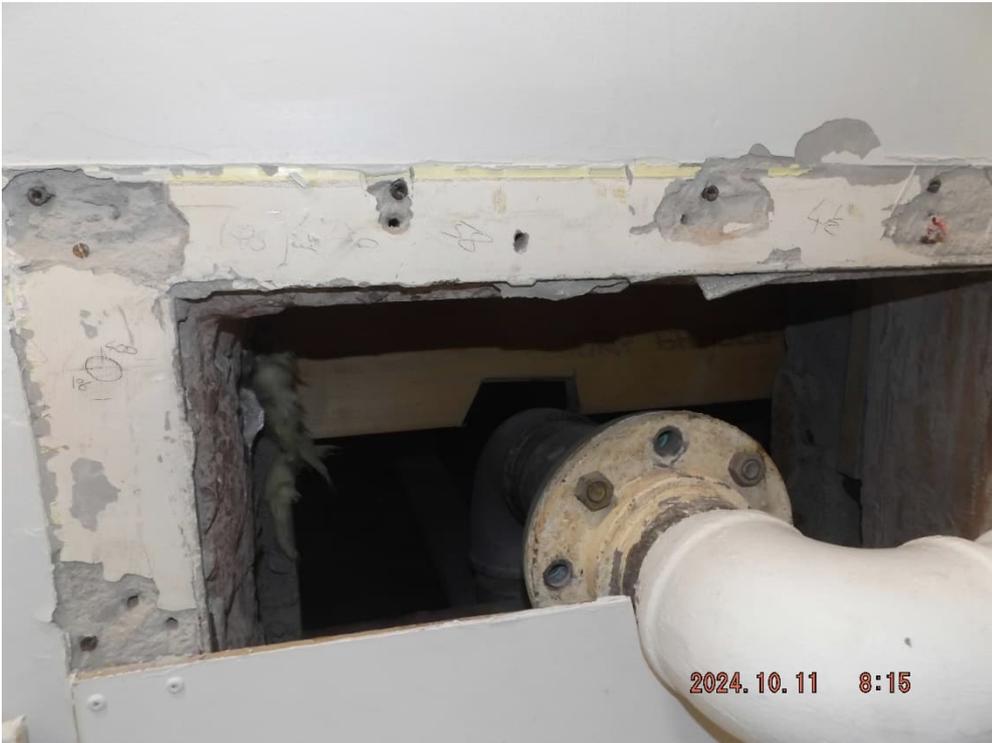
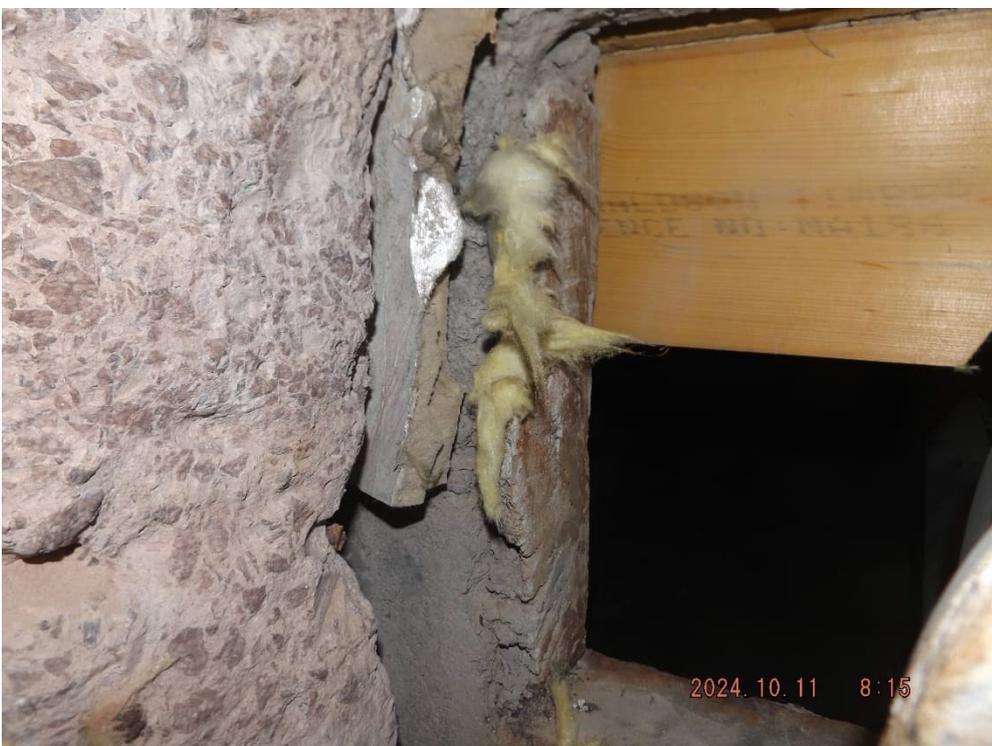
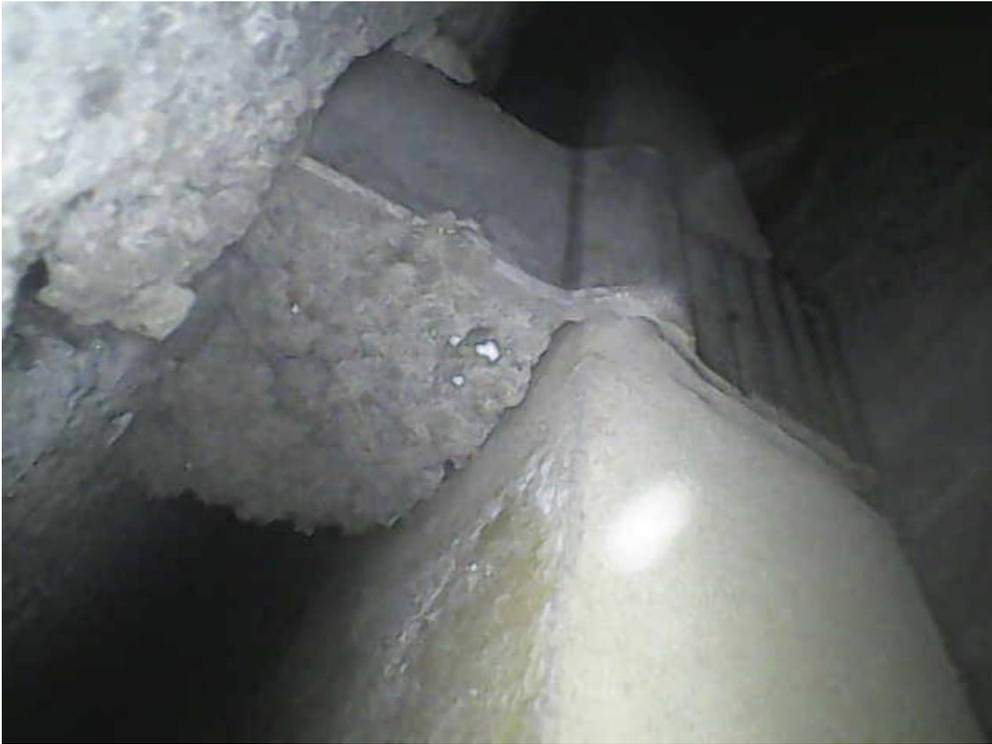
Core reference	Block condition	Mortar condition	No of Wall Ties found and condition	Comments
Visual inspection (south wall, ground storey)	100mm thick dense concrete outer leaf block in good condition. 200mm thick inner leaf of either dense concrete block or insitu concrete in good condition	Reasonable – mortar strength is adequate	2 no 450mm to right of service opening and 450mm to left of service opening/good. 1 no 450mm above service opening/covered with mortar.	65mm width cavity. No insulation noted at service opening for dry riser. Lot of mortar droppings in cavity.
Core 57 (east wall, ground storey)	100mm thick dense concrete in good condition	Reasonable – mortar strength is adequate	2 no 250mm to left upper of core and 700mm to right of core/covered with mortar	15mm cavity to 25mm insulation board. Lot of mortar droppings in cavity. Cavity width is 50mm overall. 150mm loadbearing stud wall construction in

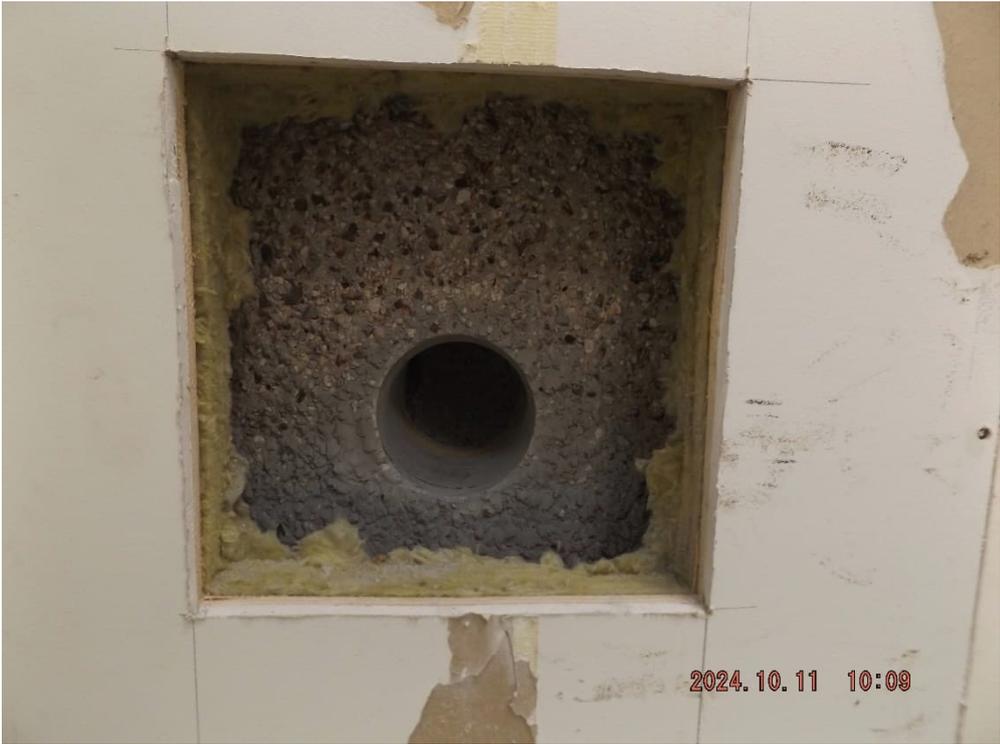
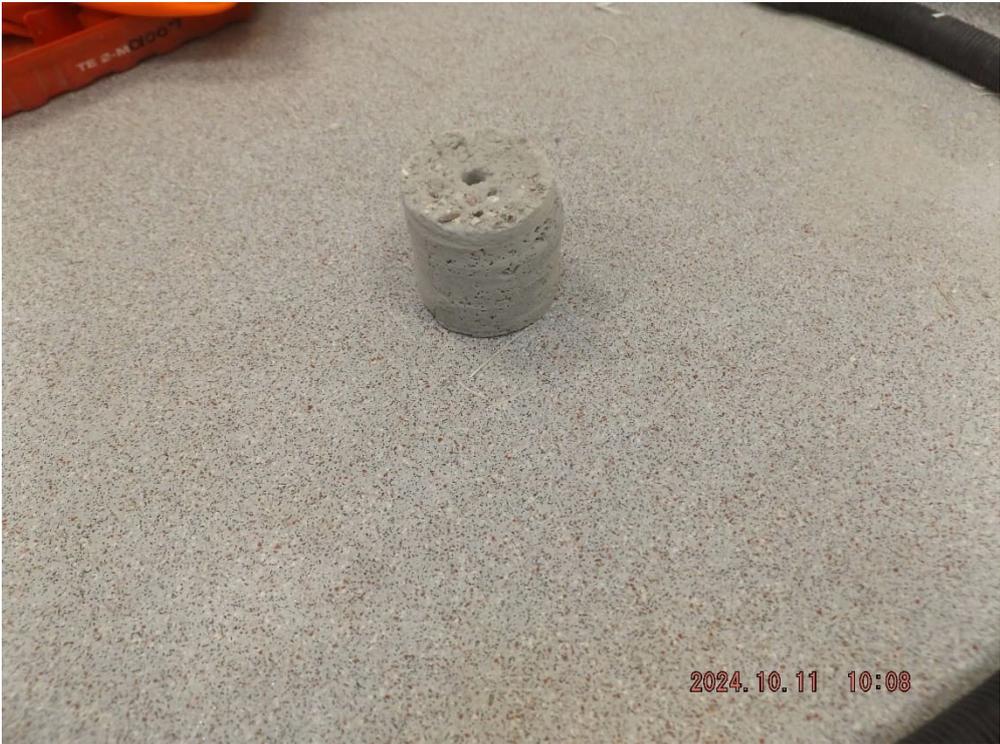
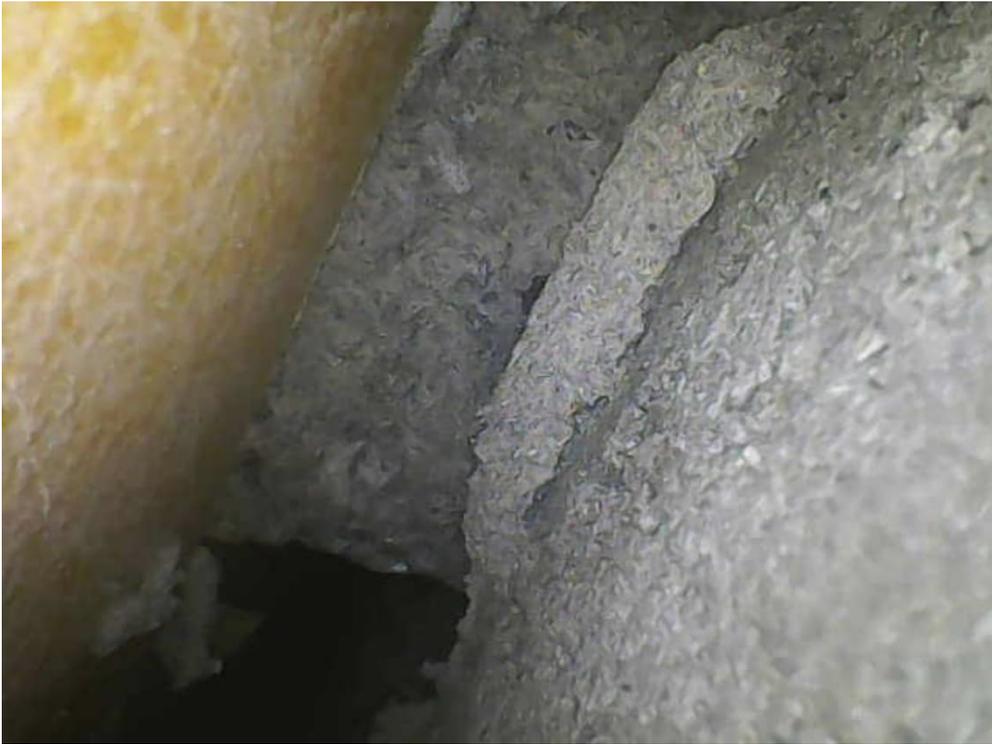
Outpatients Consulting Room 1 noted to east of Phase 1 construction
Core 58 (south wall, solum level)	100mm thick dense concrete in good condition. Inner leaf either of dense concrete block or insitu concrete in good condition	Reasonable – mortar strength is adequate	2 no 600mm to right upper of core and 600mm to left upper of core/good	60mm width cavity. No insulation noted. Lot of mortar droppings in cavity. Concrete solum with 1125mm high blockwork to wall plate.
Core 59 (south wall, solum level)	100mm thick dense concrete in good condition. Inner leaf of insitu concrete in good condition	Reasonable – mortar strength is adequate	2 no 600mm to left upper of core and 450mm to right of core/good	65mm width cavity. No insulation noted. Lot of mortar droppings in cavity. Concrete solum with 990mm high blockwork to wall plate.
Core 60 (east wall, solum level)	100mm thick dense concrete in good condition	Reasonable – mortar strength is adequate	1 no 700mm to right upper of core/good. 1 no 100mm to right of core/covered with mortar	55mm width cavity. No insulation noted. Lot of mortar droppings in cavity. 140mm loadbearing blockwork wall substructure in Outpatients Consulting Room 1 noted to east of Phase 1 construction

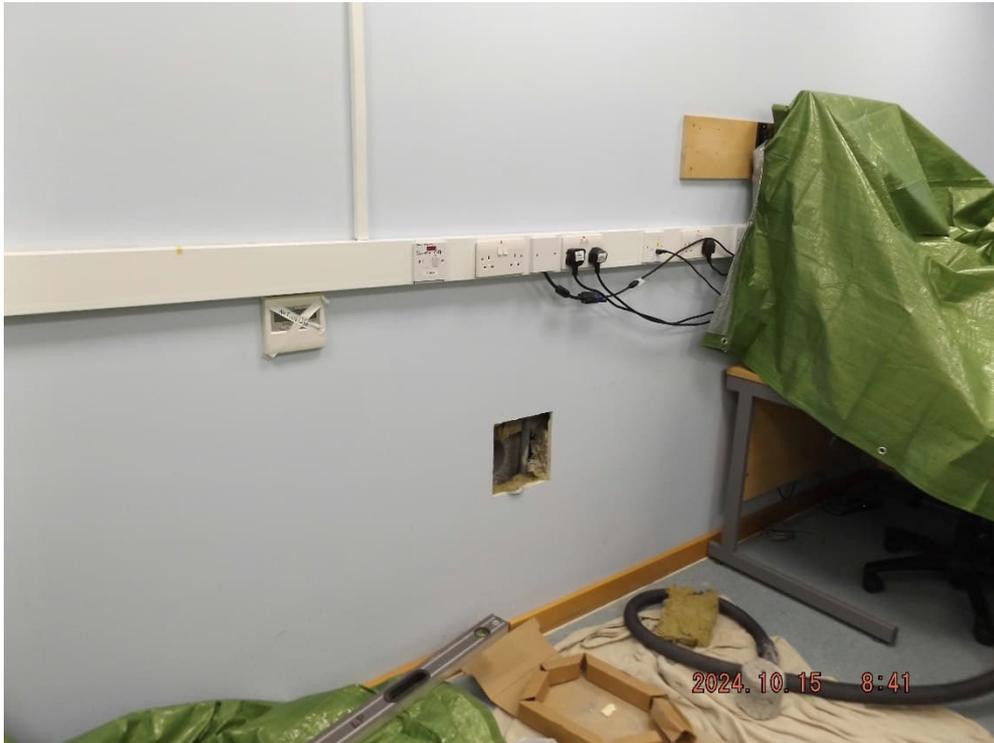
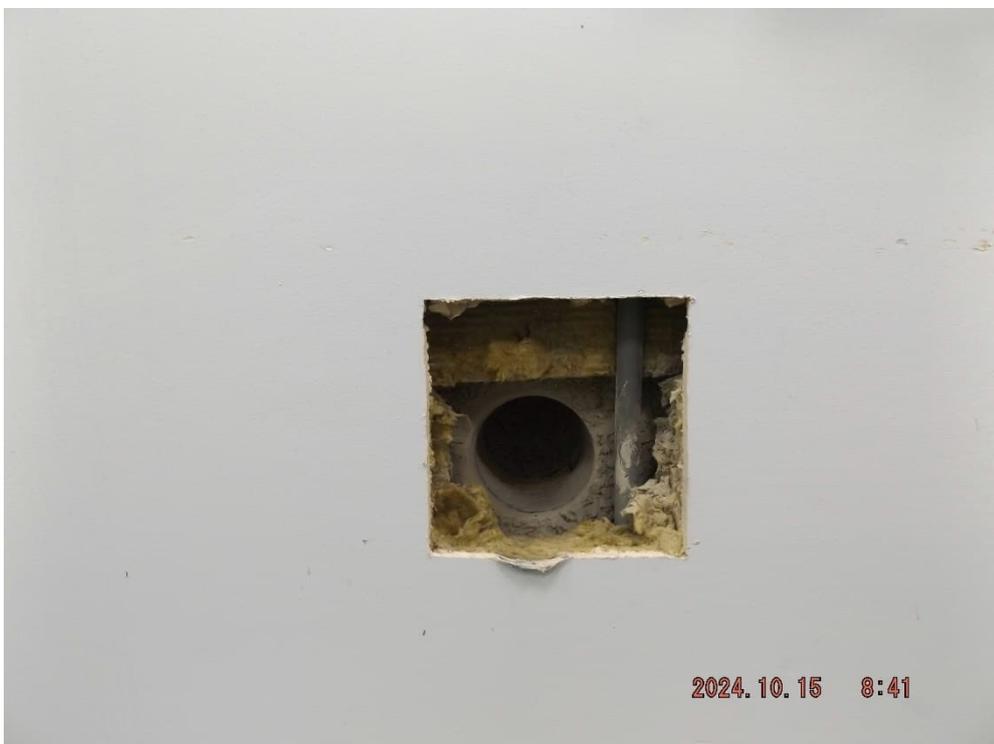
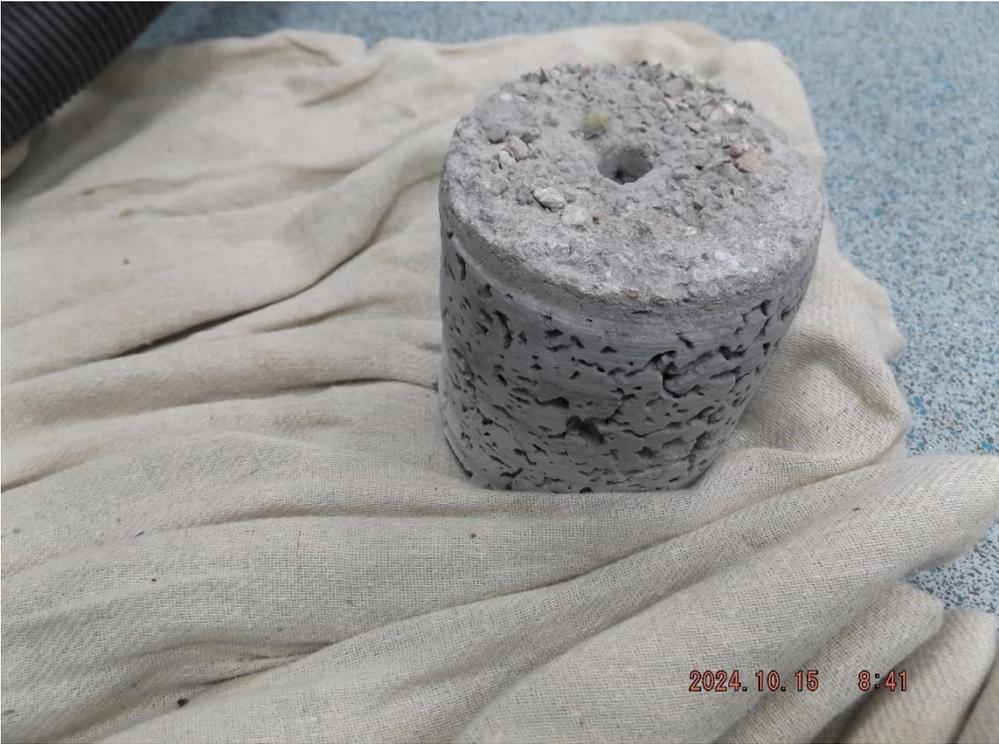
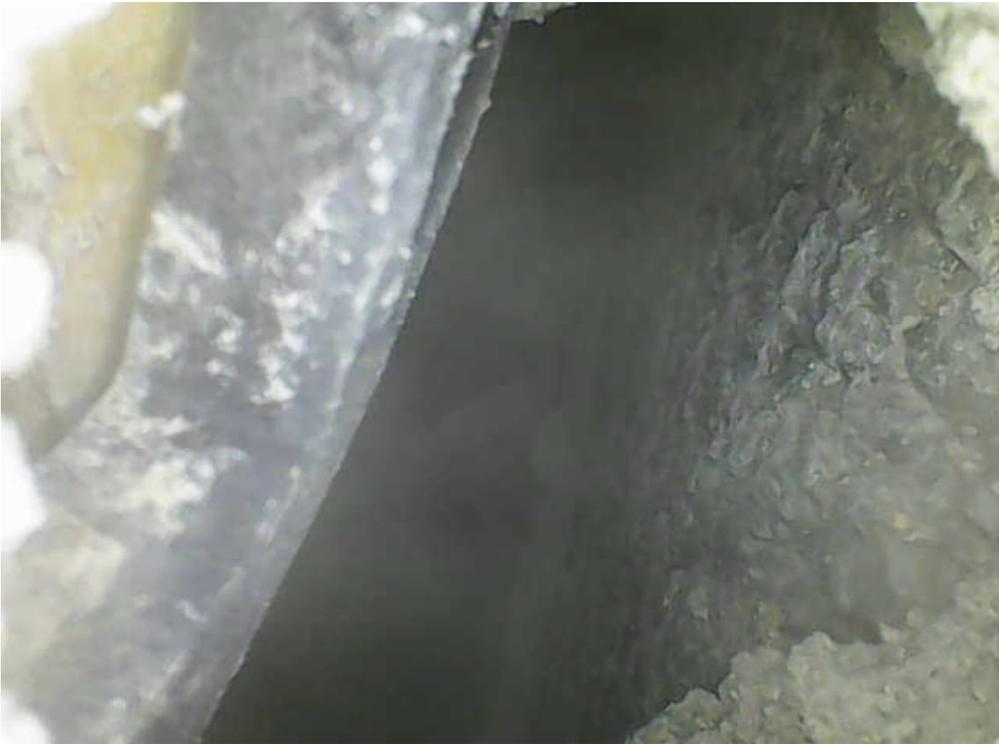
Core 62 (east wall, ground storey)	100mm thick dense concrete in good condition	Reasonable – mortar strength is adequate	2 no 600mm to left upper of core and 600mm to left lower of core/covered with mortar	20mm cavity to 25mm insulation board. Lot of mortar droppings in cavity. Cavity width is 55mm overall. 105mm non-loadbearing stud wall construction in ECG ETT room noted to east of Phase 1 construction

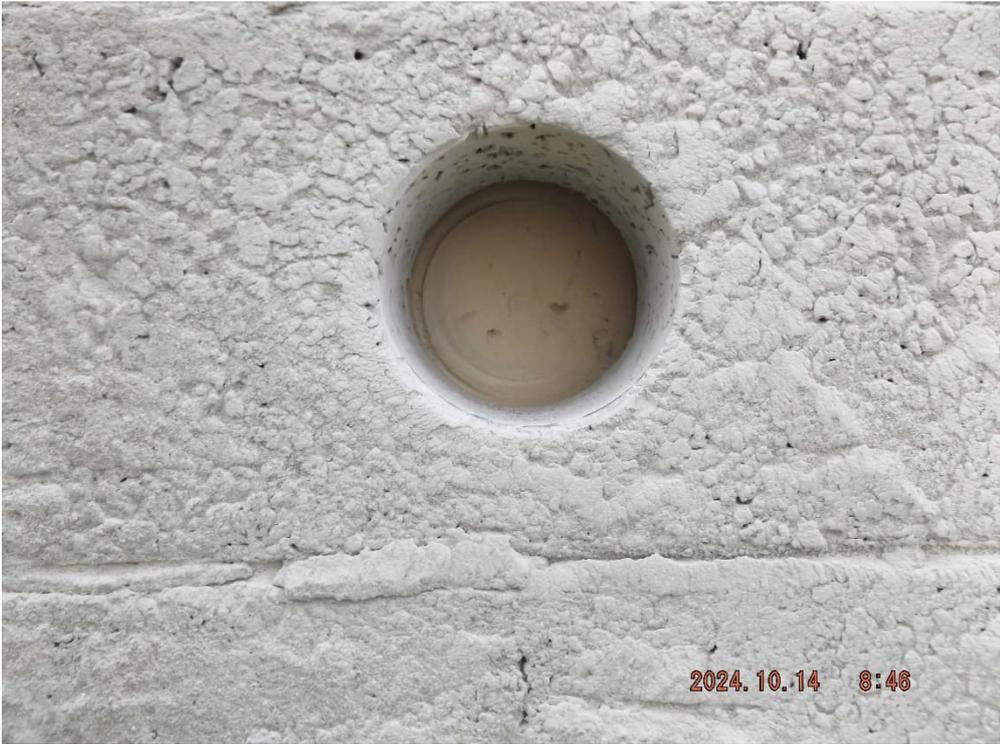
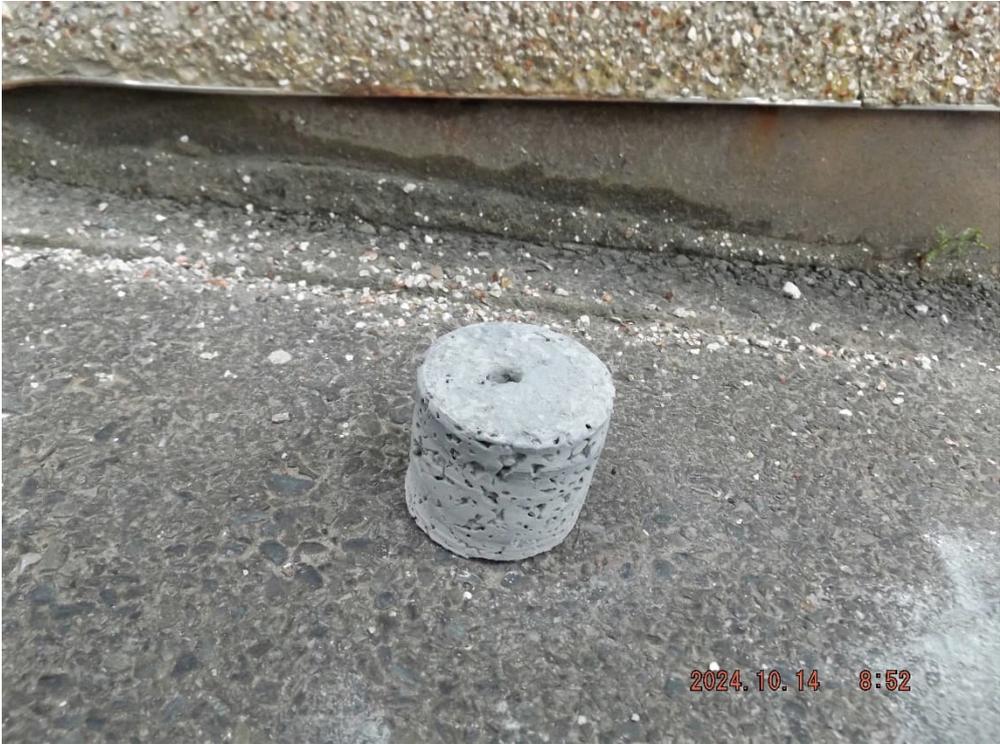
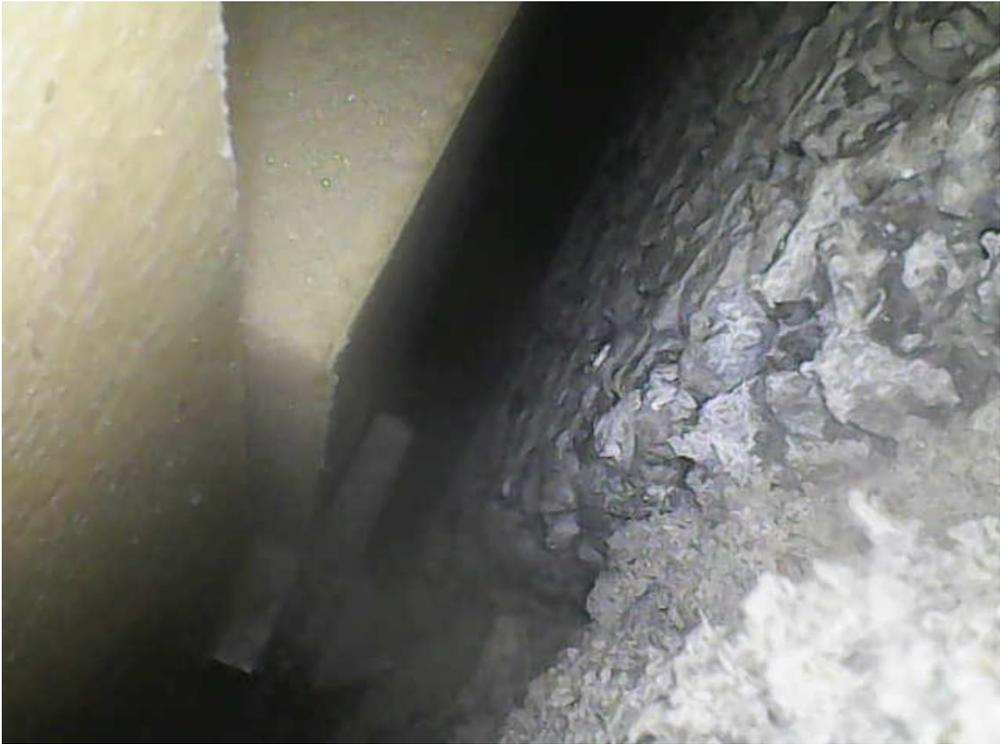
Core reference	Block condition	Mortar condition	No of Wall Ties found and condition	Comments
Core 61 (west wall, single storey)	100mm thick dense concrete in good condition.	Poor – weak and friable	2 no 200mm above and 900mm to right upper of core/good.	20mm cavity to 25mm insulation board. Lot of mortar droppings in cavity. Boss render has been removed previously due to proximity to main entrance.
Inner leaf block removed (3 Storey building stairwell north elevation wall)	140mm thick dense concrete inner leaf block in good condition	Poor to reasonable – low strength mortar in both inner and outer leafs	1 no at top of block/good. 1 no 600mm to left lower of block/covered with mortar	15mm gap to 25mm insulation board. Lot of mortar droppings in cavity. Cavity width is 60mm overall.

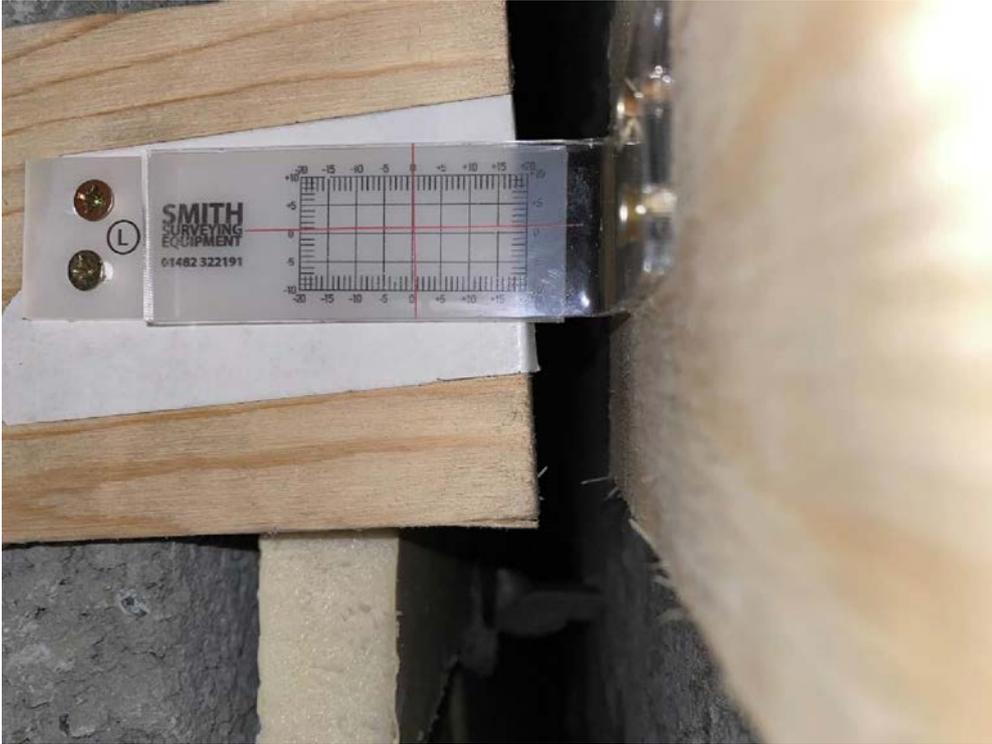
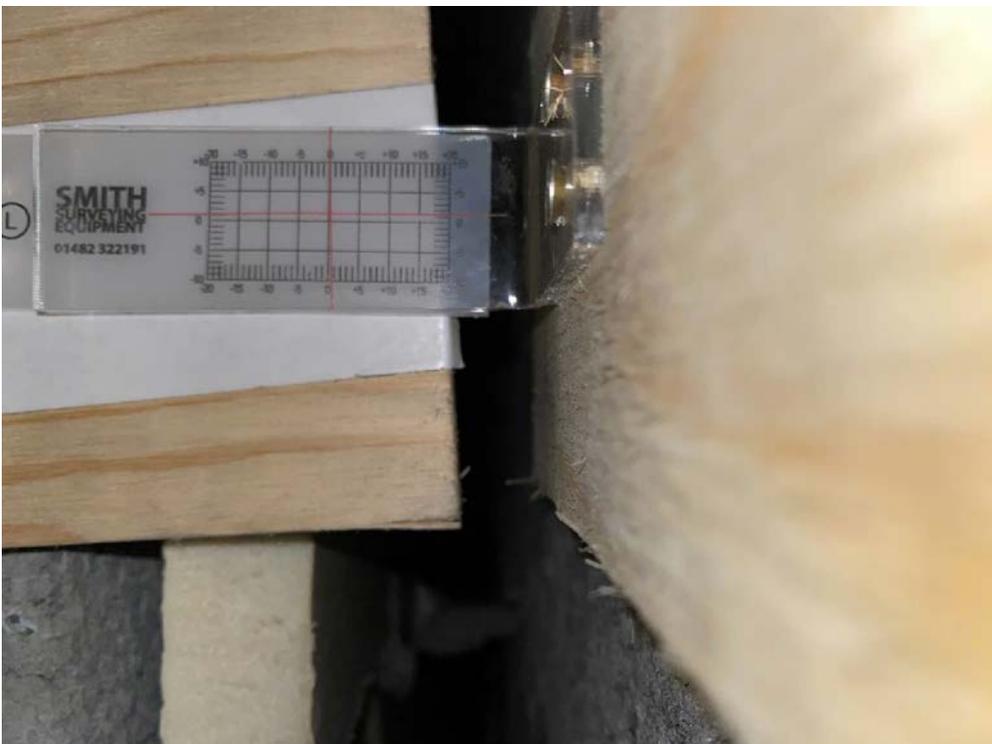
Block reference	Cavity width (October 2024)	Tell tale reading on 18/10/24	Tell tale reading on 21/10/24	Comments
Block 1 (Water Tank Room east wall)	105mm	+0.45mm	+0.45mm	No difference in readings
Block 2 (Water Tank Room east wall)	90mm	+1.85mm	+1.7mm	0.15mm difference in readings is thought to be due to a slight variance in the position of the camera
Block 3 (Water Tank room south wall)	95mm	-2.9mm	-2.9mm	No difference in readings
Block 4 (Water Tank Room north wall)	75mm	N/A	N/A	N/A
Block 5 (Lift Motor Room west wall)	80mm	N/A	N/A	N/A
Block 6 (Lift Motor Room south wall)	80mm	N/A	N/A	N/A
Block 7 (Plant Room west wall)	90mm	-2.85mm	-2.85mm	No difference in readings
Block 8 (Plant Room north wall)	80mm	N/A	N/A	N/A

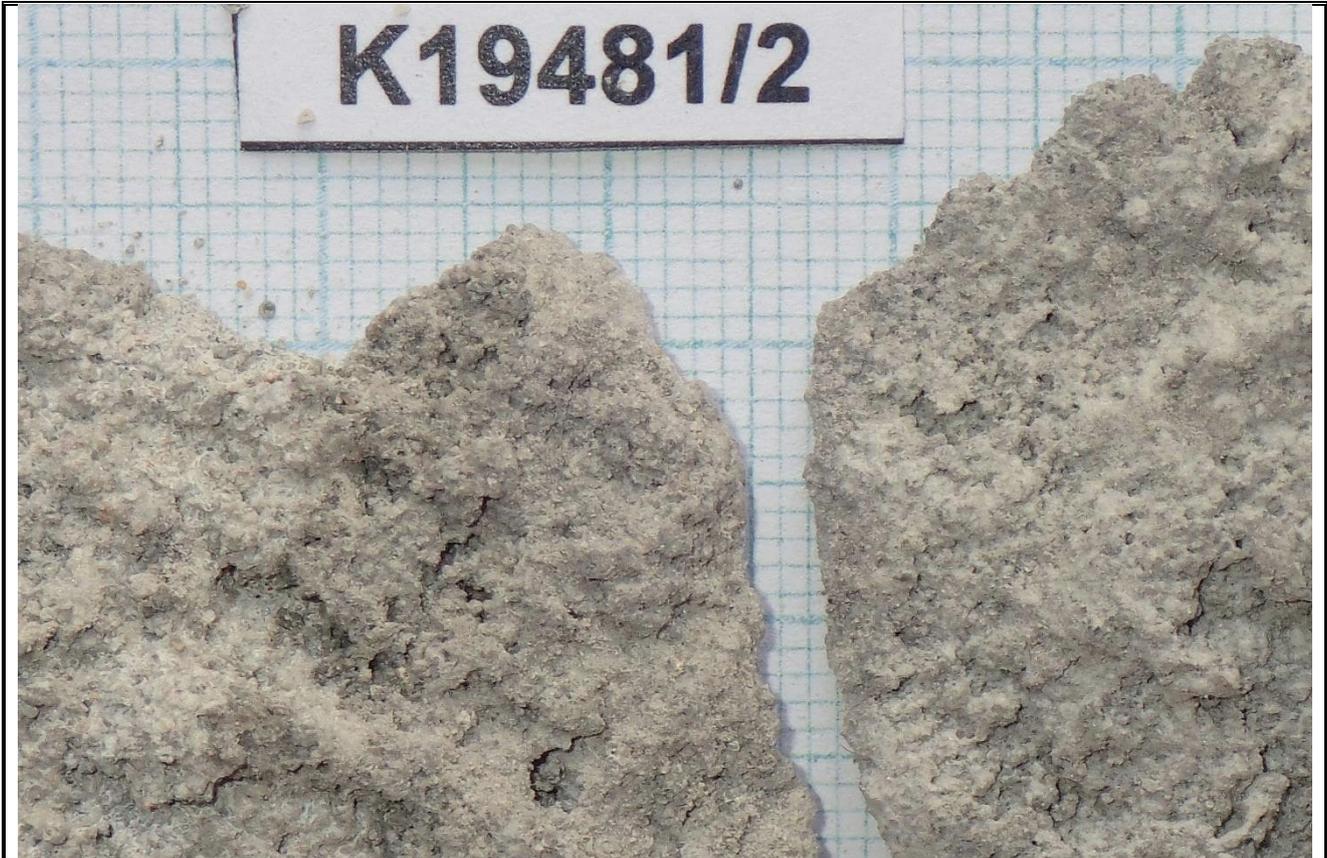
Figure B2

Laboratory reference	Client sample reference	Level of deterioration (1 = Low / 10 = High)
K19481/2	Outer leaf, Core 11, 1 of 2	Level 1
K19481/5	Inner leaf, East Elevation (South)	Level 1

Sample K19481/2 (Outer leaf, Core 11, 1 of 2)

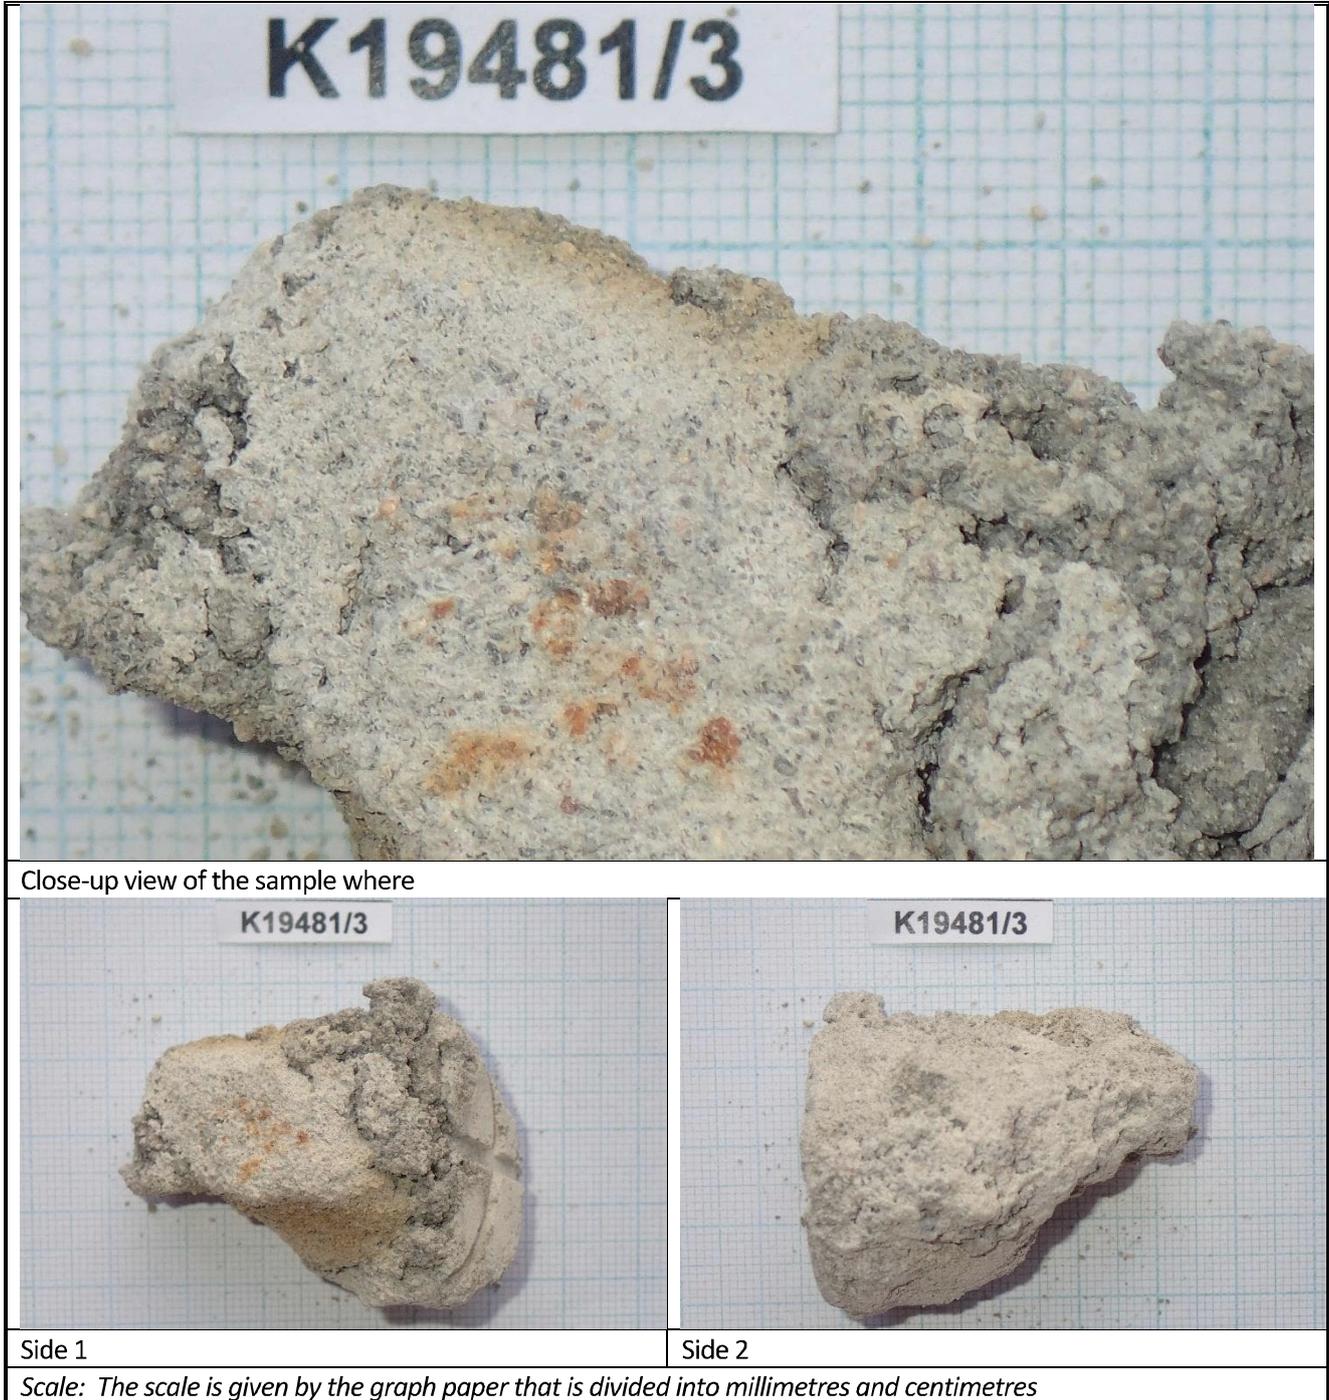
Figure 3

Sample K19481/3 (Outer leaf, Core 11, 2 of 2)

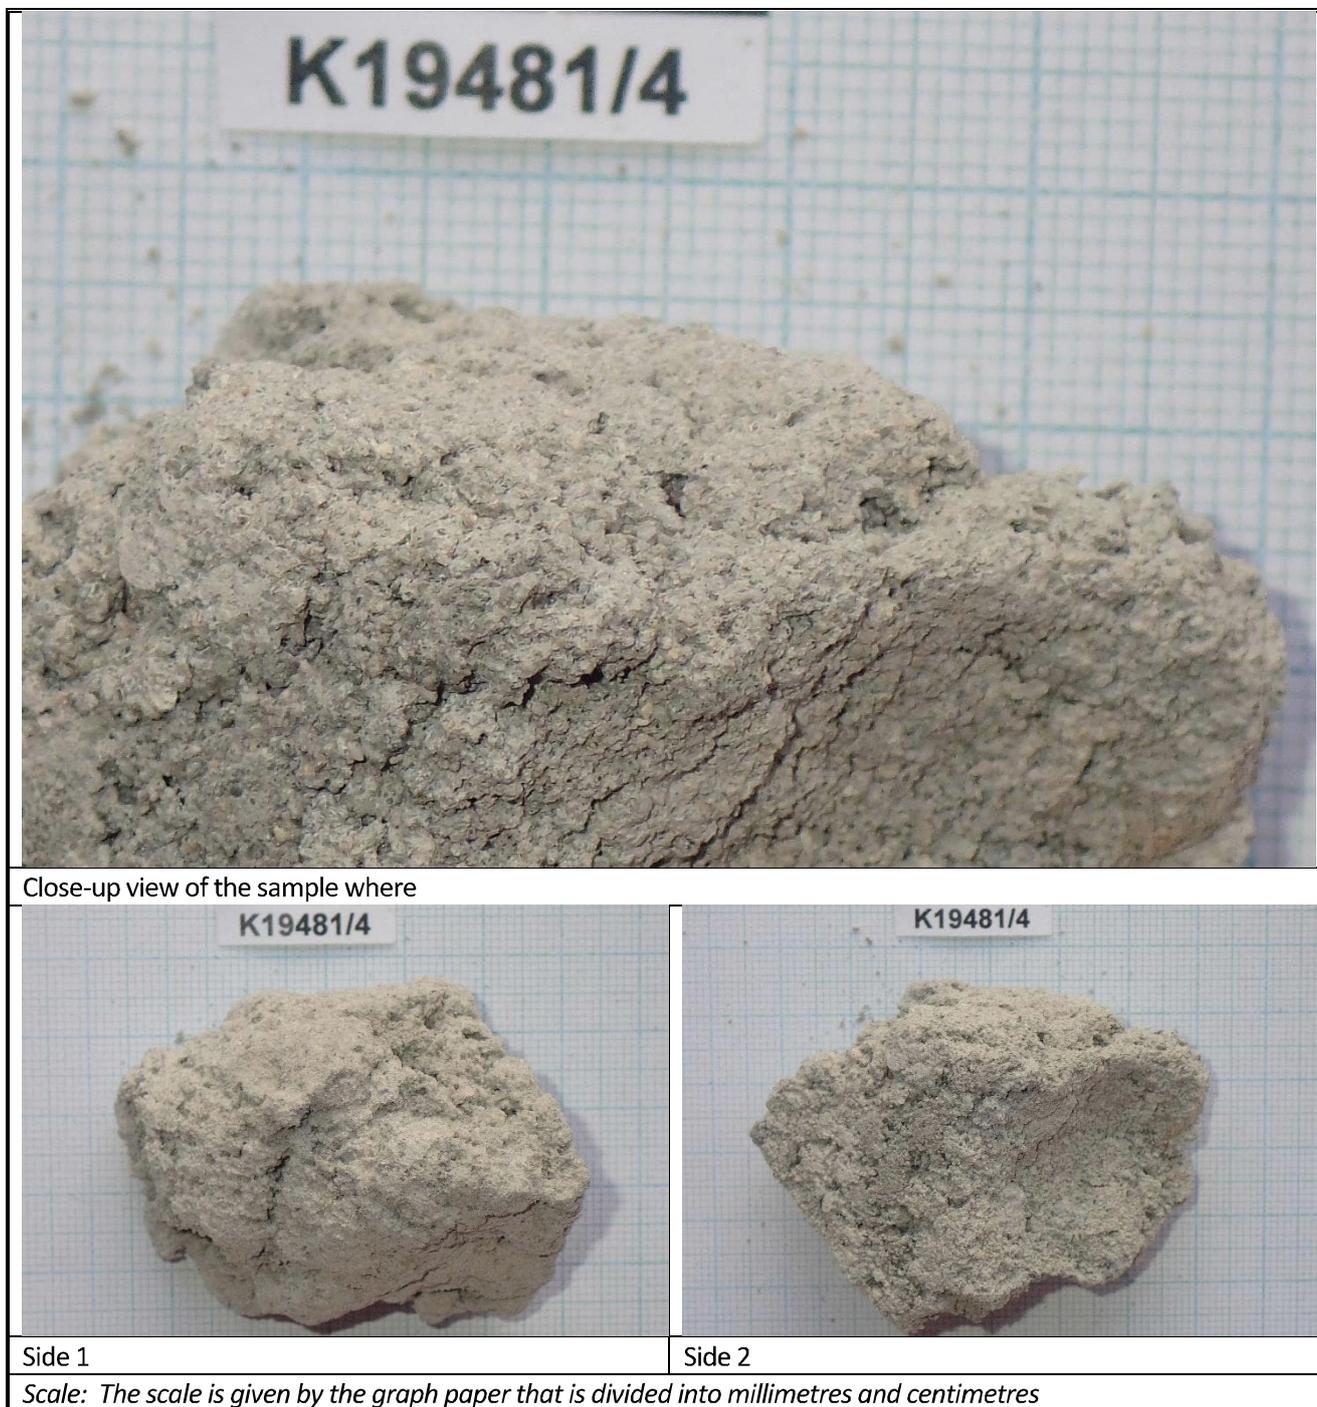
Figure B4

Sample K19481/4 (Outer leaf, Core 12)

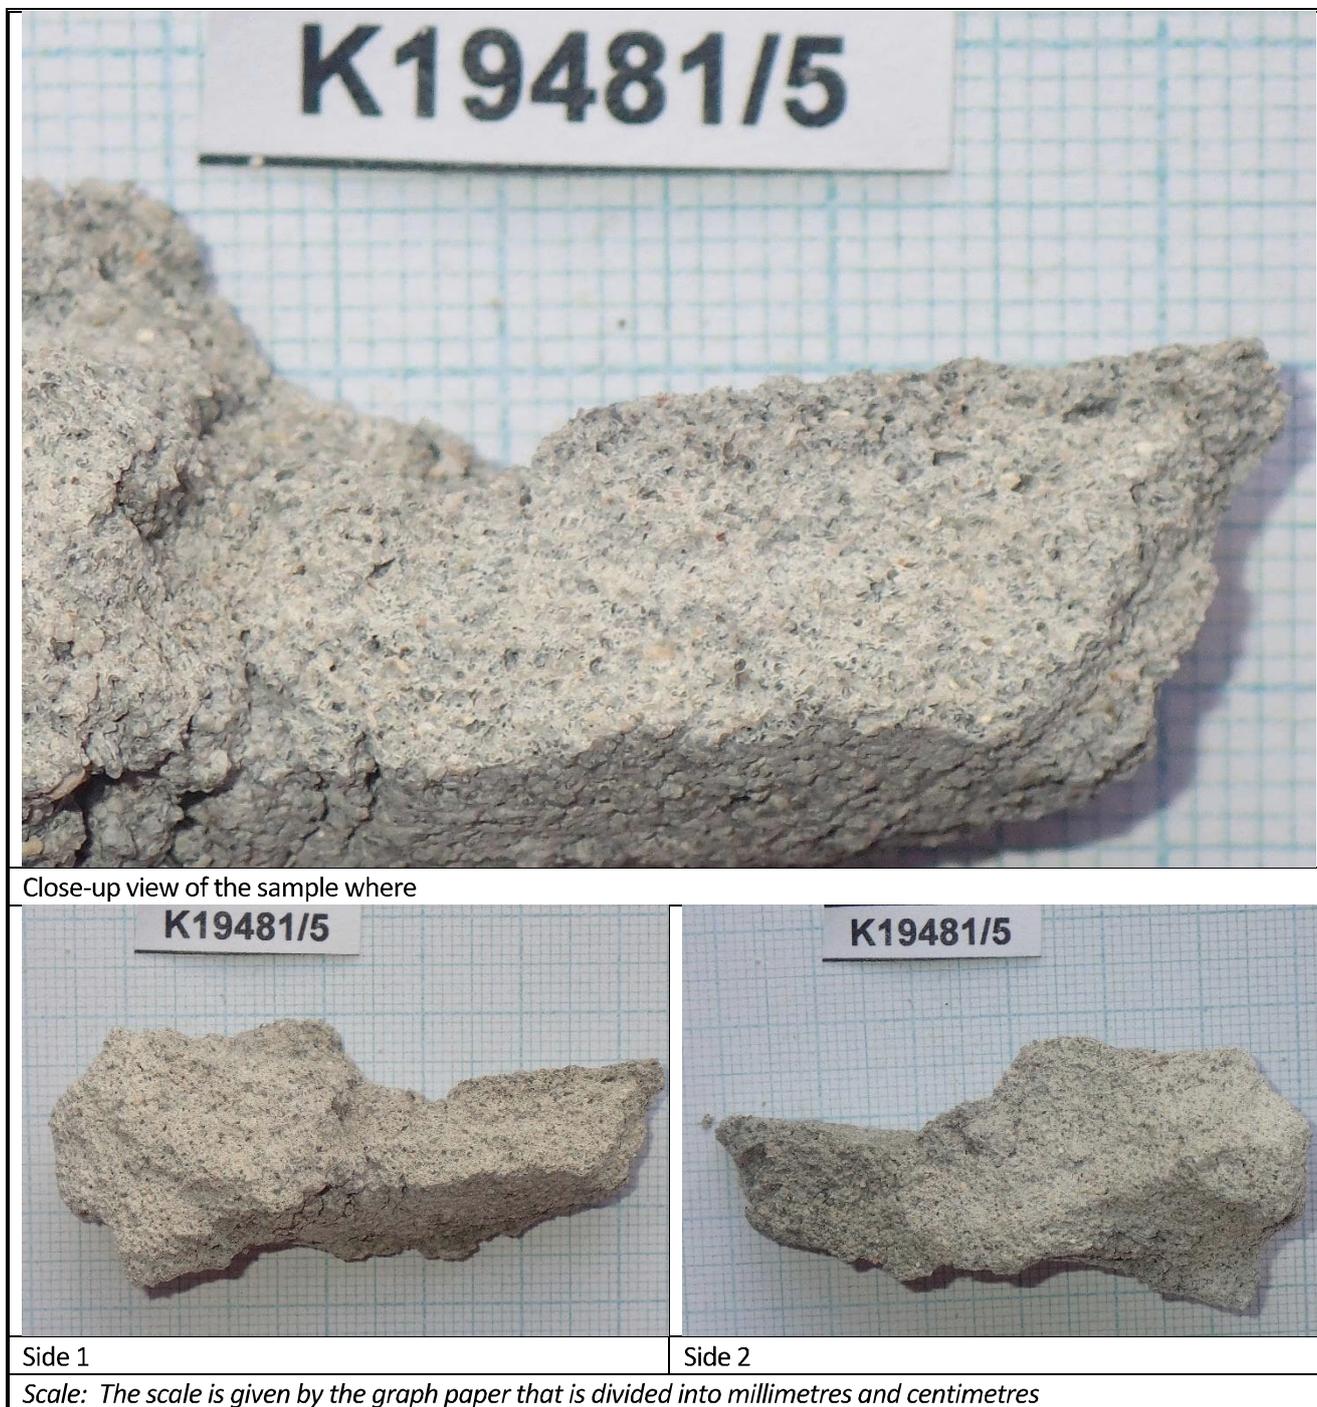
Figure B5

Sample K19481/5 (Inner leaf, East Elvn (South))

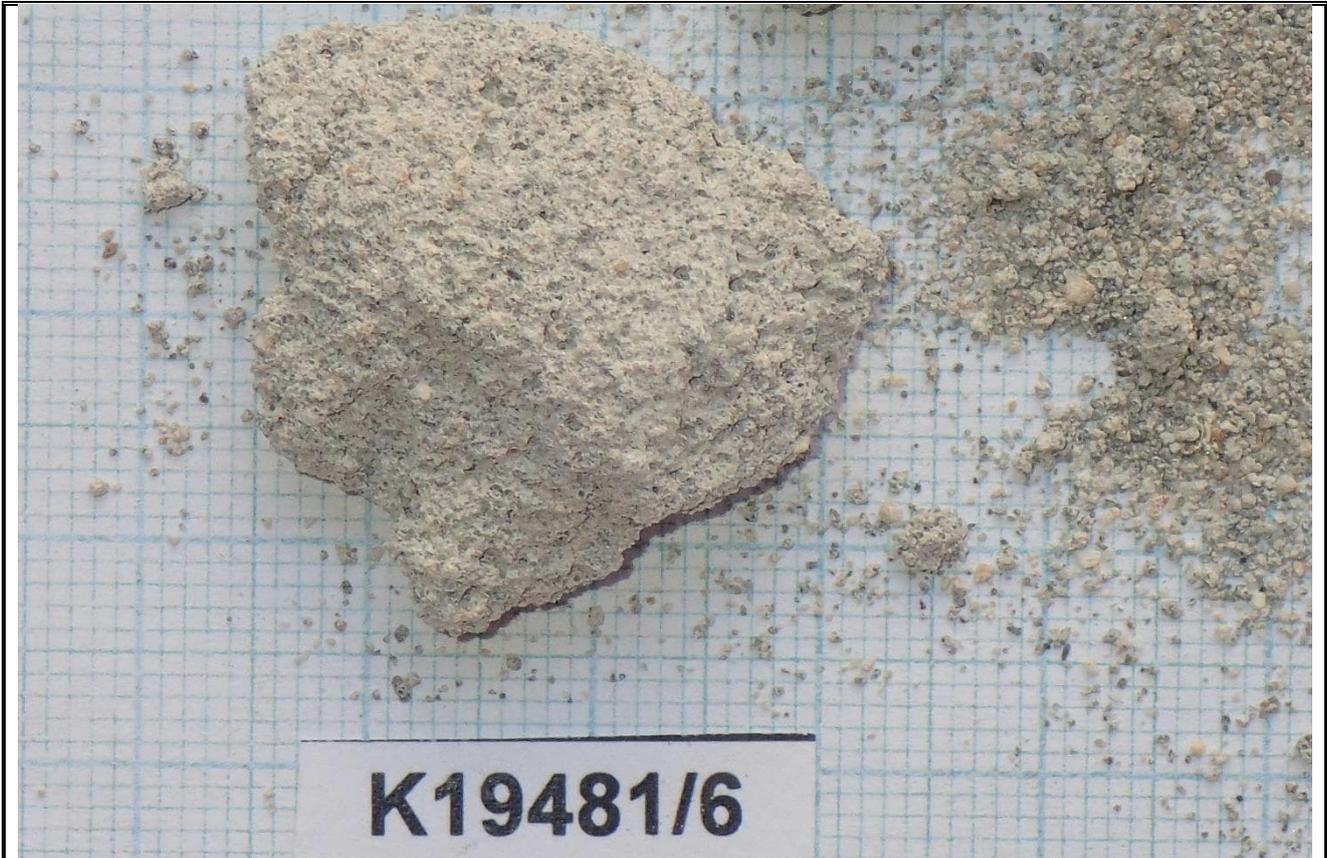
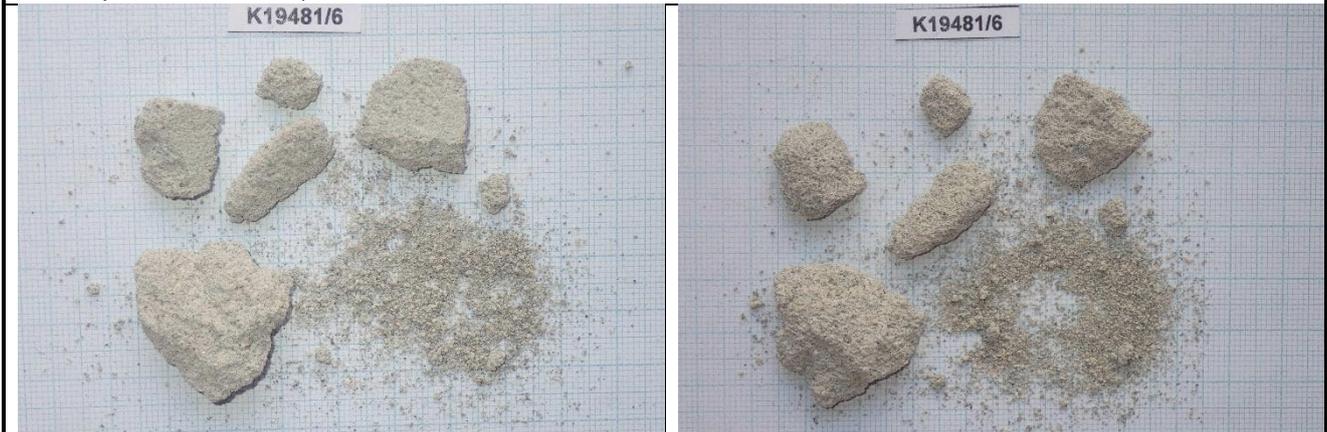
Figure B6

Sample K19481/6 (Inner leaf, North Elevation)

Close-up view of the sample where

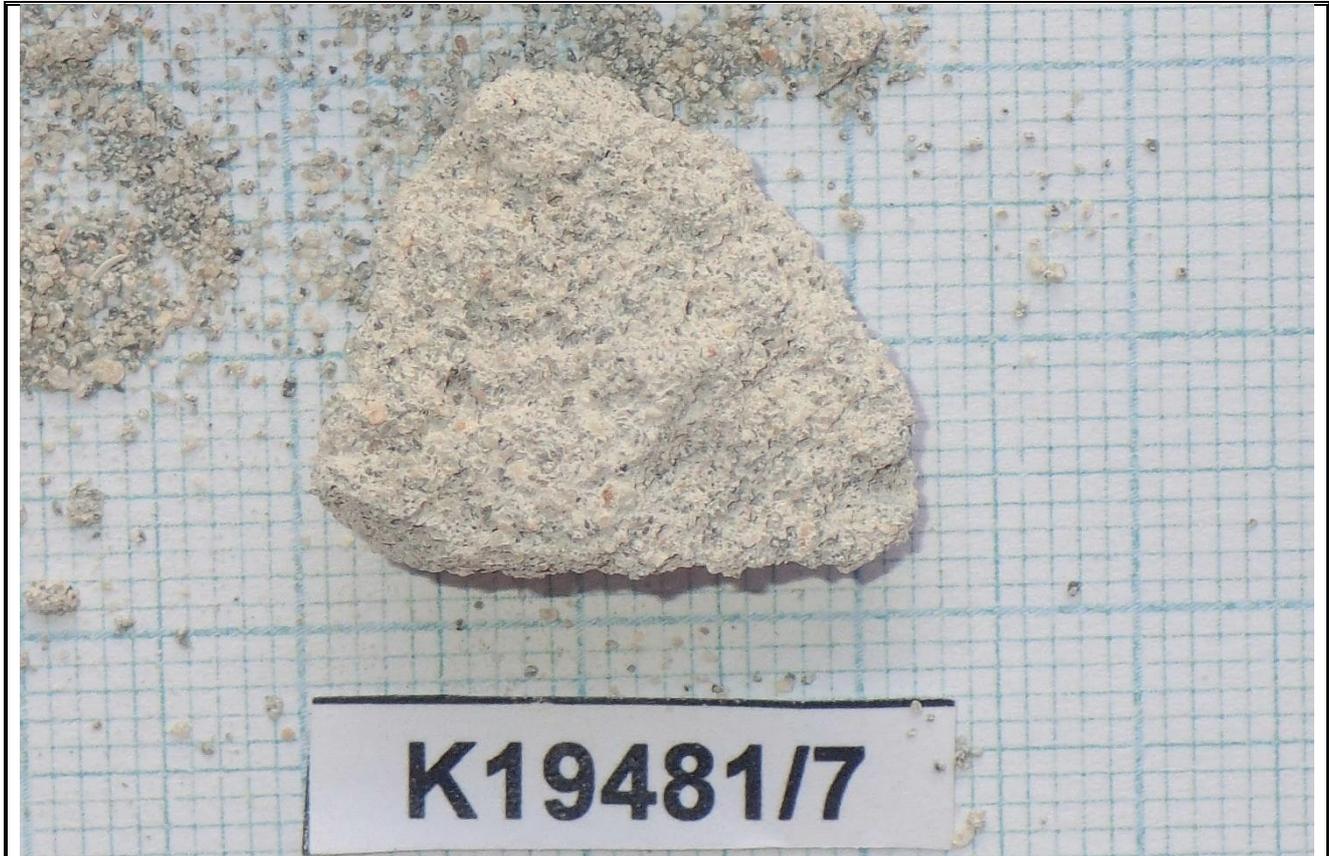
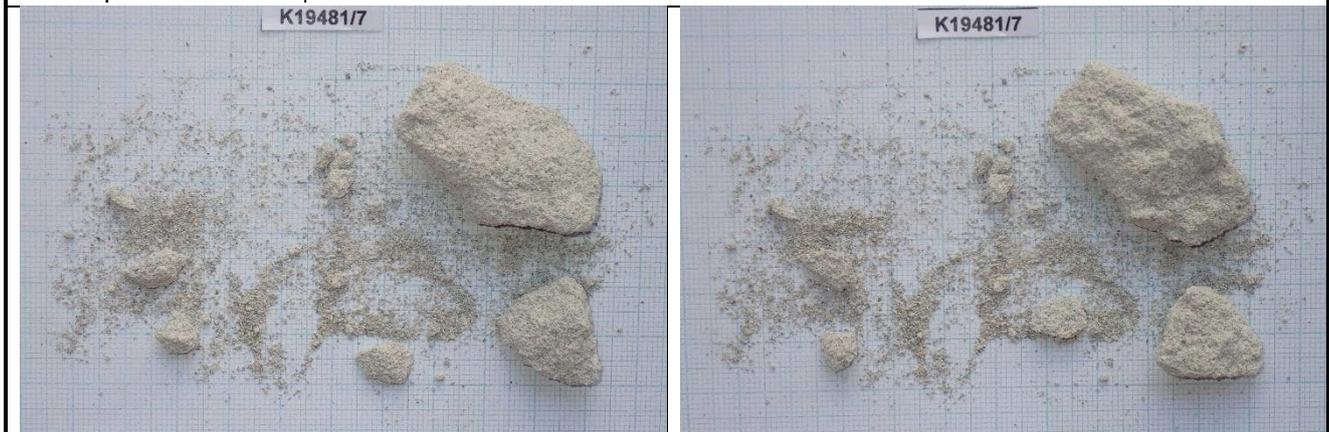
Figure B7

Sample K19481/7 (Inner Leaf, South Elevation)

Close-up view of the sample where
