Gilbert Bain Hospital Phase 1 Construction

Report on Condition of External Walls

December 2024

Document reference: 100106891NH03 | 01 | A |

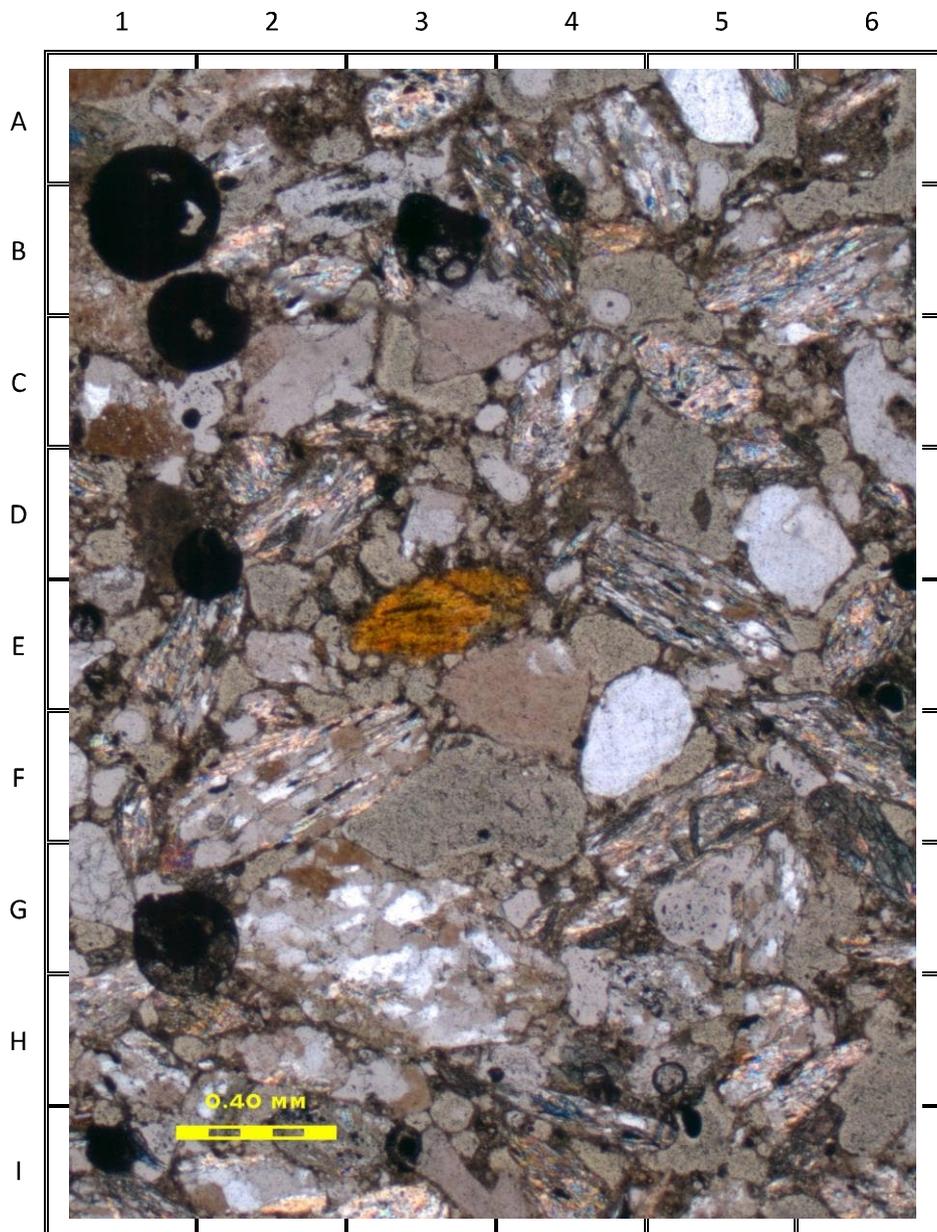
Sample K19481/2 (Outer leaf, Core11, 1 of 2)

Thin section, oblique polars: Low magnification view of the thin section showing abundant schist sand particles, visible for example in B6 and F2 that are surrounded by a carbonated matrix containing Portland cement. There are abundant voids throughout the field of view that have taken in the green fluorescent resin used during sample preparation.

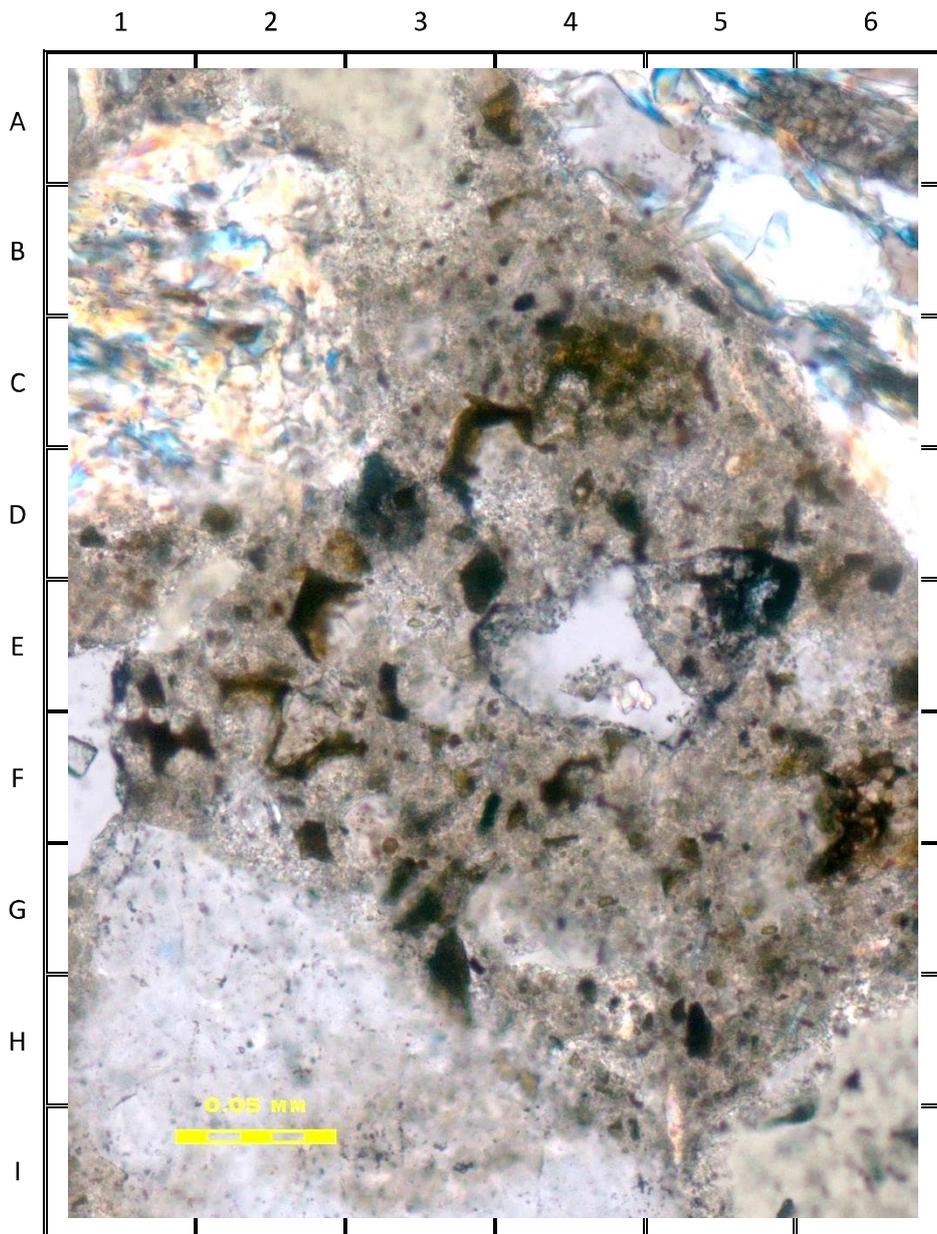
Figure C2

Sample K19481/2 (Outer leaf, Core11, 1 of 2)

Thin section, oblique polars: View showing the typical appearance of the mortar matrix with the outlines of carbonated and hydrated Portland cement grains visible for example in F1/2. Schist particles can be seen in B/C1 and A6. A quartz particle occurs in H1 and an empty void can be seen in I6.

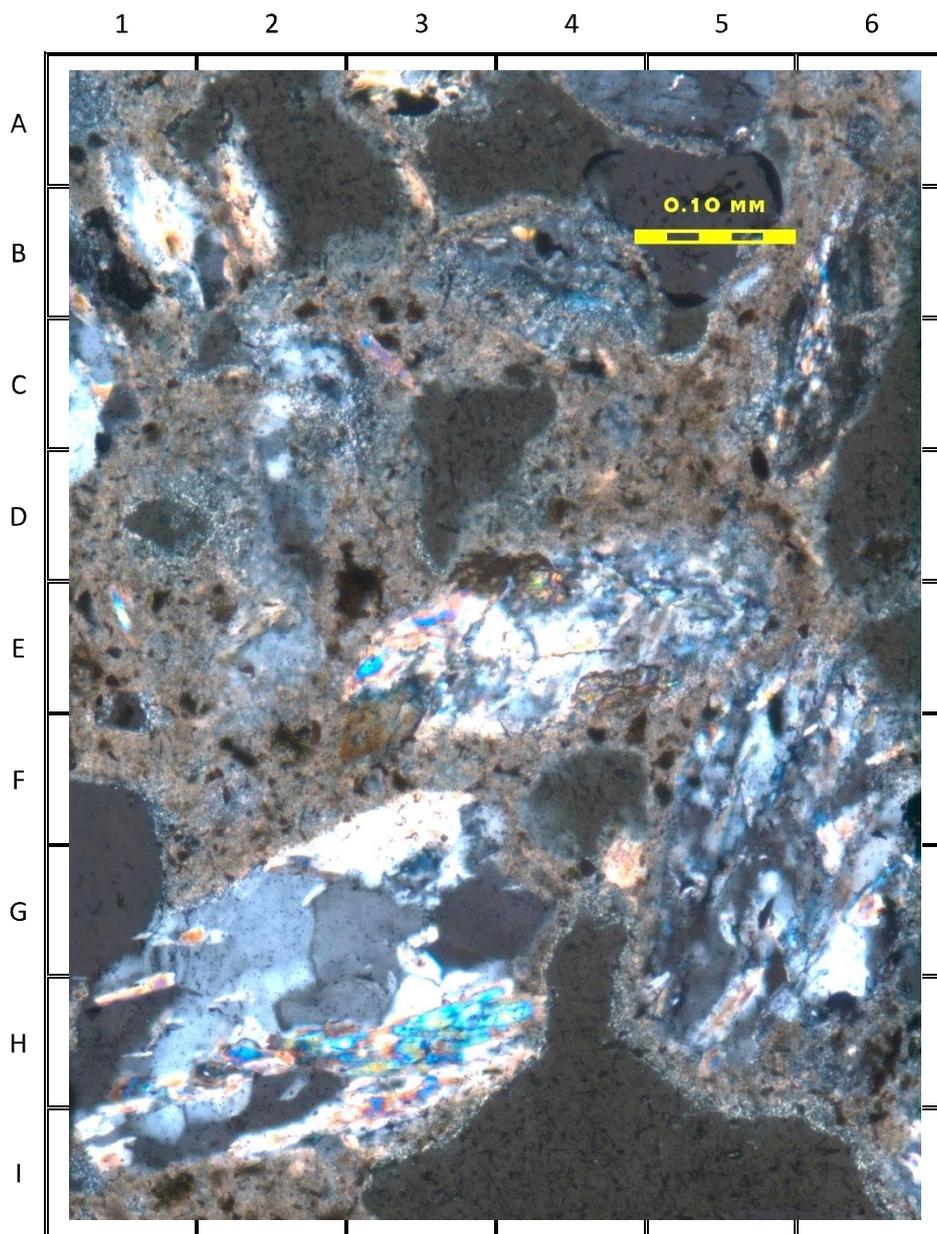
Figure C3

Sample K19481/2 (Outer leaf, Core11, 1 of 2)

Thin section, crossed polars: Areas of carbonated matrix containing the outlines of carbonated Portland cement grains can be seen for example in E1. Schist particles occur in H2/3 and G5/6. Empty voids can be seen for example in G1 and D6.

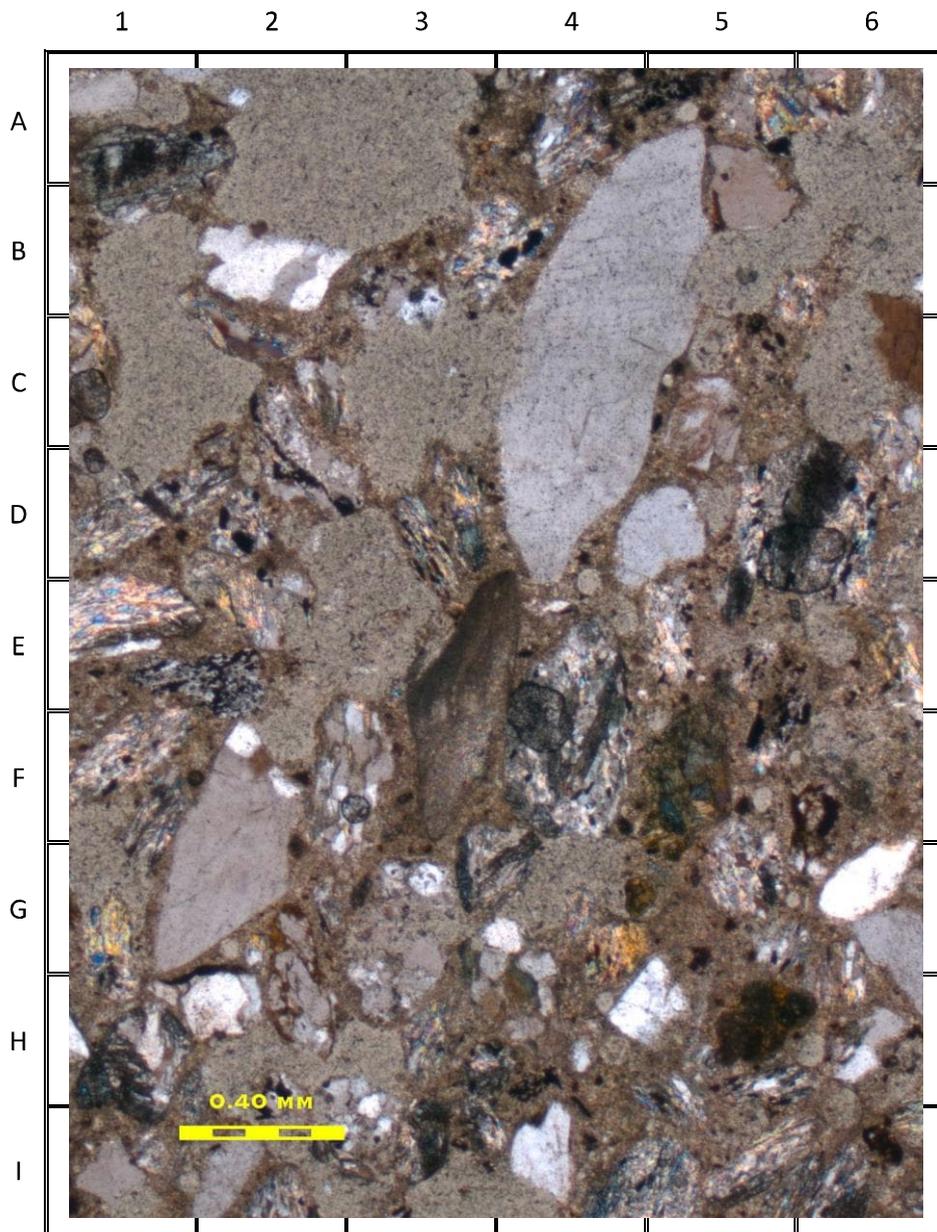
Figure C4

Sample K19481/5 (Inner leaf, East Elevation (South))

Thin section, oblique polars: Low magnification view of the thin section showing abundant schist sand particles, visible for example in E1 and F1 that are surrounded by a carbonated matrix containing Portland cement. Quartz particles can be seen in C4 and G2. There are abundant voids throughout the field of view that have taken in the green fluorescent resin used during sample preparation.

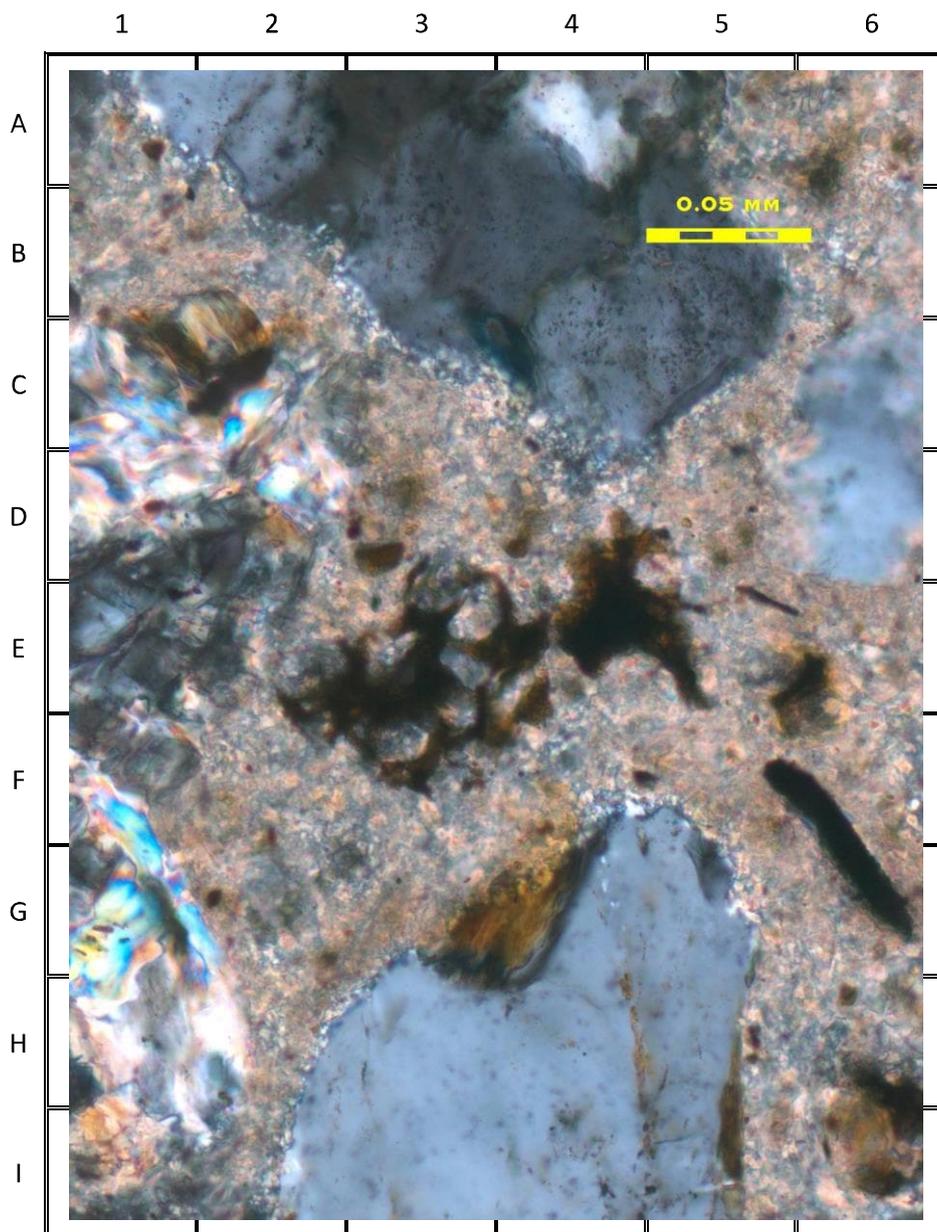
Figure C5

Sample K19481/5 (Inner leaf, East Elevation (South))

Thin section, oblique polars: View showing the typical appearance of the mortar matrix with the outlines of carbonated and hydrated Portland cement grains visible for example in E3. Schist particles can be seen in D1 and H1. Quartz particles occur in B3 and H/13.

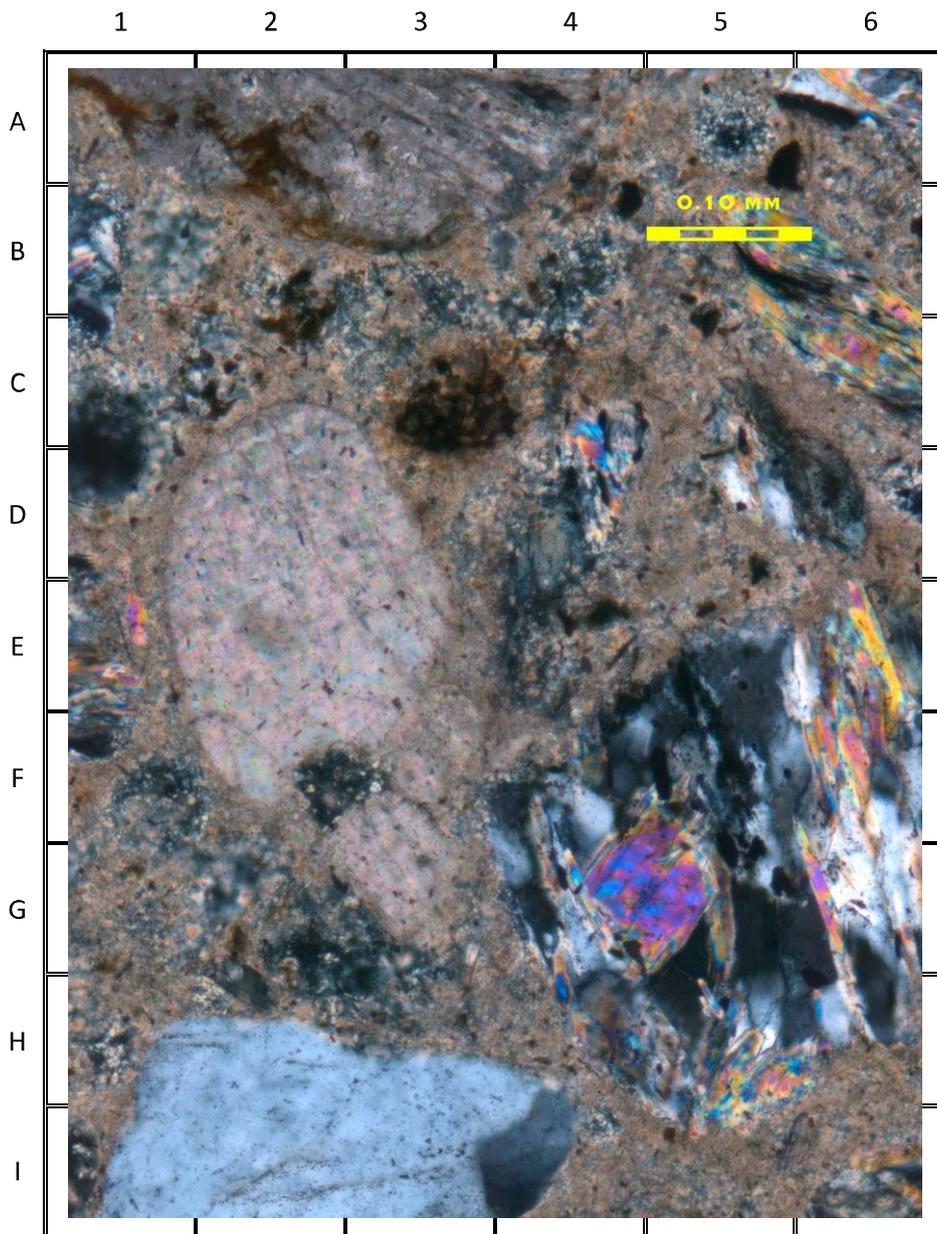
Figure C6

Sample K19481/5 (Inner leaf, East Elevation (South))

Thin section, crossed polars: A shell particle occurs in E2. Schist particles can be seen in G5/6 and A2/3. A quartz particle occurs in I2. The aggregate particles are surrounded by carbonated matrix with a fine-grained texture that can be seen for example in I5 and G1.
