# **Gilbert Bain Hospital Phase 1 Construction**

Report on Condition of External Walls

December 2024

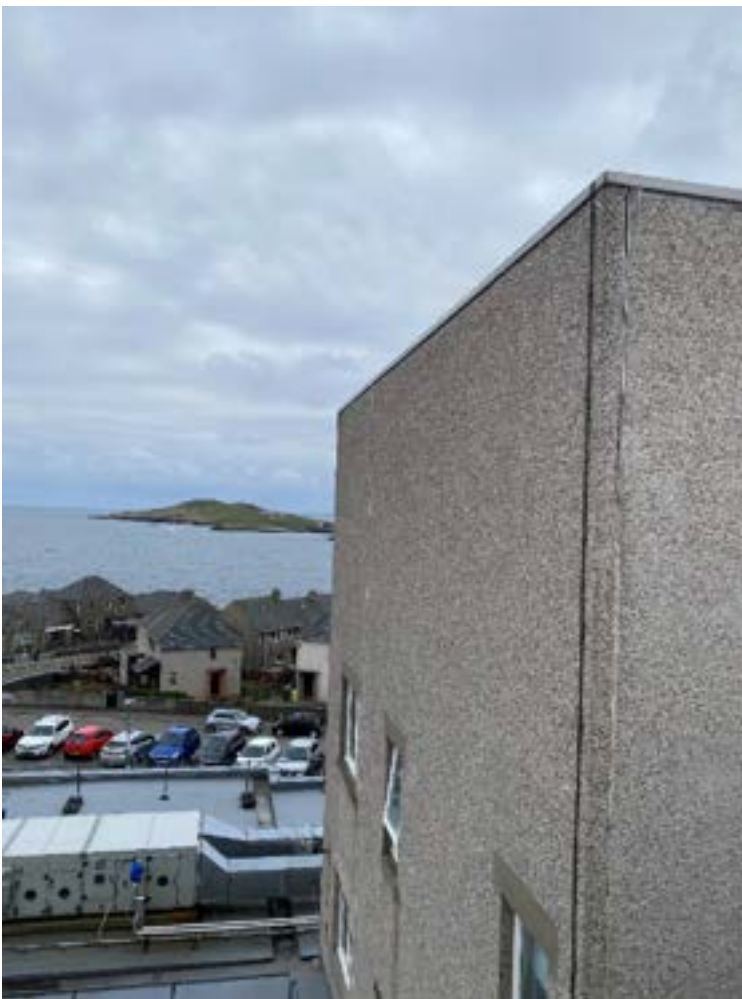
**Figure 2.1: View of the east elevation wall from the north**

At this visit the walls were inspected visually and an estimate of the outward movement of the upper two metres of the 4 Storey building east elevation wall was made with a theodolite sited on the adjacent roof to the north. It was estimated that the wall had moved 20mm outward at the head with the outward lean springing from a point 2m below the top of the wall. The north elevation movement joint was void of sealant over this height of the wall. Figure 2.1 includes a view of the east elevation wall from the north.

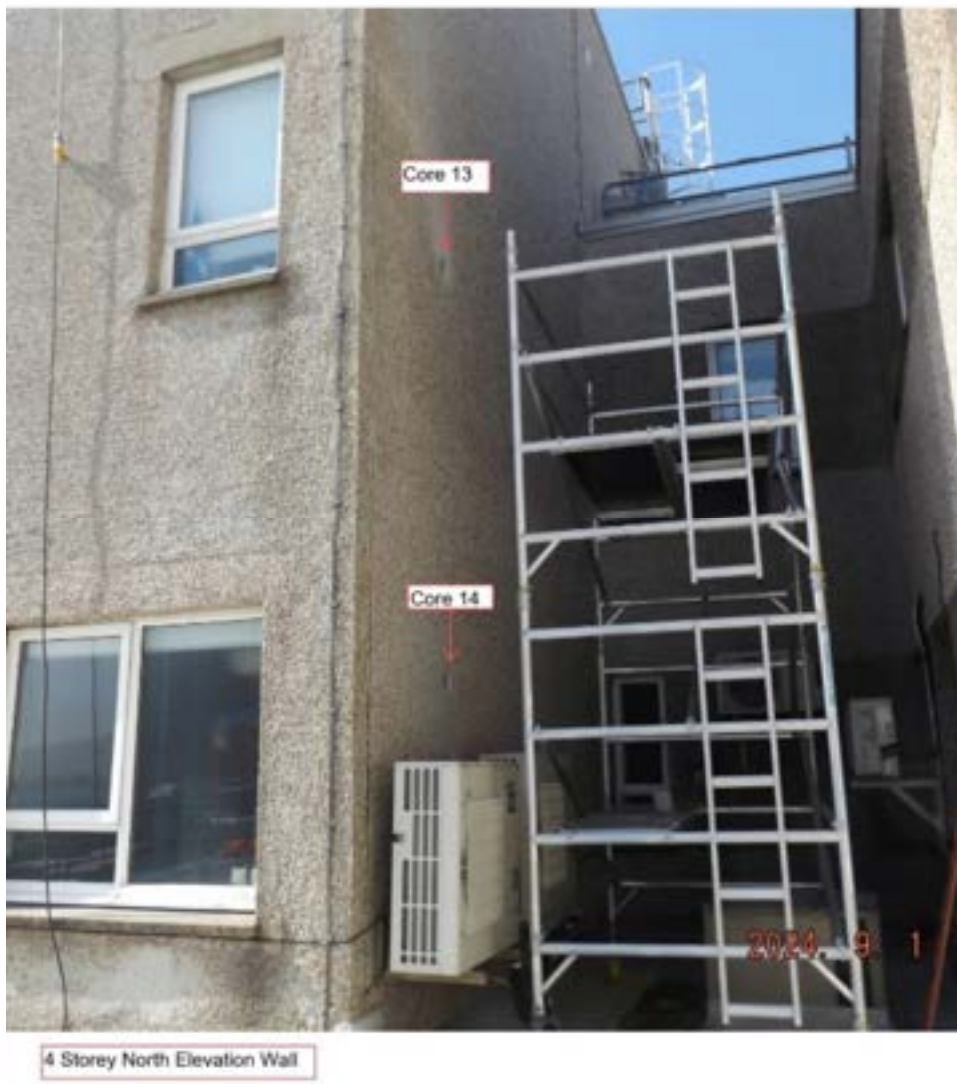
**Figure 2.9: 2 no cores at the 4 Storey north elevation wall**

100mm diameter cores were removed from the north, east and south elevations of the 4 Storey building. The core locations are included in Figures 2.9 to 2.11 inclusive. Cores extracted included 2 no cores at the 4 Storey north elevation wall, 9 no cores at the 4 Storey east elevation wall and 3 no cores at the 4 Storey south elevation wall.

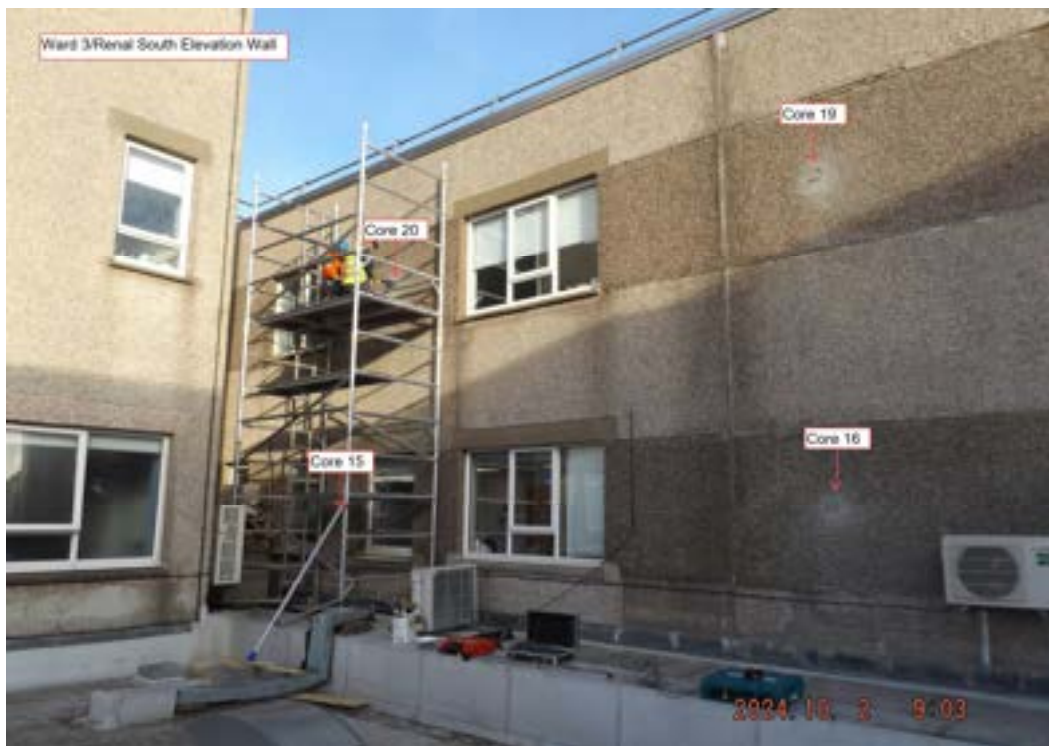
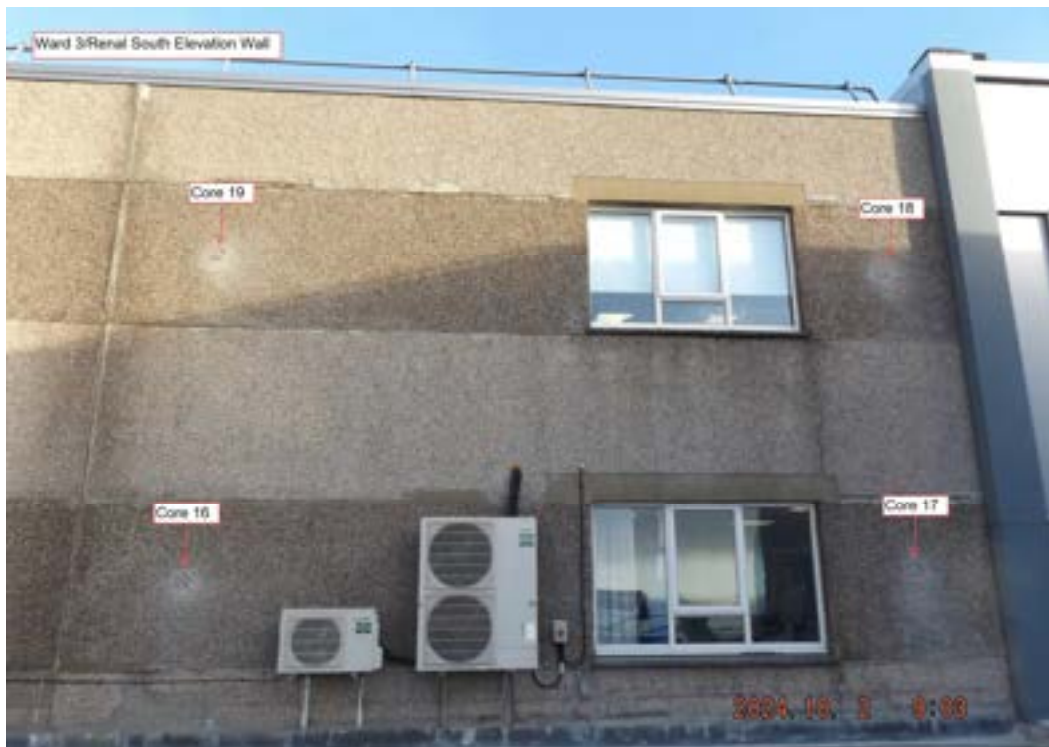
100mm diameter cores were removed from the south elevation of the 3 Storey building including Ward 3 at the top floor and Renal on the first floor. The core locations are included in Figures 2.14 and 2.15.

Figure 2.14: Cores at the south elevation of Ward 3 and Renal 1 of 2

**Figure 2.15: Cores at the south elevation of Ward 3 and Renal 2 of 2**

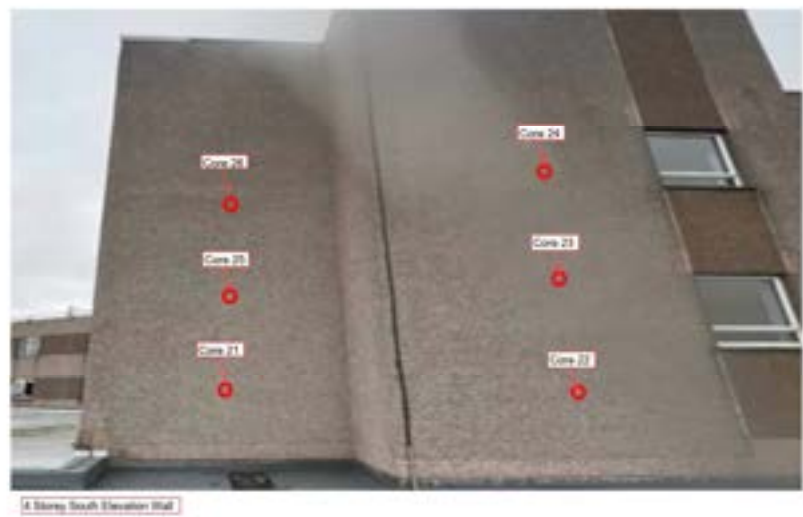
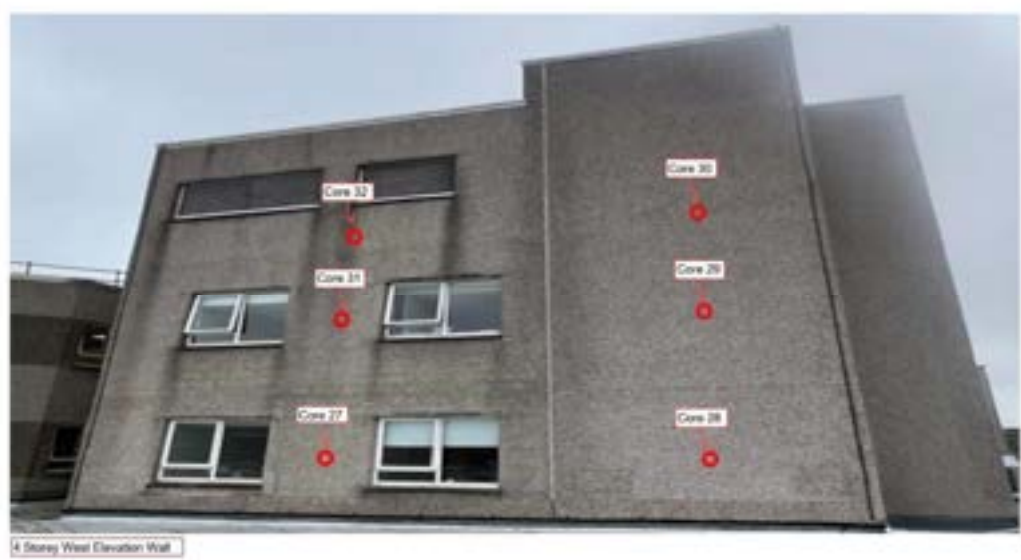
100mm diameter cores were removed from the south and west elevations of the 4 Storey building. The core locations are included in Figures 2.16 and 2.17. Sample photographs of extracted cores, the exposed cavity and wall ties located with an endoscope inspection are included in Appendix E. Notes of key findings at each core location are also included in Appendix E. The core inspections confirmed that the outer leaf was of good quality dense concrete blocks with weak mortar jointing. Wall ties were present in the cavity but were difficult to locate due to the narrow cavity and significant amount of mortar droppings in the cavity. The wall ties were of the vertical twist type and where they could be inspected closely appeared to be in good condition.

Figure 2.16: 4 Storey south wall cores – 6 no cores at the 4 Storey south elevation wall

Figure 2.17: 4 Storey west wall cores – 6 no cores at the 4 Storey west elevation wall

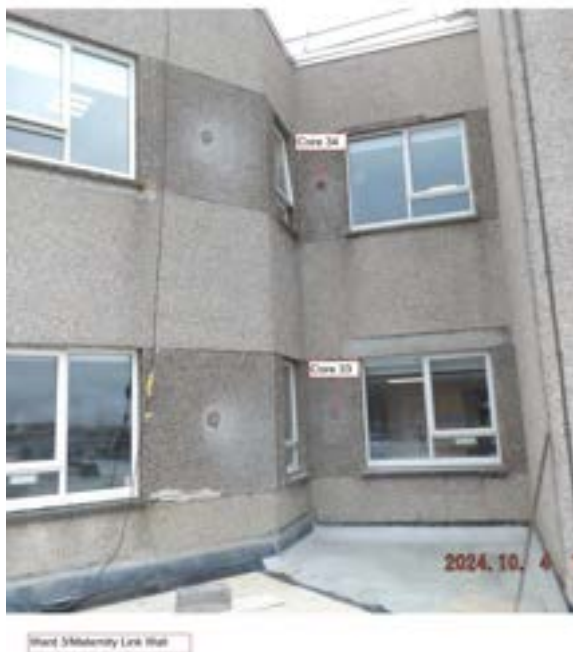
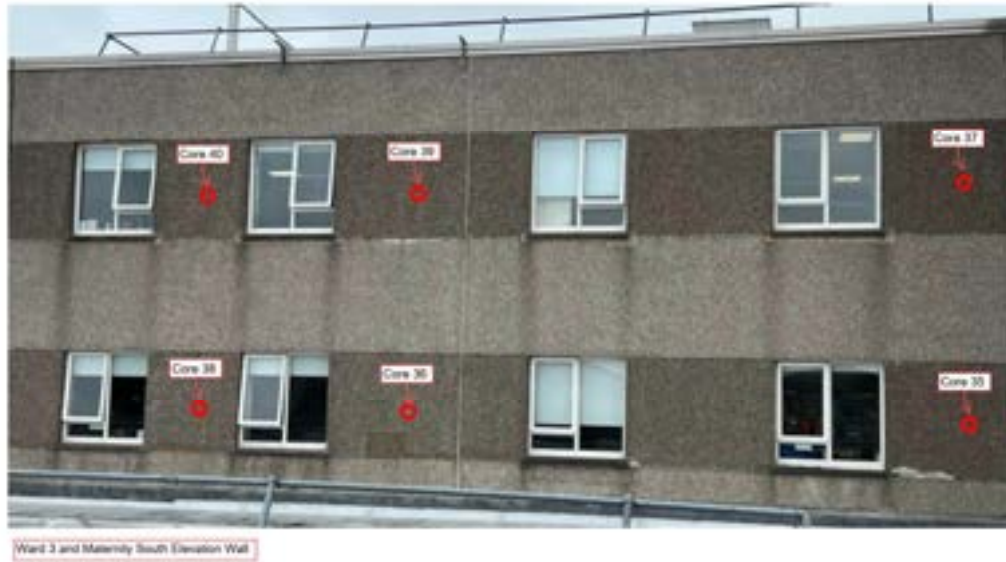
100mm diameter cores were removed from the link between the 3 and 4 Storey buildings and from the south elevation of the 3 Storey building including Ward 3 at the top floor and Maternity on the first floor. The core locations are included in Figures 2.18 and 2.19. Sample photographs of extracted cores, the exposed cavity and wall ties located with an endoscope inspection are included in Appendix F. Notes of key findings at each core location are also included in Appendix F. The core inspections confirmed that the outer leaf was of good quality dense concrete blocks with some weak and some reasonable mortar jointing. Wall ties were present in the cavity but were difficult to locate due to the narrow cavity and significant amount of mortar droppings in the cavity. The wall ties were of the vertical twist type and where they could be inspected closely appeared to be in good condition.

**Figure 2.18: Cores at the Link west elevation of Ward 3 and Maternity**

**Figure 2.19: 3 Storey south wall cores” – Cores at the south elevation of Ward 3 and Maternity**

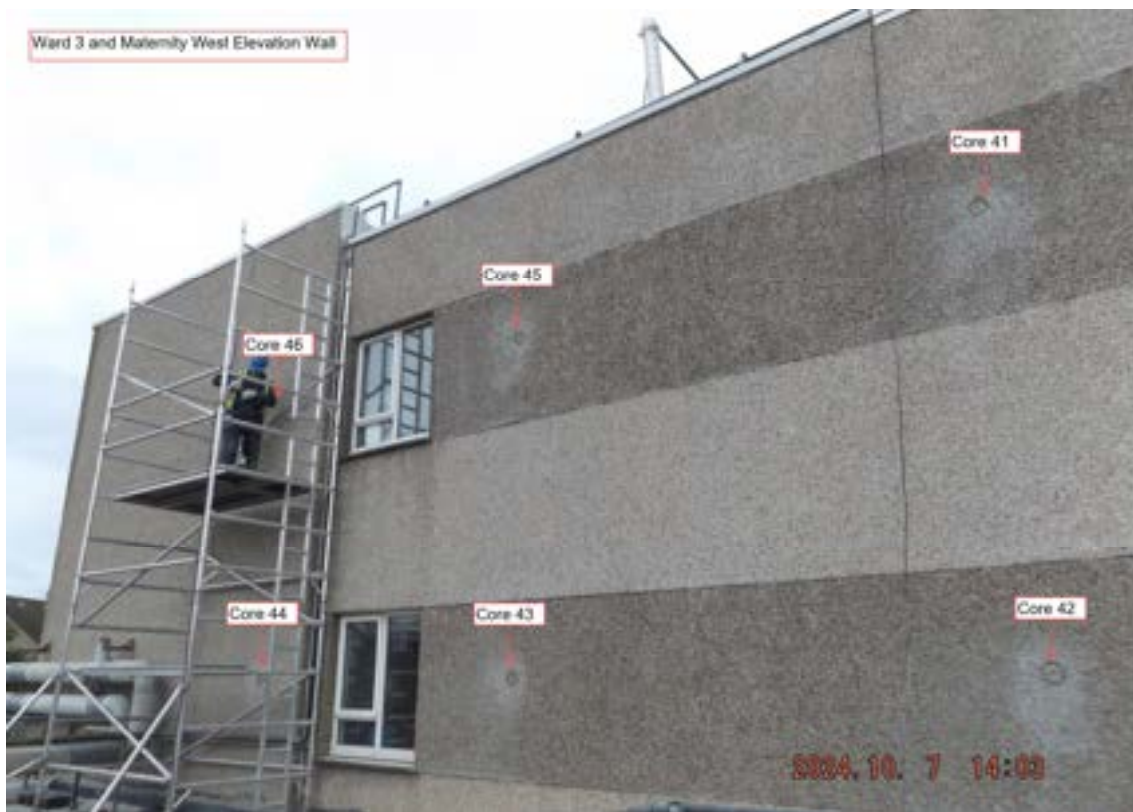
**Figure 2.20: Cores at the west elevation of Ward 3 and Maternity**

100mm diameter cores were removed from the west elevation of the 3 Storey building including Ward 3 at the top floor and Maternity on the first floor. The core locations are included in Figure 2.20. Sample photographs of extracted cores, the exposed cavity and wall ties located with an endoscope inspection are included in Appendix G. Notes of key findings at each core location are also included in Appendix G. The core inspections confirmed that the outer leaf was of good quality dense concrete blocks with some poor and generally more reasonable mortar jointing. Wall ties were present in the cavity but were difficult to locate due to the narrow cavity and significant amount of mortar droppings in the cavity. The wall ties were of the vertical twist type and where they could be inspected closely appeared to be in good condition.

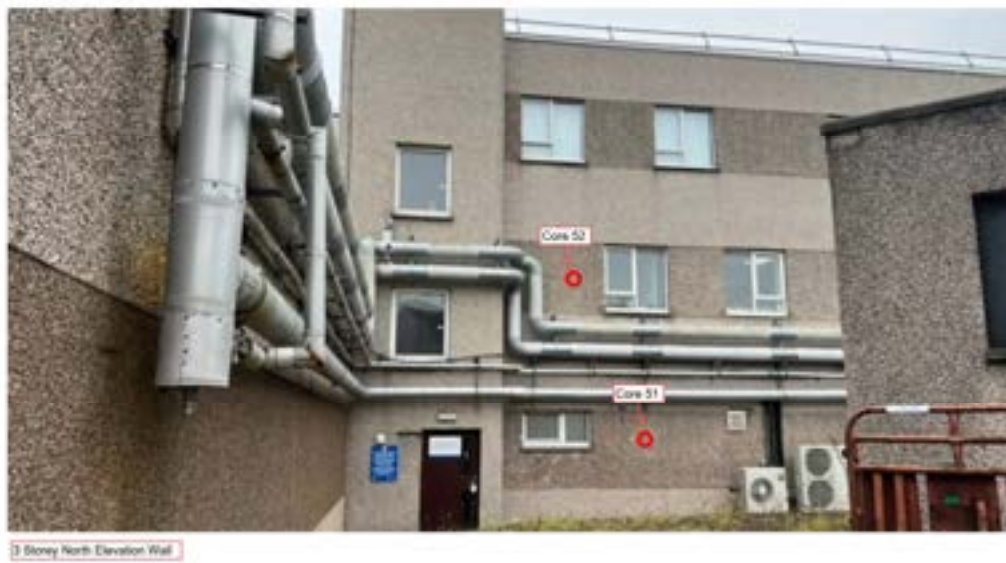
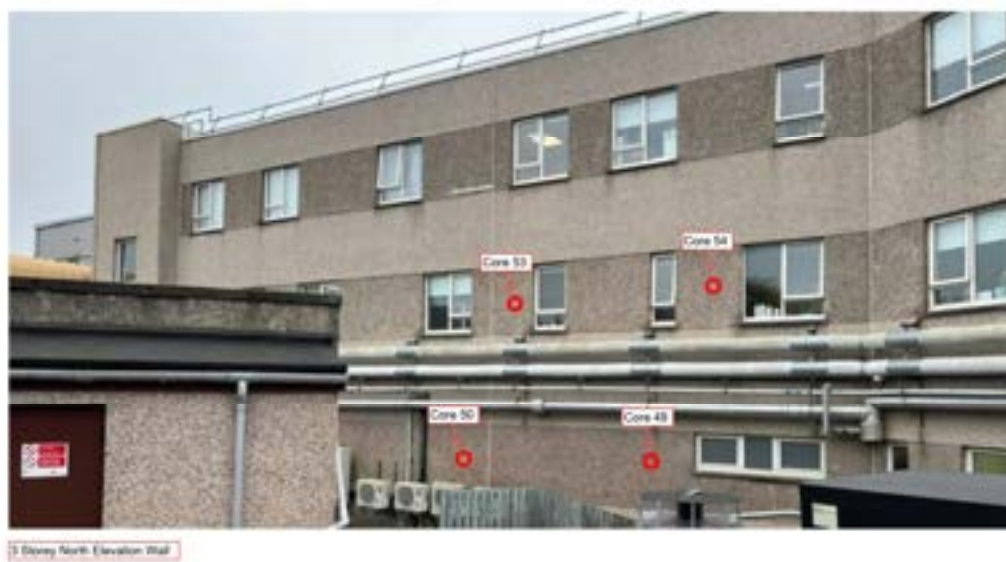
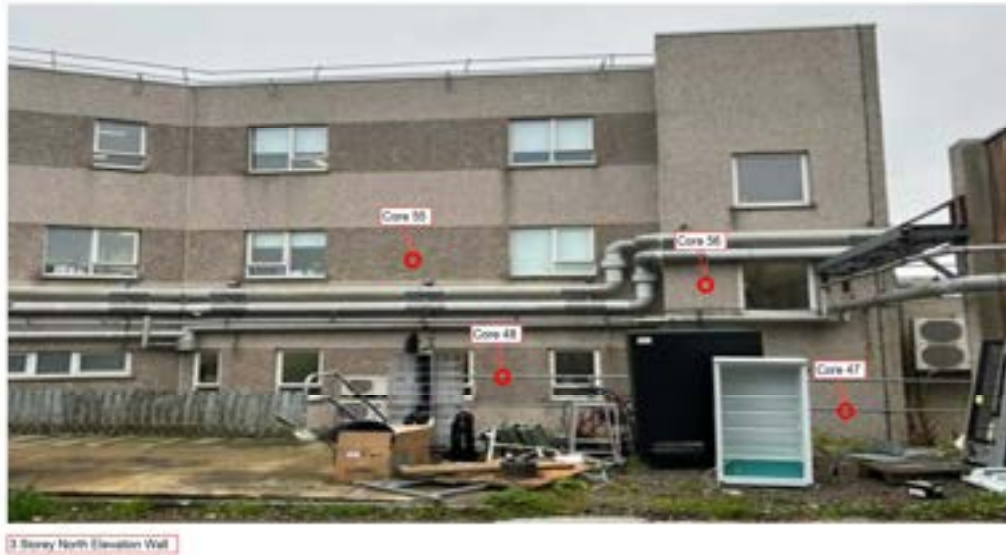
100mm diameter cores were removed from the north elevations of the 3 Storey building. The north elevation includes Ward 3 at the upper floor, Maternity and Renal at the first floor and A&E and X-Ray at the ground floor. The core locations are included in Figures 2.25 to 2.27 inclusive. Sample photographs of extracted cores, the exposed cavity and wall ties located with an endoscope inspection are included in Appendix I. Notes of key findings at each core location are also included in Appendix I. The core inspections confirmed that the outer leaf was of good quality dense concrete blocks with reasonable mortar jointing. Wall ties were present in the cavity but were difficult to locate due to the narrow cavity and significant amount of mortar droppings in the cavity. The wall ties were of the vertical twist type and where they could be inspected closely appeared to be in good condition. Dry dash render was noted to boss at the west side of the north elevation wall and boss in patches towards the east side of the wall.

Figure 2.25: Cores at the 3 Storey north elevation wall 1 of 3

**Figure 2.26: Cores at the 3 Storey north elevation wall 2 of 3**

**Figure 2.27: Cores at the 3 Storey north elevation wall 3 of 3**

We would not consider that remedial works are required to the north elevation of the 3 Storey building other than identifying and replacing areas of boss render which present a hazard of falling onto the footpath below. At the single storey Outpatients wall adjacent to the entrance area the mortar was found to be poor but from visual inspection we do not consider there to be a high risk of the outer leaf wall displacing relative to the inner leaf wall and no remedial works are recommended for this area.

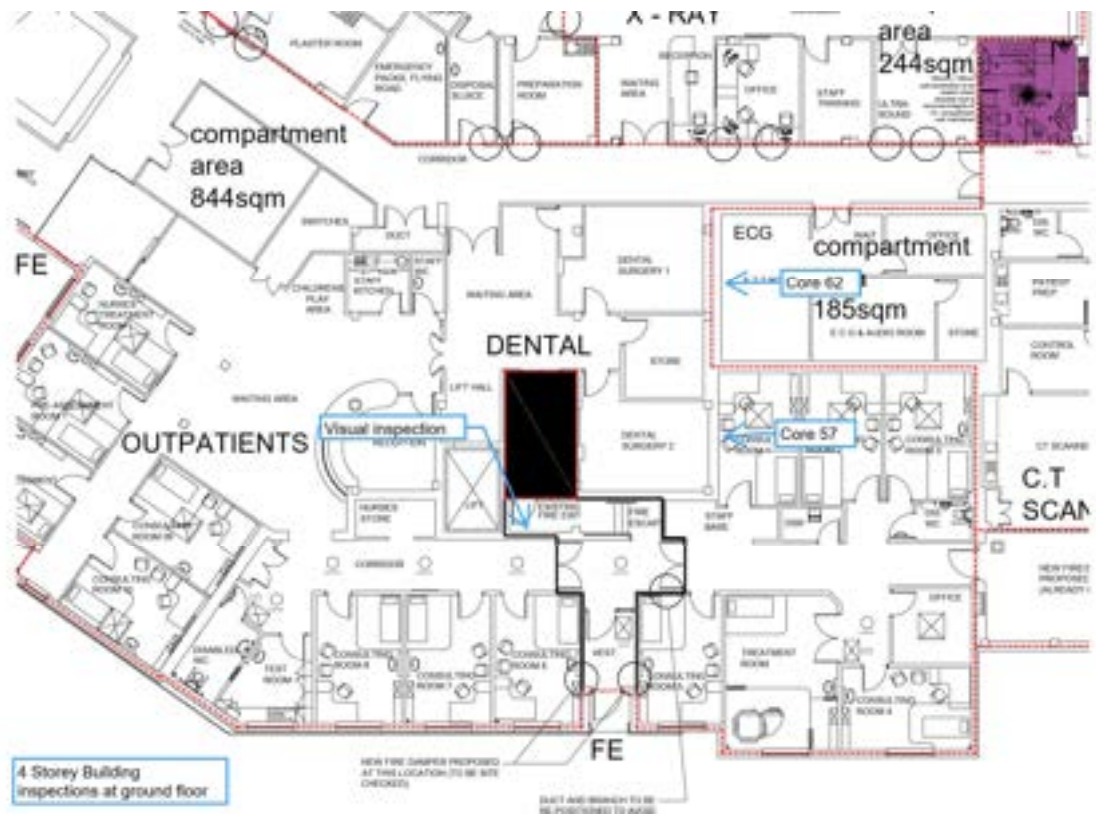
Figure 2.28: 4 Storey South and East Walls (ground floor)

Cores were extracted from various areas at ground floor and solum levels around the south and east perimeter wall of the 4 Storey building corresponding to the positions of the external walls above the Outpatients roof. The locations of the inspections are shown in Figure 2.28 and Figure 2.29. Sample photographs of extracted cores, the exposed cavity and wall ties located with an endoscope inspection are included in Appendix J. Photographs and notes of key findings are also included in Appendix J. The core inspections confirmed that the outer leaf was of good quality dense concrete blocks with reasonable mortar jointing. The inner leaf at locations around the stair and lift appeared to be of insitu concrete construction. Wall ties were present in the cavity but were difficult to locate due to the narrow cavity and significant amount of mortar droppings in the cavity. The wall ties were of the vertical twist type and where they could be inspected closely appeared to be in good condition. The cavity widths varied from 50 to 55mm at the east wall and 60 to 65mm at the south wall. This would confirm earlier observations that the cavity increases in width towards the top of these walls.

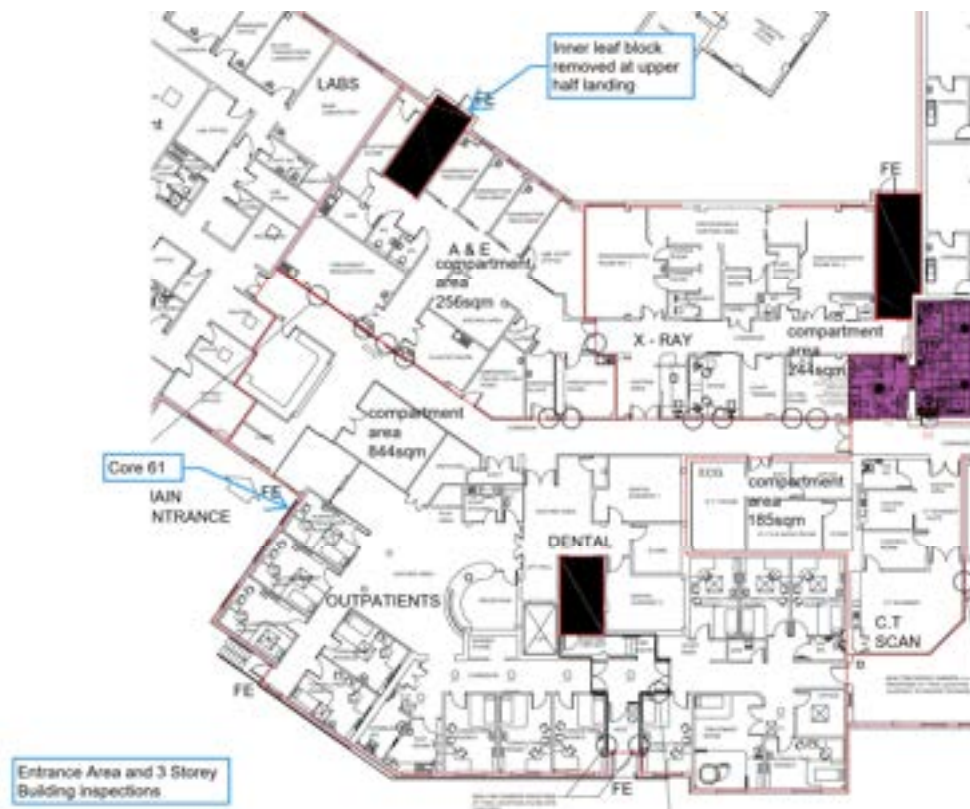
Figure 2.30: Entrance Area and 3 Storey North Wall

A core was extracted from the west wall of the single storey Outpatients building adjacent to the main entrance to the hospital and an inner leaf block was removed at half landing level of the A & E stair at the north elevation of the 3 Storey building. The locations of the inspections are shown in Figure 2.30. Sample photographs of extracted cores, the exposed cavity and wall ties located with an endoscope inspection are included in Appendix K. Photographs and notes of key findings are also included in Appendix K. The core inspection at the Outpatients confirmed that the outer leaf was of good quality dense concrete blocks with poor mortar jointing. Boss render had been removed previously at this location for safety. The inner leaf block inspection at the 3 Storey building confirmed that the inner and outer leaf was of good quality dense concrete blocks with poor to reasonable mortar jointing. The cavity width was measured as 60mm at this location.

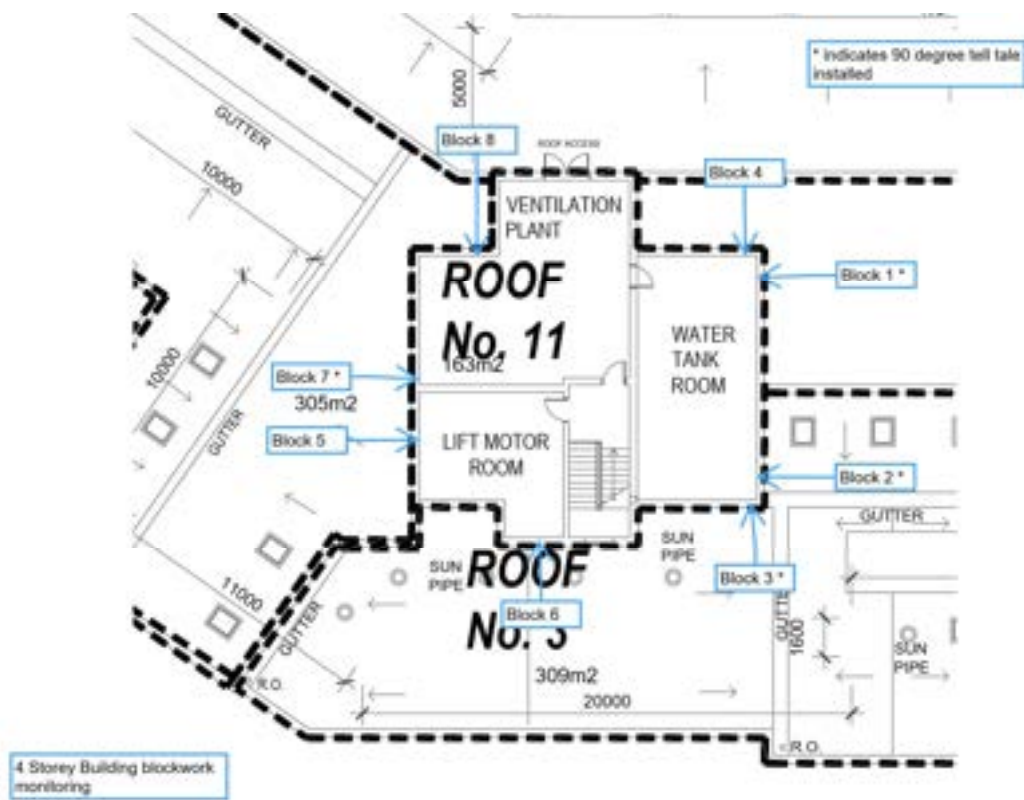
Figure 2.31: Block movement monitoring

90 degree tell tales were fixed in position at 4no blockwork inspection locations in the Water Tank Room and Plant Room. The blockwork inspection locations which are referenced in Appendices C and H are shown in Figure 2.31. Initial readings on the tell tales were taken on 18 October and following high winds from the south with 70 mph gusts on 20 October and from the west changing to west south west with 55 mph gusts on 21 October. The monitoring results are included in Appendix L. No movement of the outer leaf relative to the inner leaf was recorded in this period. The 0.15mm difference in readings at Block 2 is thought to be due to a slight variance in the position of the camera. There was no water ingress noted at the cavity resulting from the heavy rain which accompanied the winds part of the time.

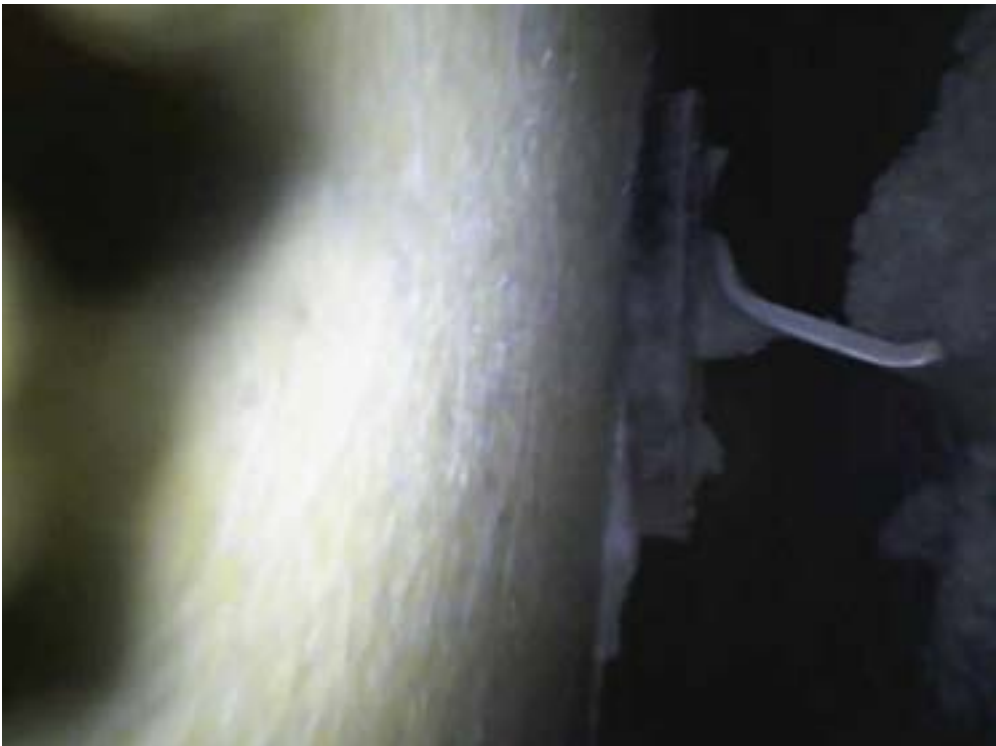
Block 1

| Block reference | Block condition | Mortar condition | No of Wall Ties found and condition | Comments |
|---|---|---|---|---|
| Block 1<br>(east wall) | 100mm thick dense concrete in good condition | Poor – inner leaf weak and friable; outer leaf very weak and friable | 3no to upper, lower and right side of block within 450mm and 2 no adjacent to RC column to left of block/good | 105mm cavity overall with 25mm insulation board displaced 20mm off inner leaf wall. Insufficient wall tie embedment in outer leaf. |

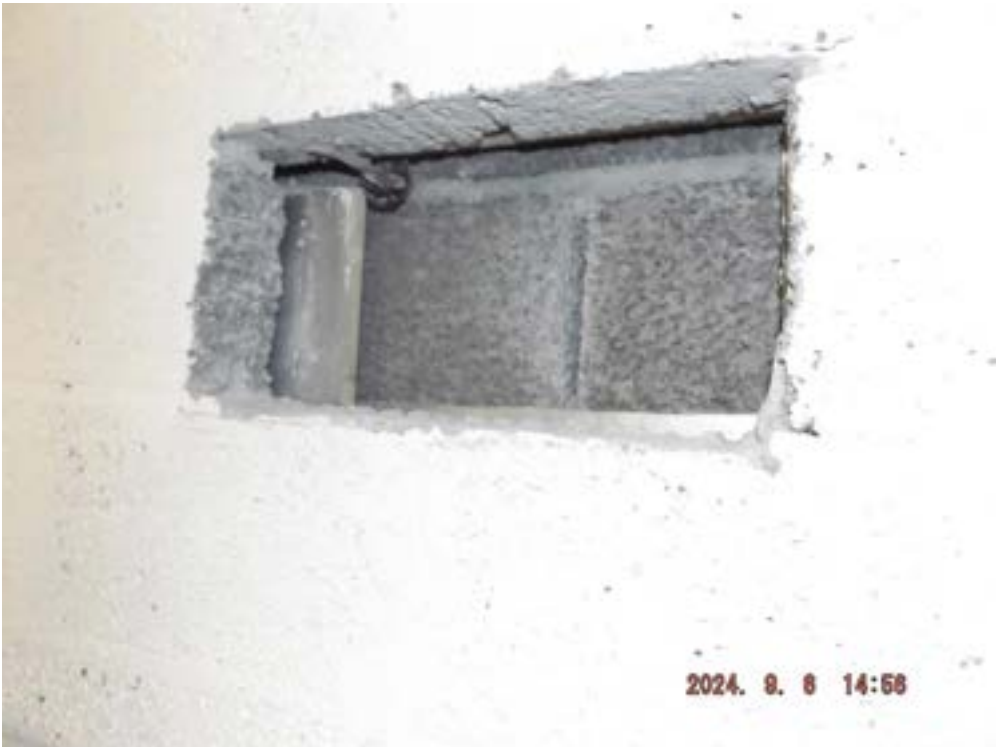
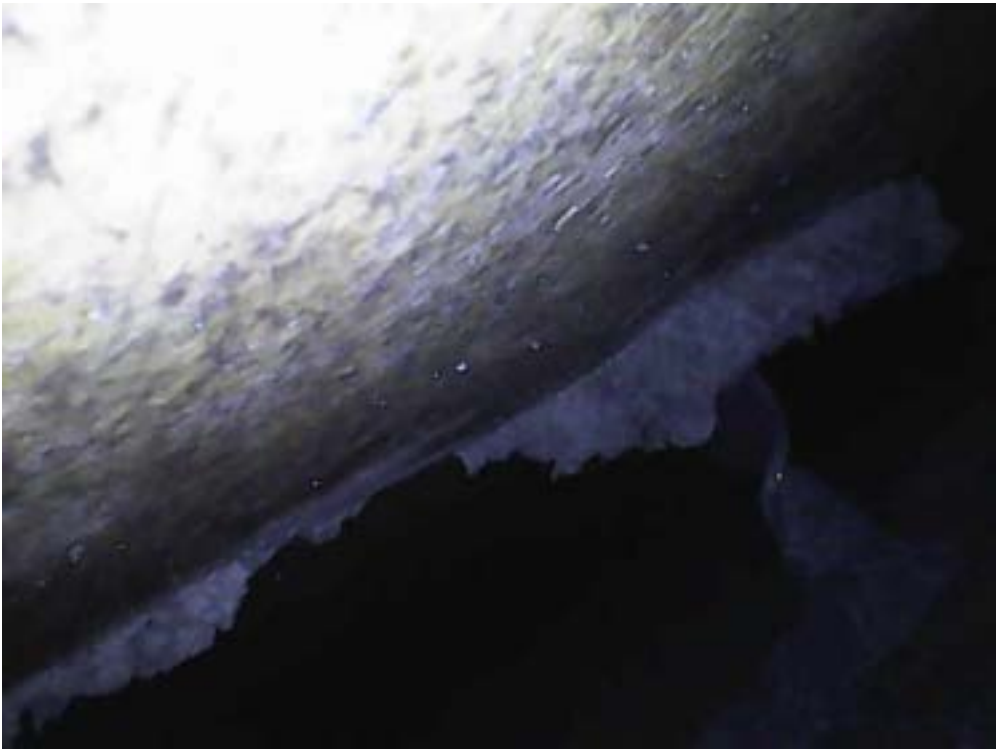
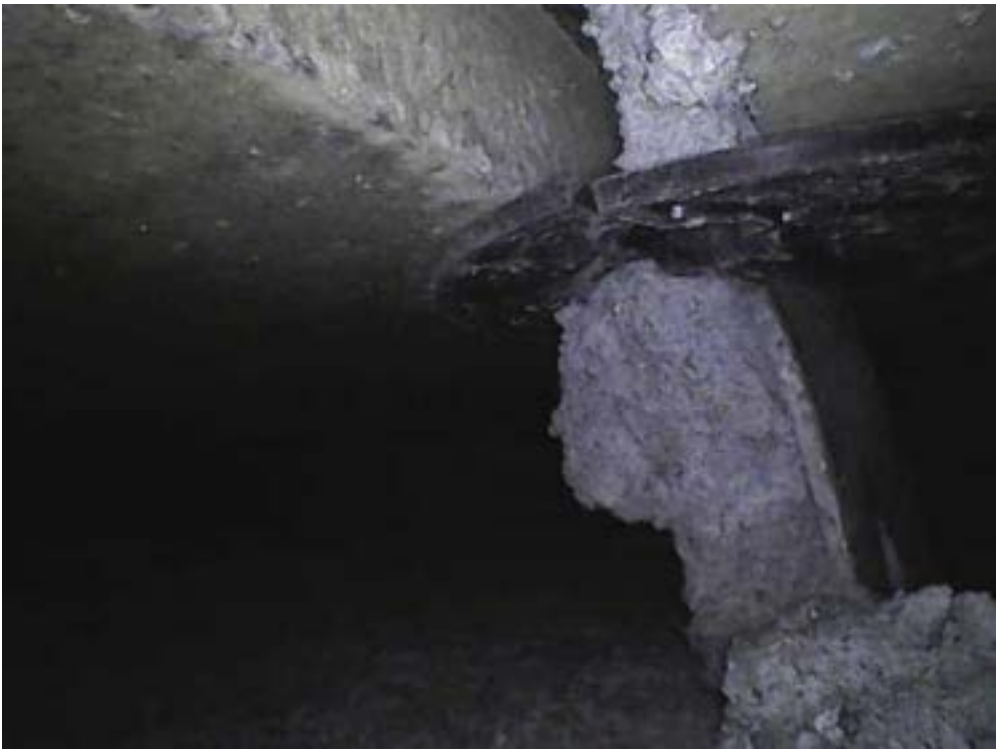
Block 2

| Block reference | Block condition | Mortar condition | No of Wall Ties found and condition | Comments |
|---|---|---|---|---|
| Block 2<br>(east wall) | 100mm thick dense concrete in good condition | Poor – inner leaf weak and friable; outer leaf very weak and friable | 4no to top of block, upper right, lower left and lower right side of block within 900mm/good | 90mm cavity overall with 25mm insulation board displaced 20mm off inner leaf wall. Wall tie at top of block slightly loose. Insufficient wall tie embedment in outer leaf. |

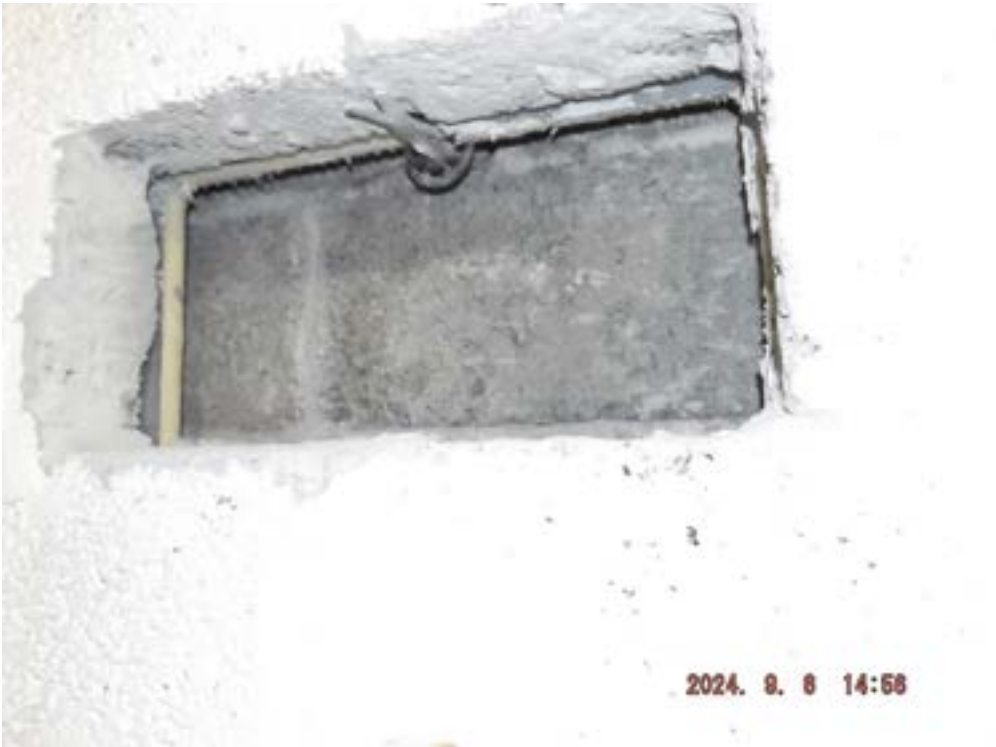
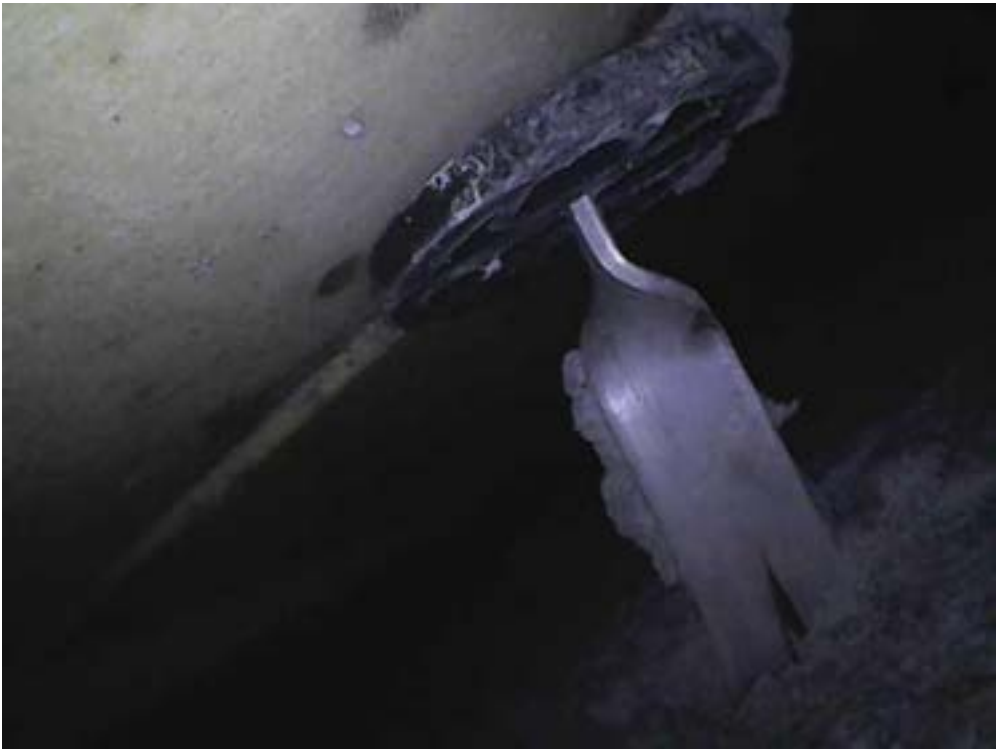
Block 3

| Block reference | Block condition | Mortar condition | No of Wall Ties found and condition | Comments |
|---|---|---|---|---|
| Block 3<br>(south wall) | 100mm thick dense concrete in good condition | Poor – inner leaf very weak and friable; outer leaf very weak and friable | 4no to top of block, upper, upper right and lower right side of block within 450mm and 2 no adjacent to RC column to left of block/good | 95mm cavity overall with 25mm insulation board displaced 20mm off inner leaf wall. Wall tie at top of block loose. Insufficient wall tie embedment in outer leaf. Mortar sample taken |

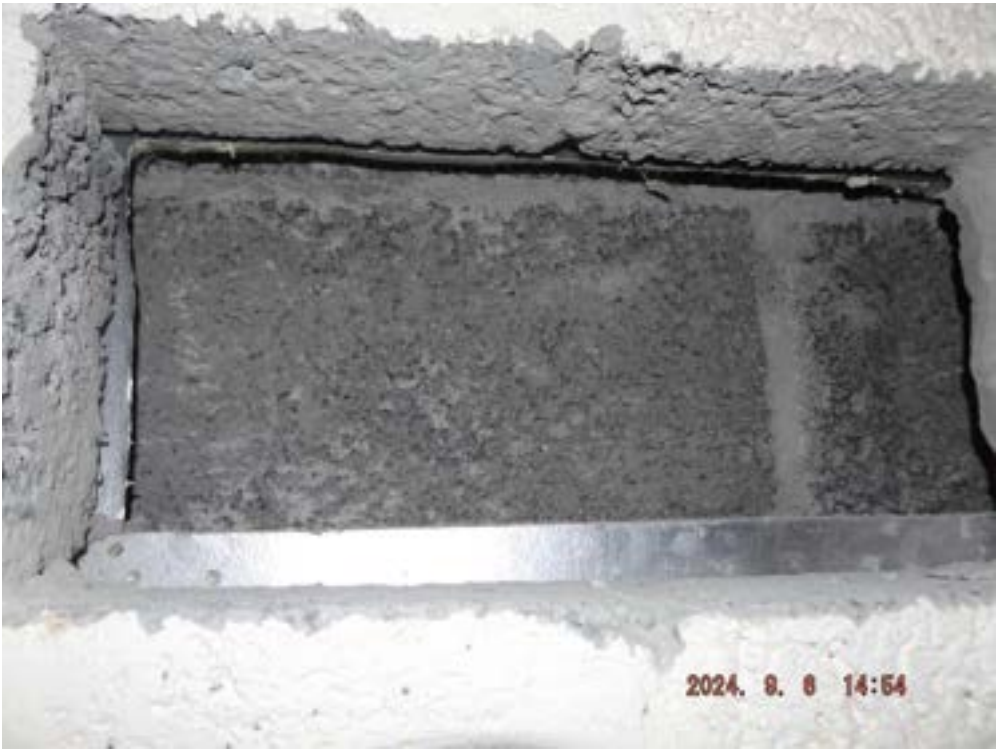
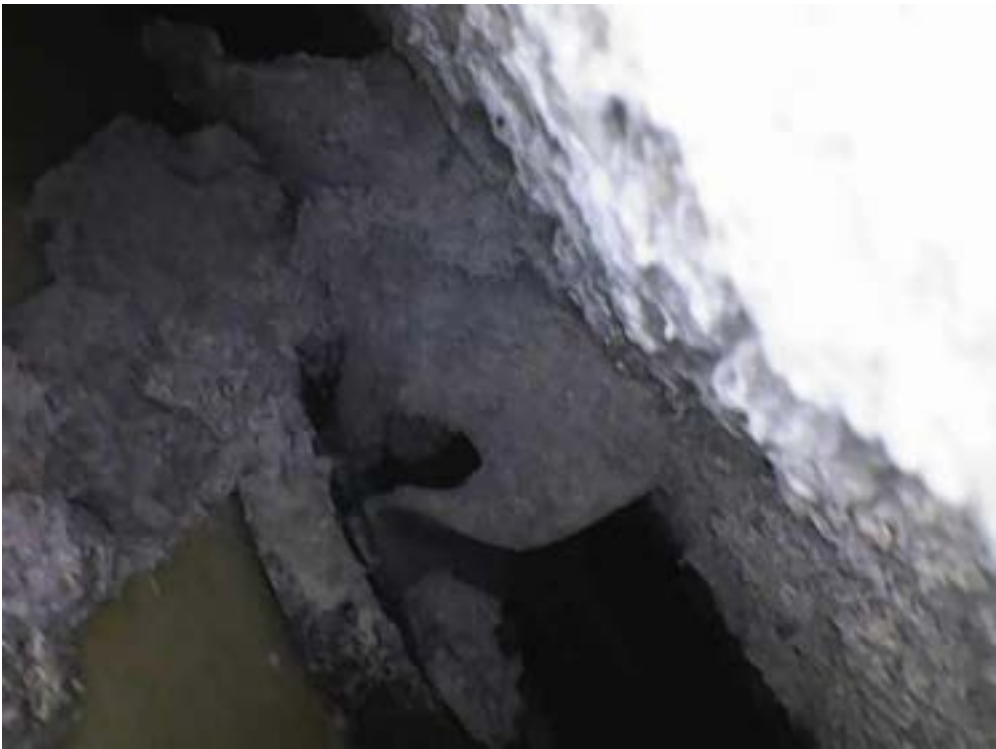
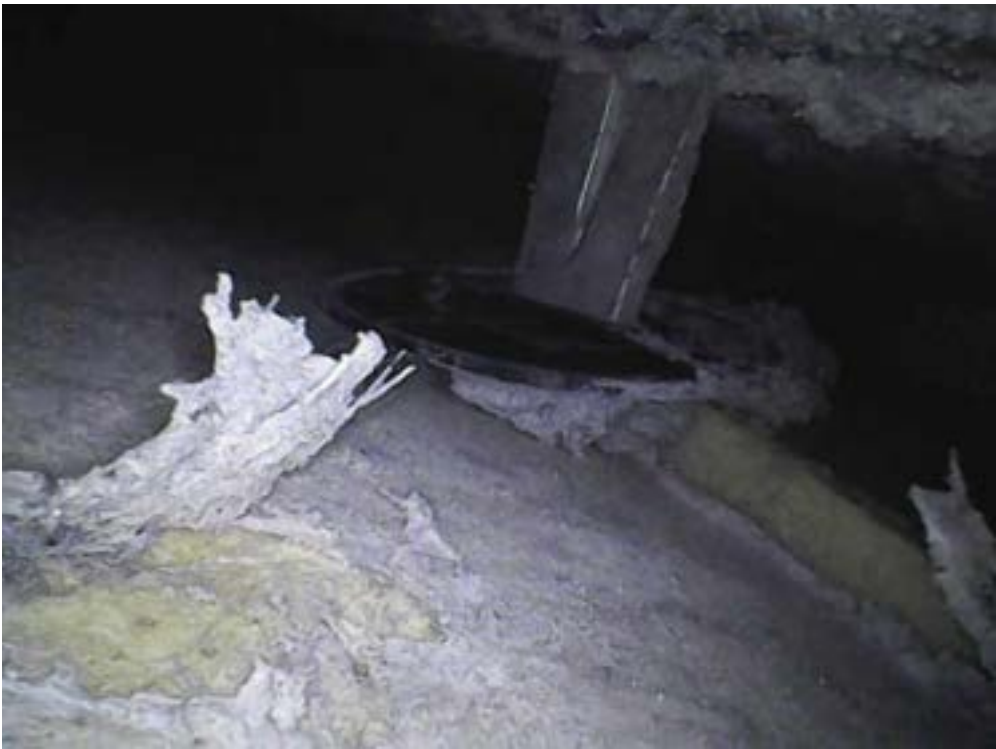
Block 4

| Block reference | Block condition | Mortar condition | No of Wall Ties found and condition | Comments |
|---|---|---|---|---|
| Block 4<br>(north wall) | 100mm thick dense concrete in good condition | Poor – inner leaf very weak and friable; outer leaf very weak and friable | 3no to upper, lower and left side of block within 450mm and 2 no adjacent to RC column to right of block/covered in mortar | 75mm cavity overall with 25mm insulation board displaced 15mm off inner leaf wall. Insufficient wall tie embedment in outer leaf. Mortar sample taken |

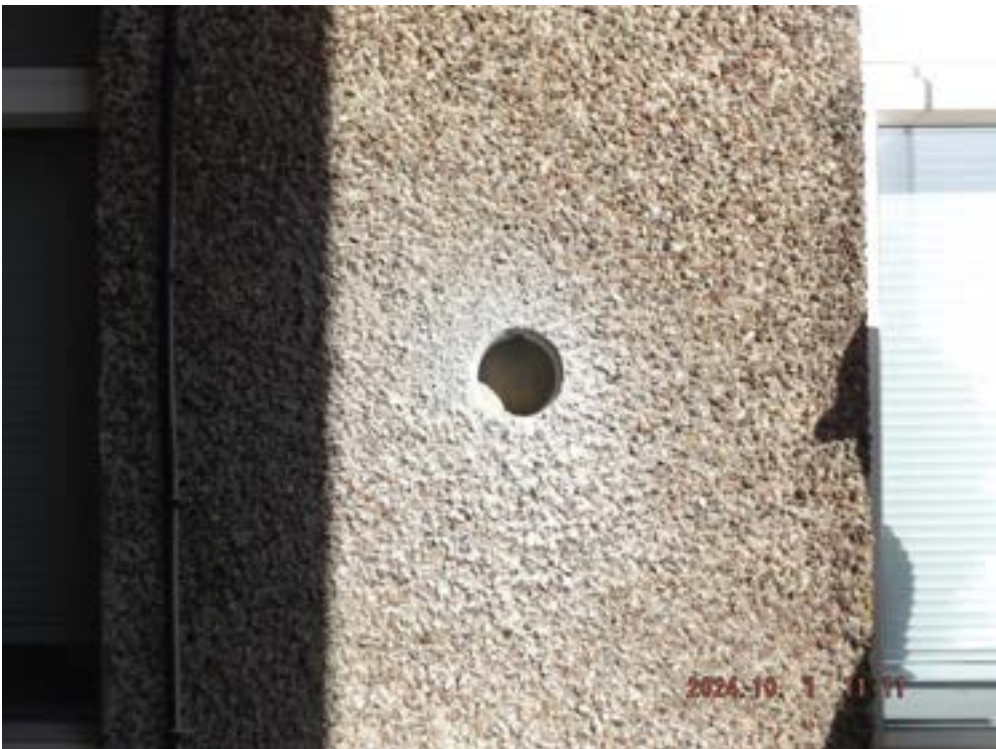
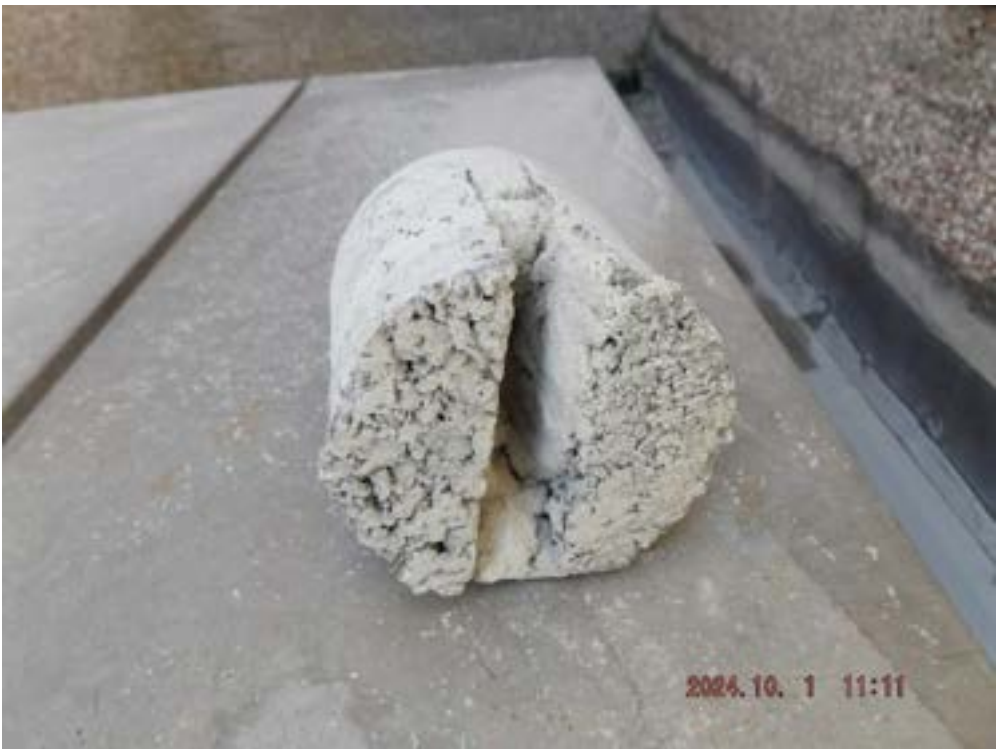
| Core reference | Block condition | Mortar condition | No of Wall Ties found and condition | Comments |
|---|---|---|---|---|
| Core 15 | 100mm thick dense concrete in good condition | Poor – satisfactory strength but 50% voided joint at core | Suspected ties 300mm and 1200mm above and 600mm below core/covered with mortar | 20mm cavity to 25mm insulation board. Lot of mortar droppings in cavity |
