# **Gilbert Bain Hospital Phase 1 Construction**

Report on Condition of External Walls

December 2024

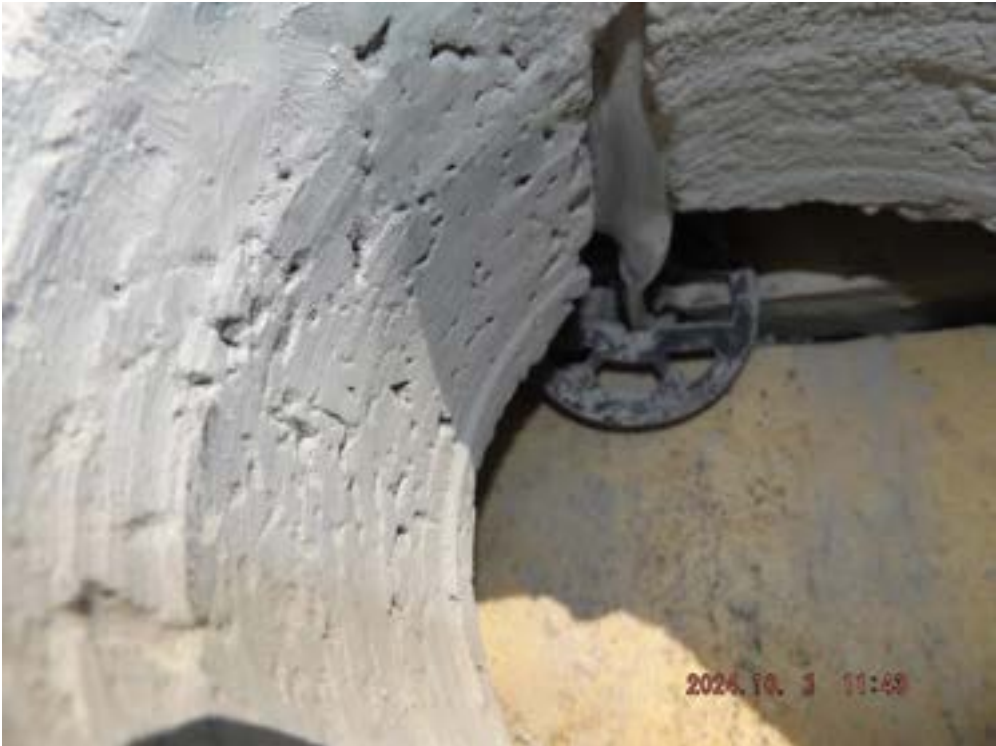
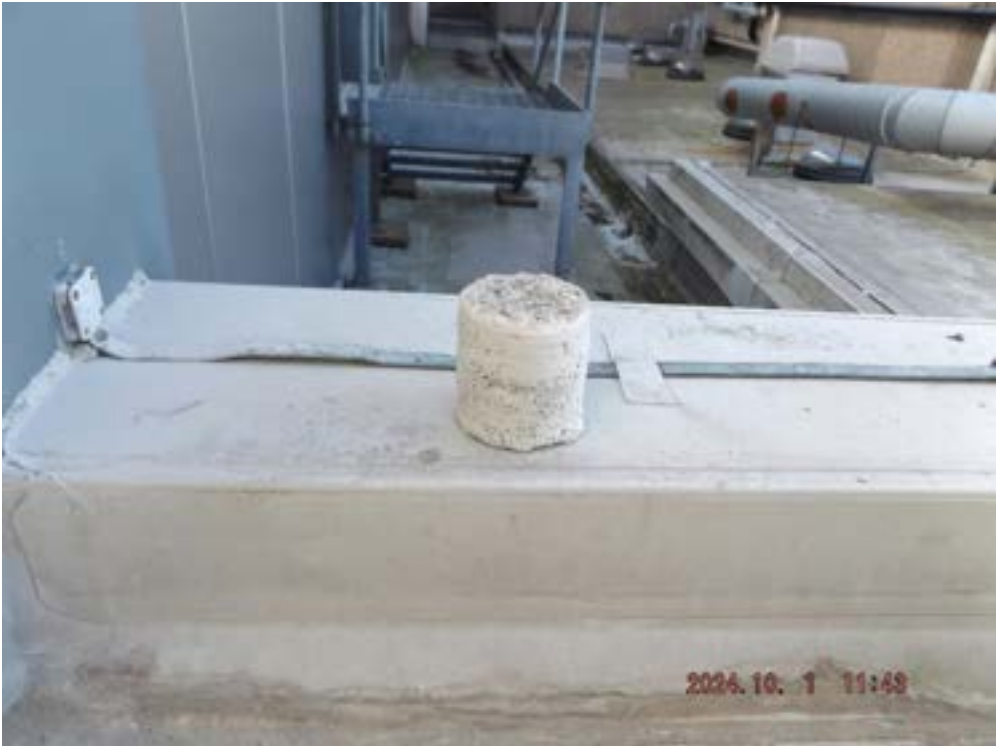
| Core reference | Block condition | Mortar condition | No of Wall Ties found and condition | Comments |
|---|---|---|---|---|
| Core 17 | 100mm thick dense concrete in good condition | Reasonable – strength of mortar satisfactory | 1 no at core/good. 2no suspected 600mm above and 600mm to left lower of core/covered with mortar | 25mm cavity to 25mm insulation board. Lot of mortar droppings in cavity |

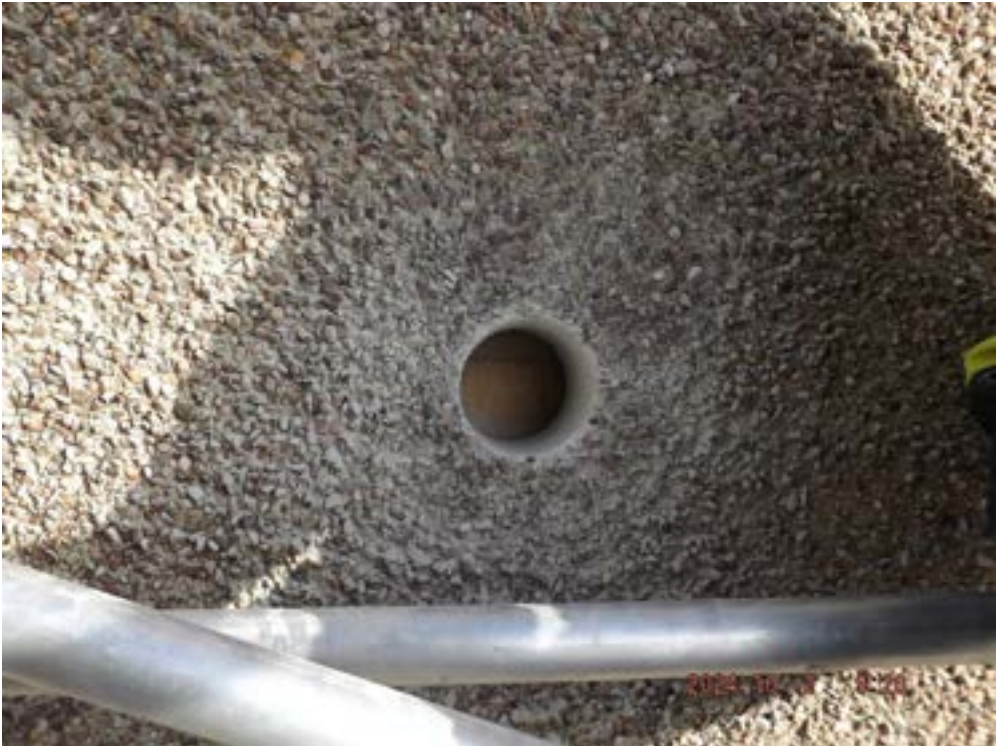
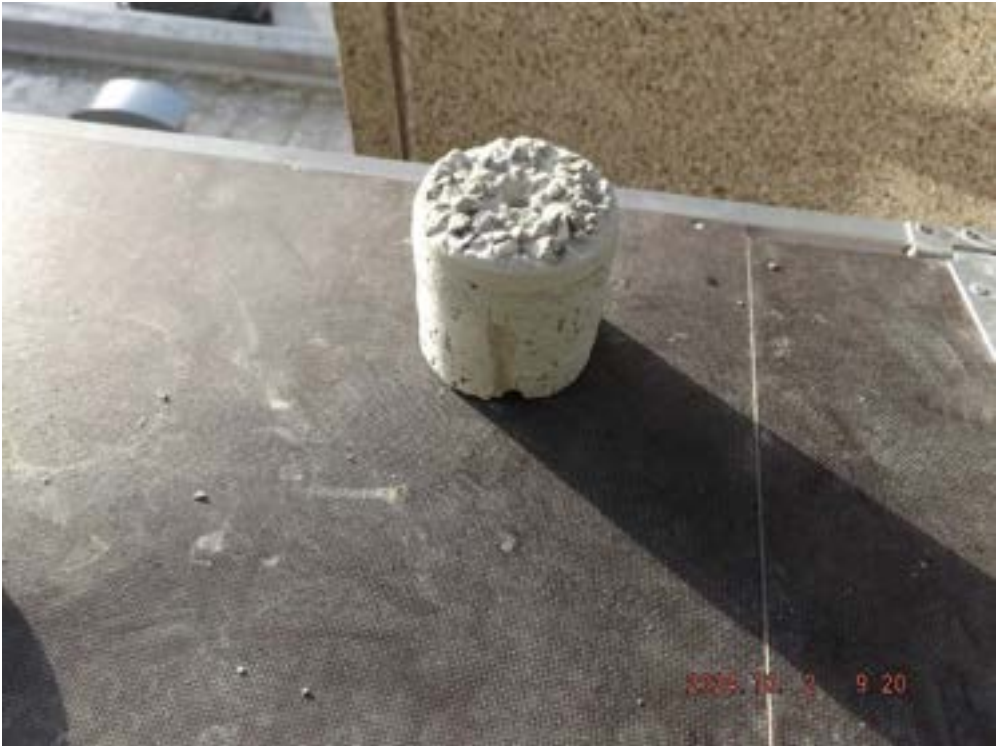
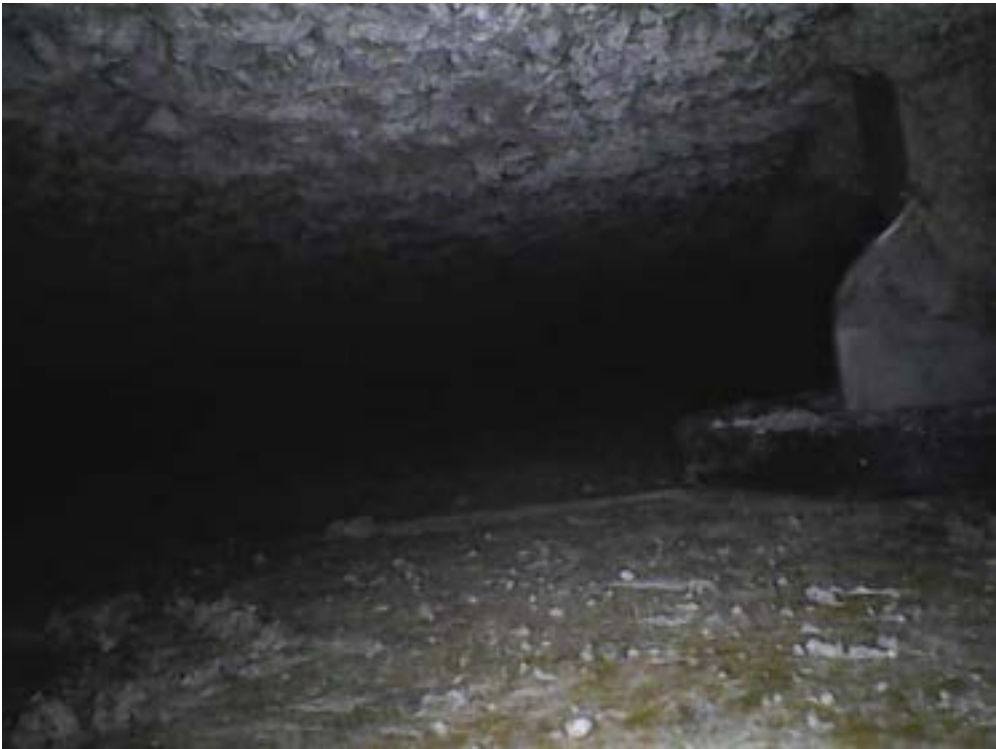
| Core reference | Block condition | Mortar condition | No of Wall Ties found and condition | Comments |
|---|---|---|---|---|
| Core 20 | 100mm thick dense concrete in good condition | Poor –weak and friable | 2no 350mm to upper left and 250mm to lower right of core/good. 1no suspected tie 800mm to upper right/covered with mortar | 30mm cavity to 25mm insulation board. Lot of mortar droppings in cavity |

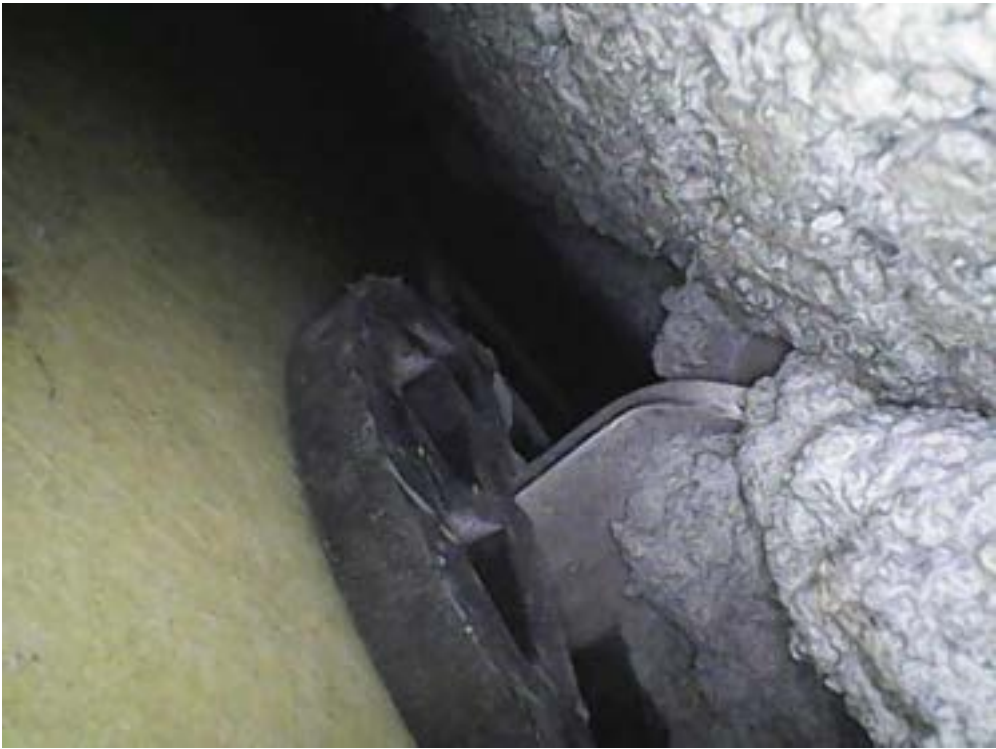
Wall tie at Core 19

| Core reference | Block condition | Mortar condition | No of Wall Ties found and condition | Comments |
|---|---|---|---|---|
| Core 19 | 100mm thick dense concrete in good condition | Reasonable – strength of mortar satisfactory | 1no at core/good. 2no suspected 900mm above and 600mm to right lower of core/covered with mortar | 30mm cavity to 25mm insulation board. Lot of mortar droppings in cavity |

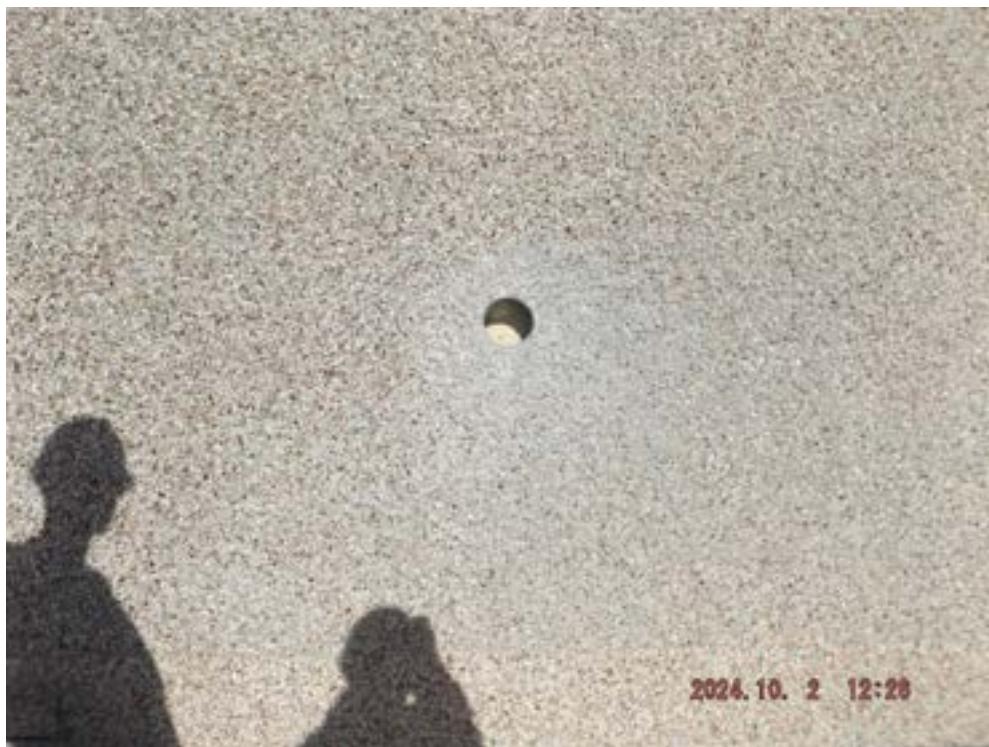
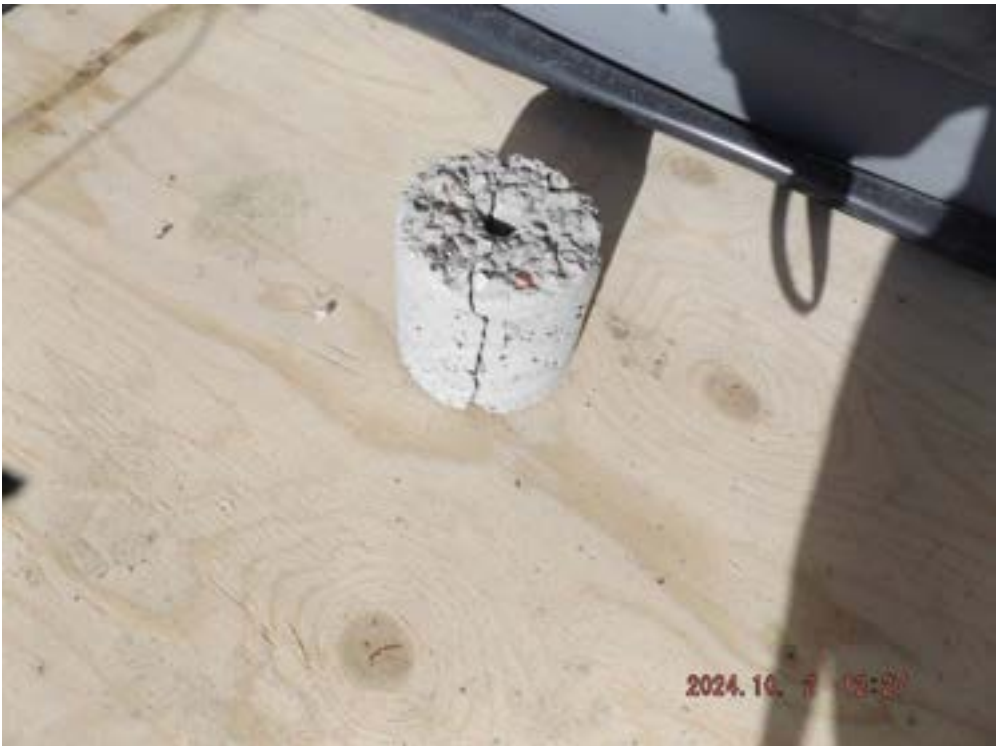
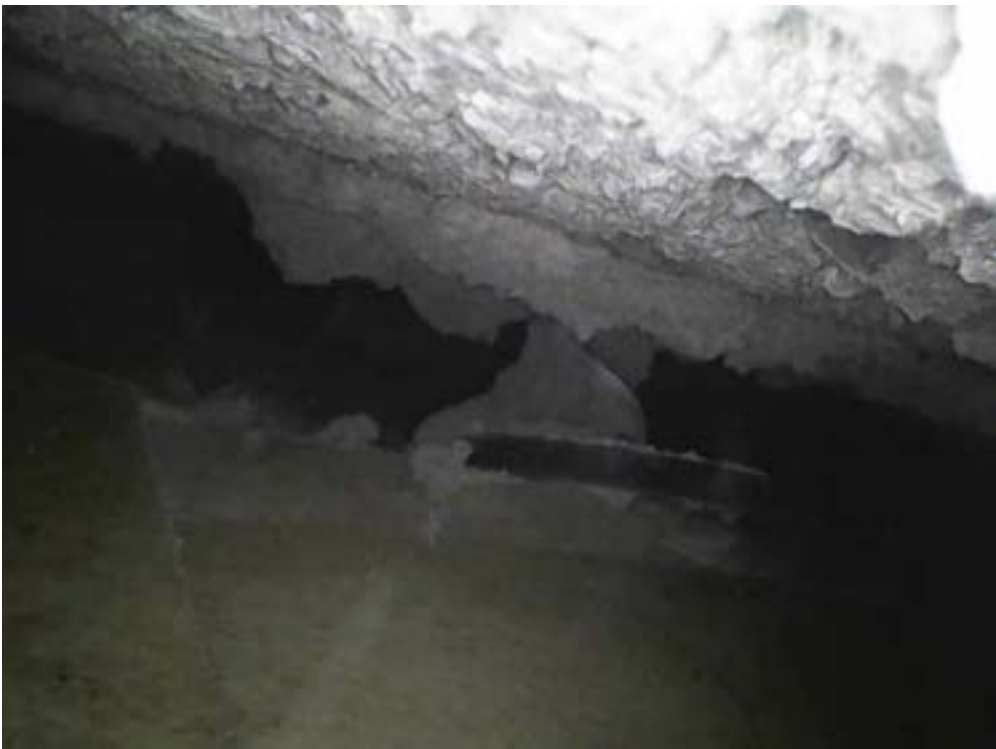
#### Core 21

| Core reference | Block condition | Mortar condition | No of Wall Ties found and condition | Comments |
|---|---|---|---|---|
| Core 21 (south wall) | 100mm thick dense concrete in good condition | Reasonable - mortar satisfactory | 2no 600mm above core and 450mm to right of core /good. 1no 1200mm below core/covered with mortar | 30mm cavity to 25mm insulation board. Lot of mortar droppings in cavity |

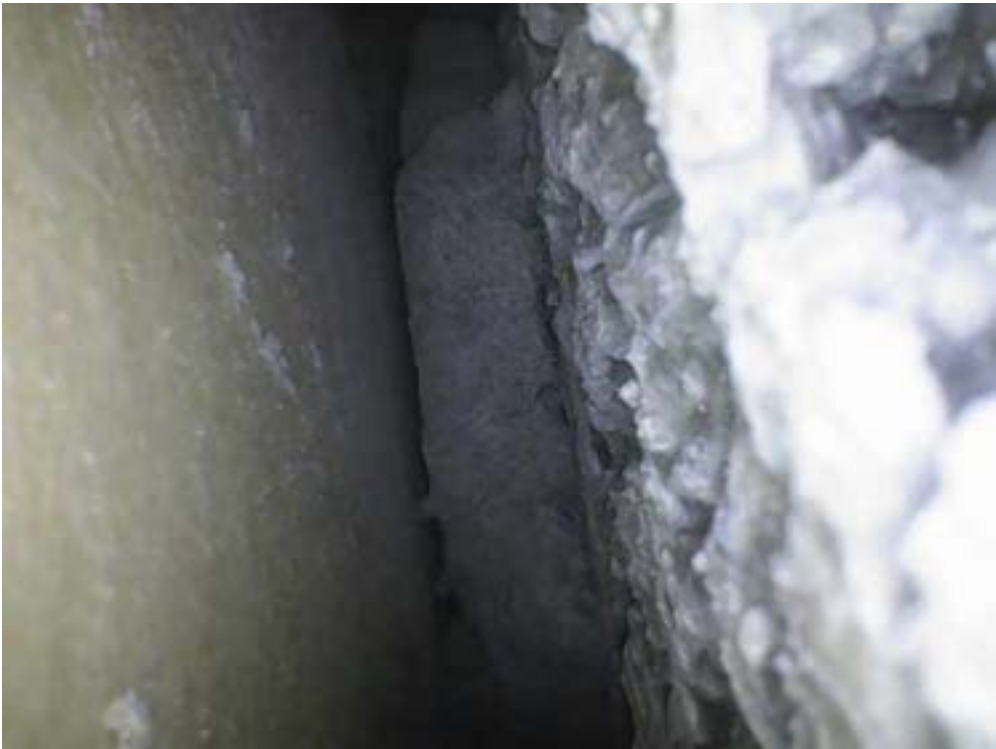
Wall tie at Core 28

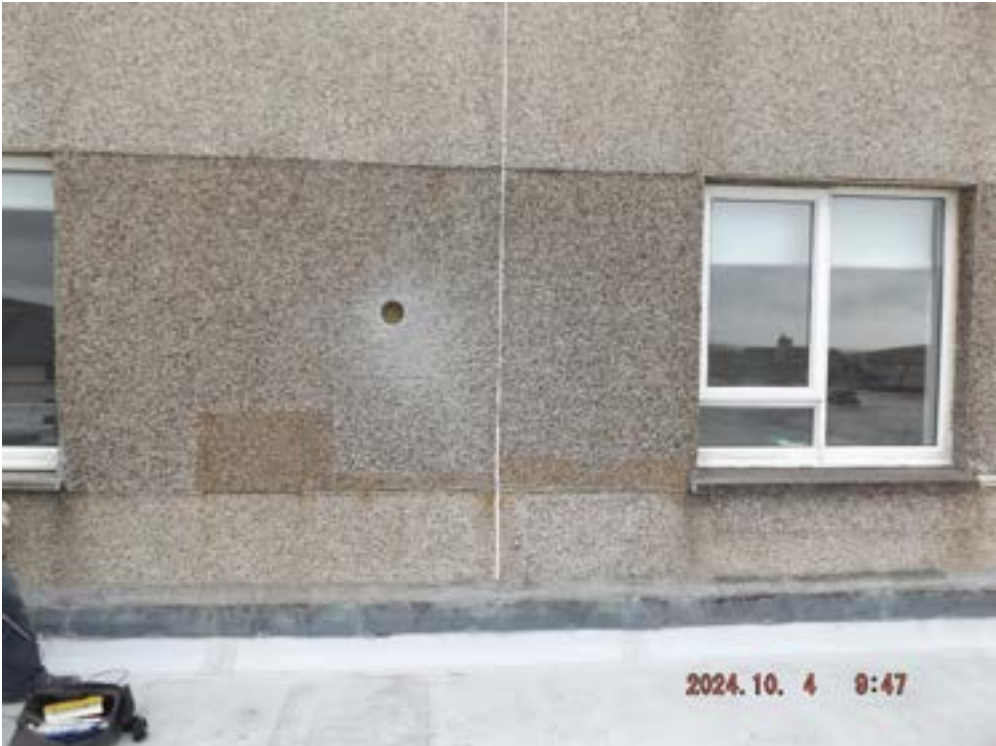
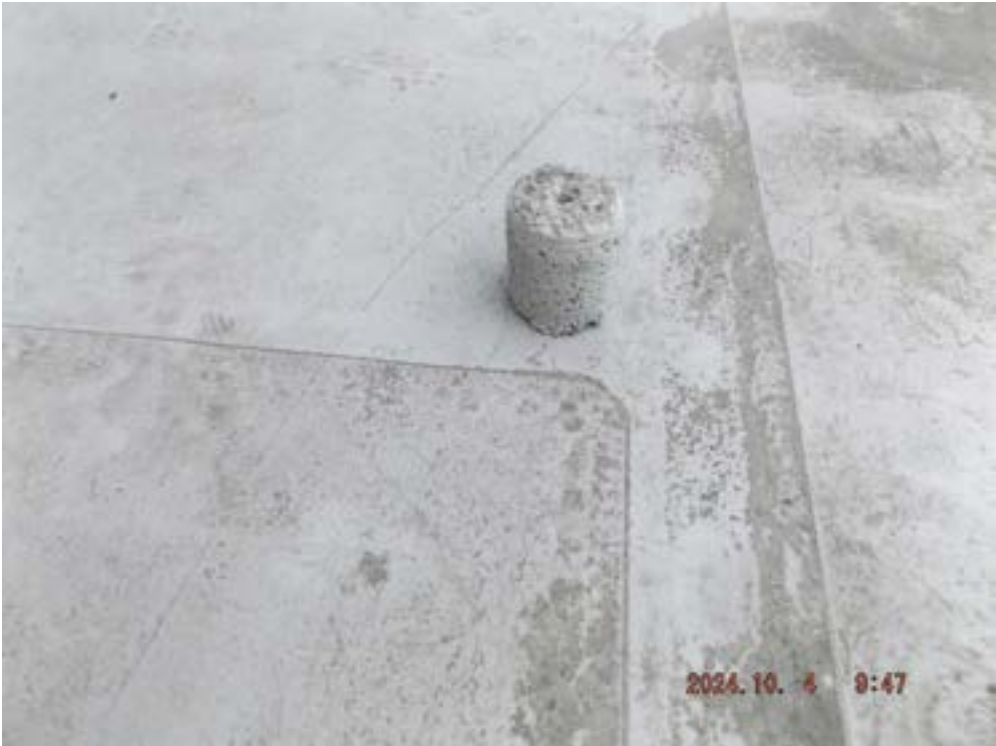
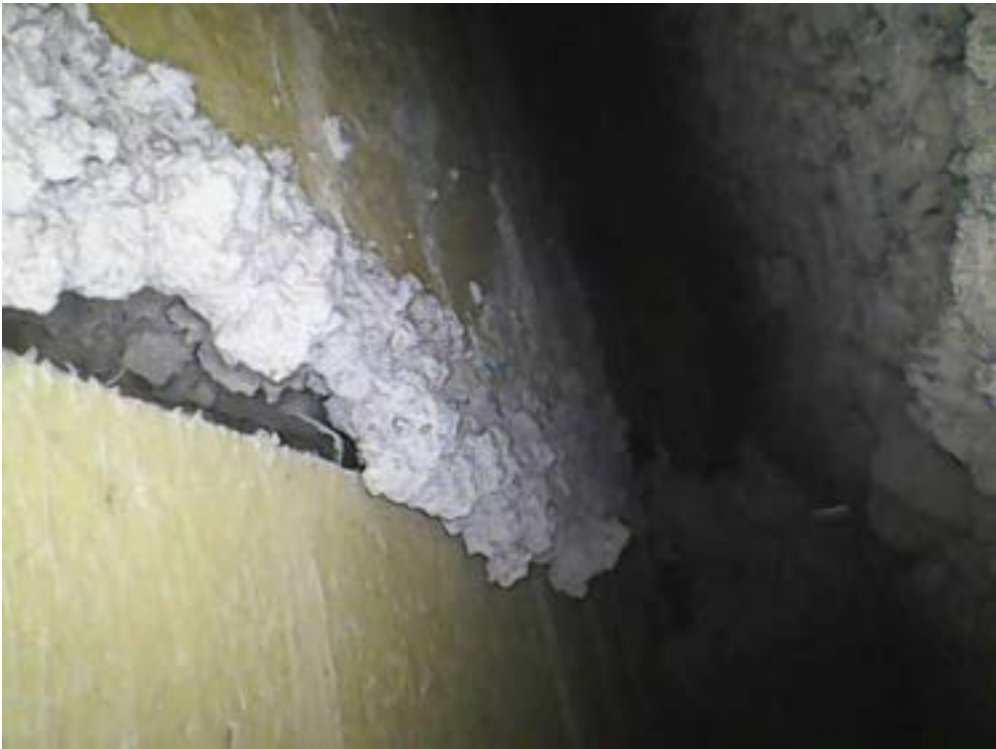
| Core reference | Block condition | Mortar condition | No of Wall Ties found and condition | Comments |
|---|---|---|---|---|
| Core 34 (link west wall) | 100mm thick dense concrete in good condition | Poor – weak and friable | 1no at core/good. 2no 450mm above core and 450mm below core/covered with mortar | 30mm cavity to 25mm insulation board. Lot of mortar droppings in cavity. |

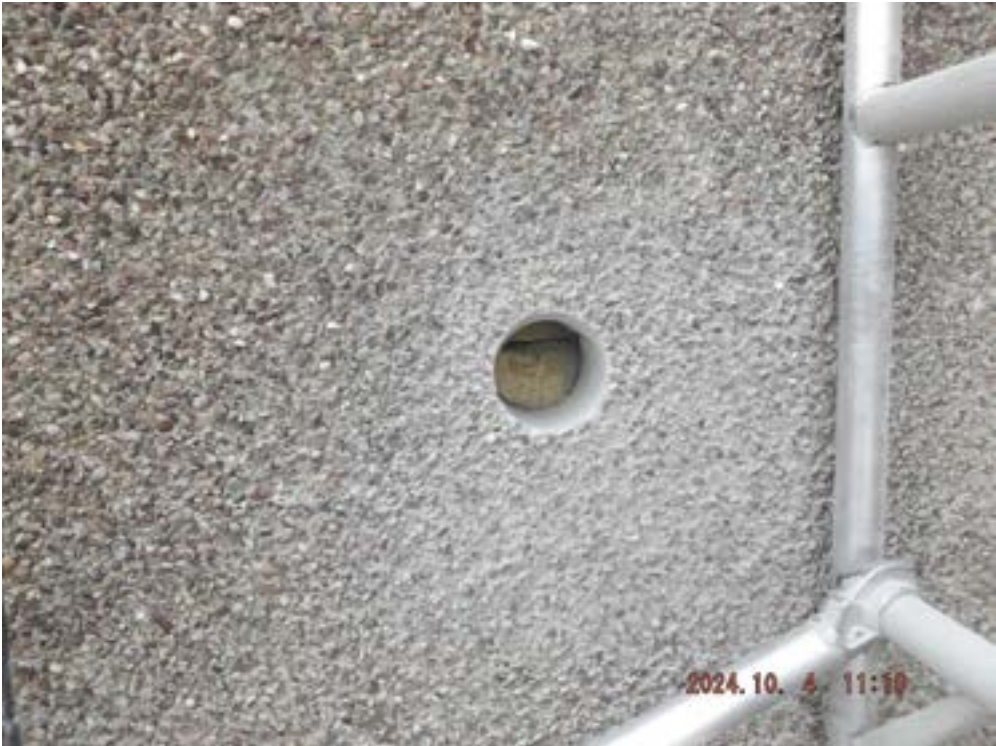
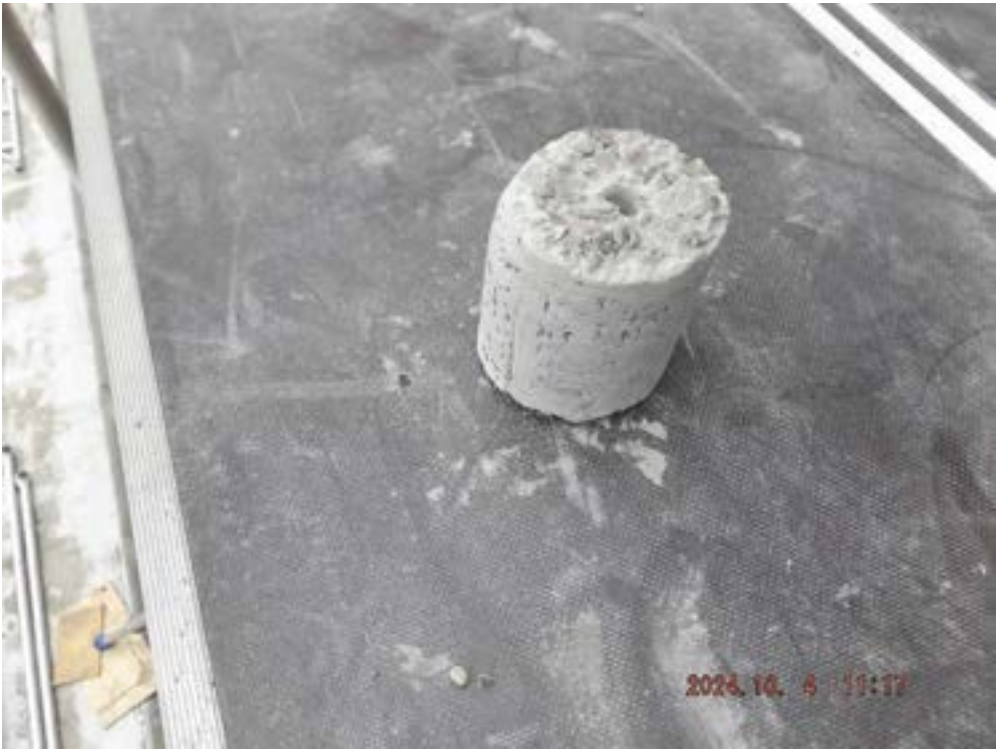
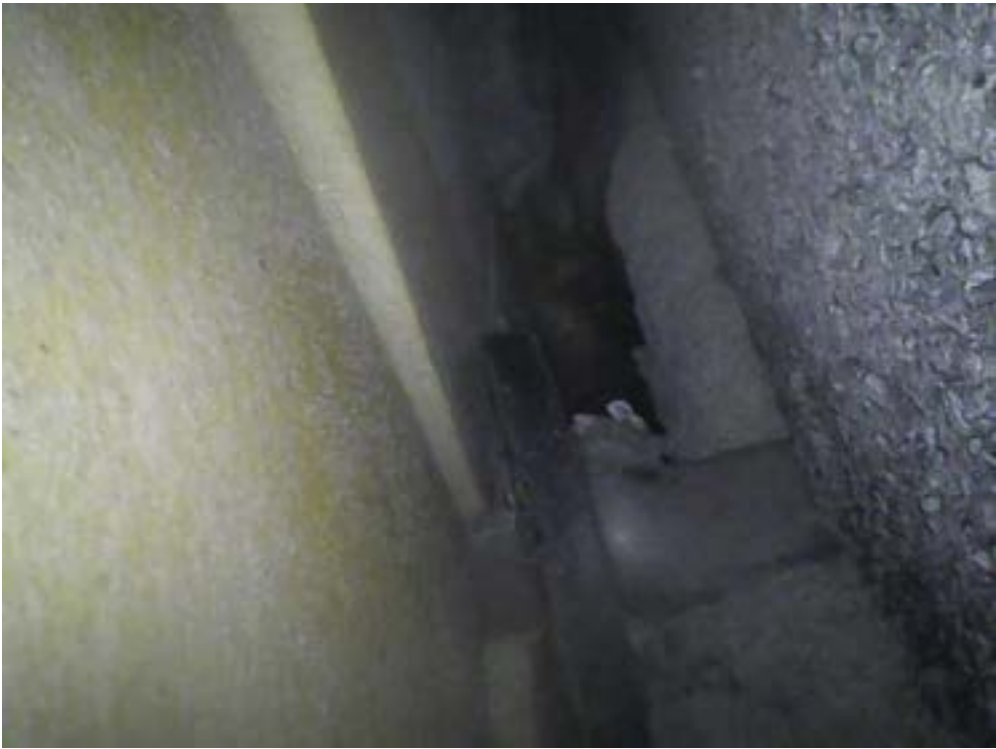
| Core reference | Block condition | Mortar condition | No of Wall Ties found and condition | Comments |
|---|---|---|---|---|
| Core 38 (south wall) | 100mm thick dense concrete in good condition | Reasonable – strength adequate | 3 no 900mm above core, 450mm to left of core and 500mm to right lower of core/good | 25mm cavity to 25mm insulation board. Lot of mortar droppings in cavity |

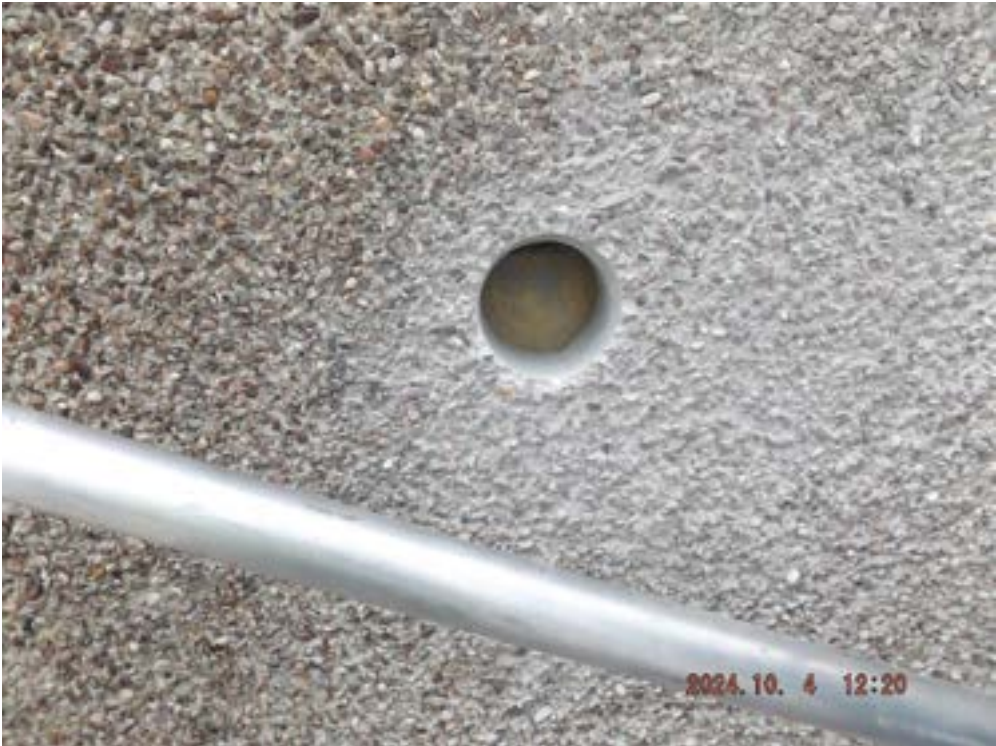
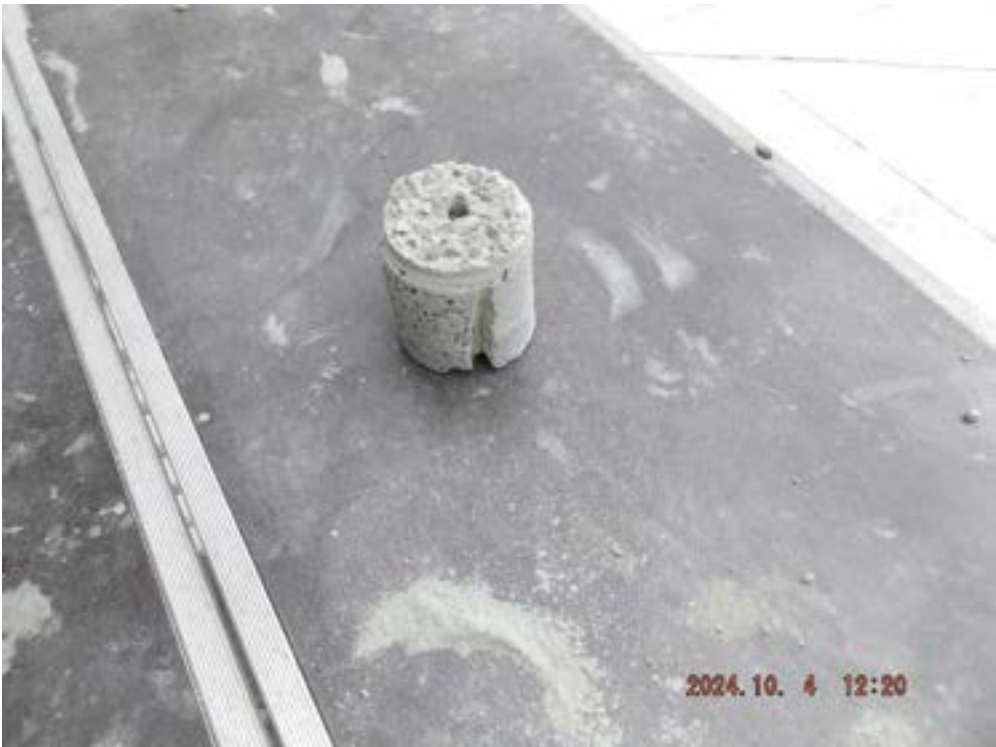
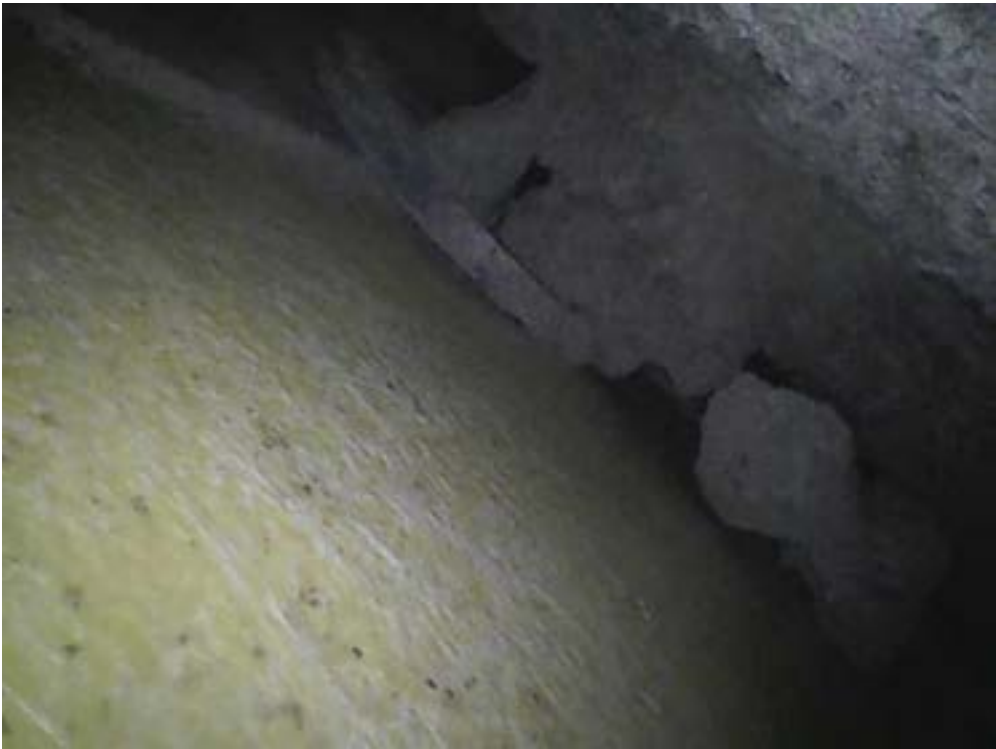
| Core reference | Block condition | Mortar condition | No of Wall Ties found and condition | Comments |
|---|---|---|---|---|
| Core 40 (south wall) | 100mm thick dense concrete in good condition | Poor to reasonable –low strength | 2 no 600mm to left lower of core and 850mm to left lower of core/good | 40mm cavity to 25mm insulation board. Lot of mortar droppings in cavity |

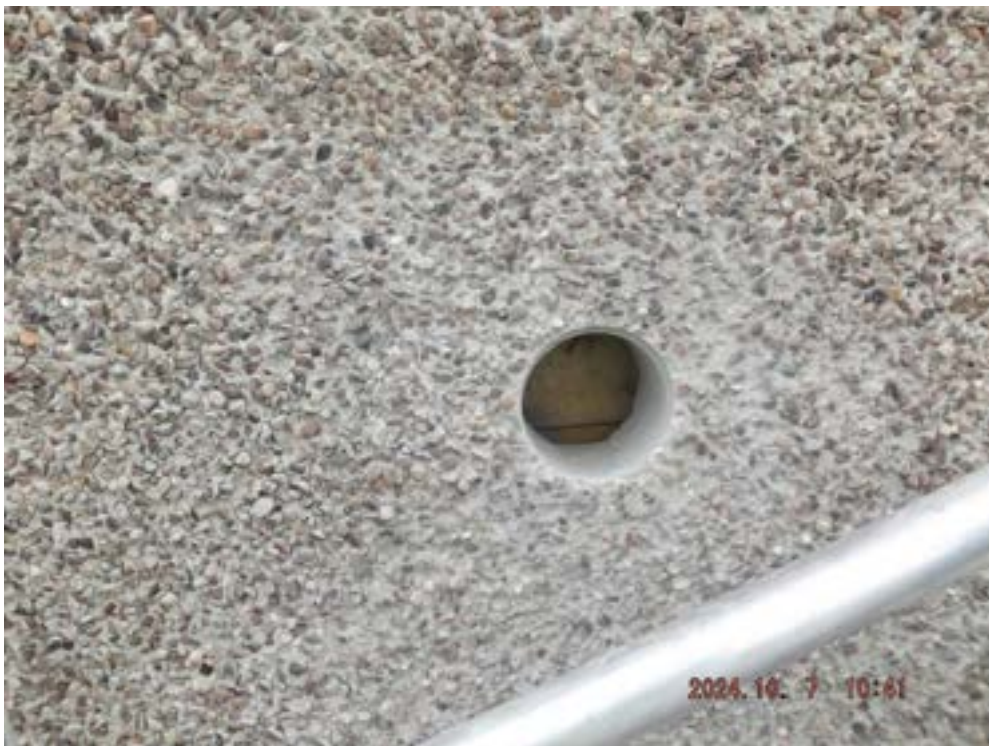
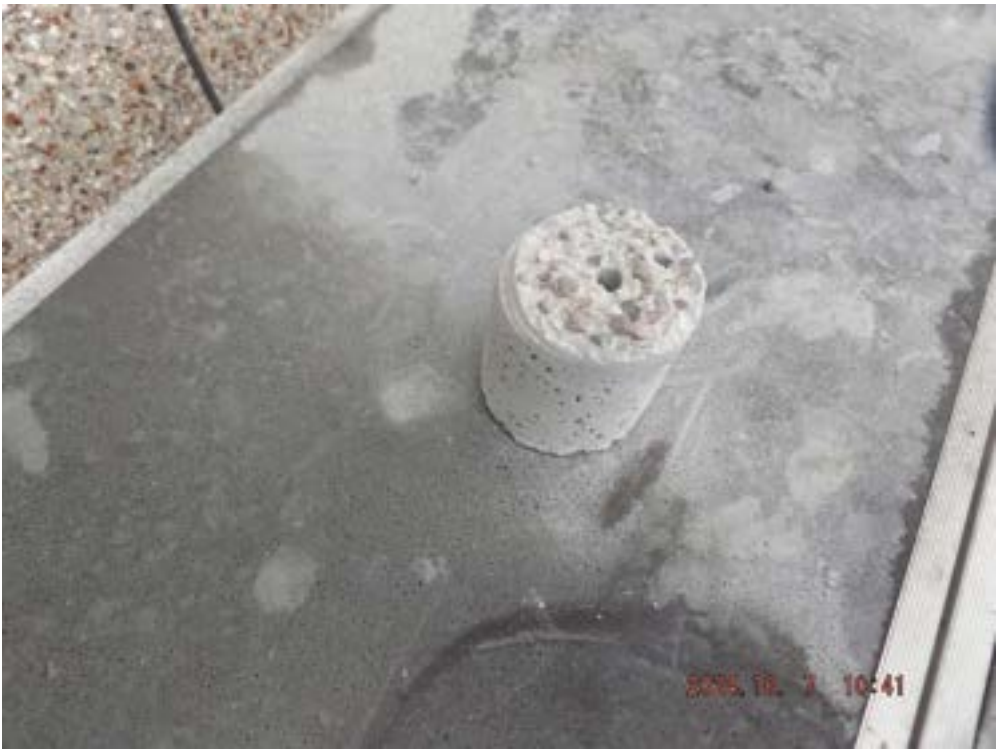
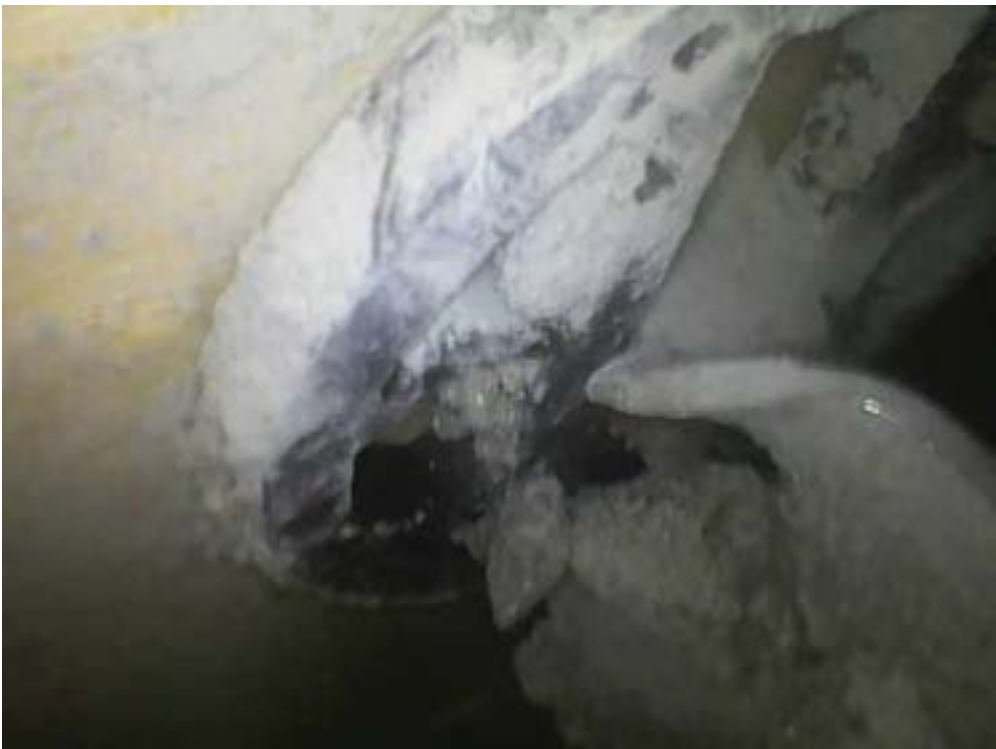
#### Core 41

| Core reference | Block condition | Mortar condition | No of Wall Ties found and condition | Comments |
|---|---|---|---|---|
| Core 41 (west wall) | 100mm thick dense concrete in good condition | Reasonable – strength adequate | 2 no 150mm to left lower and 1200mm to right upper of core /good. 1 no 1350mm to left upper of core/covered with mortar | 40mm cavity to 25mm insulation board. Lot of mortar droppings in cavity |

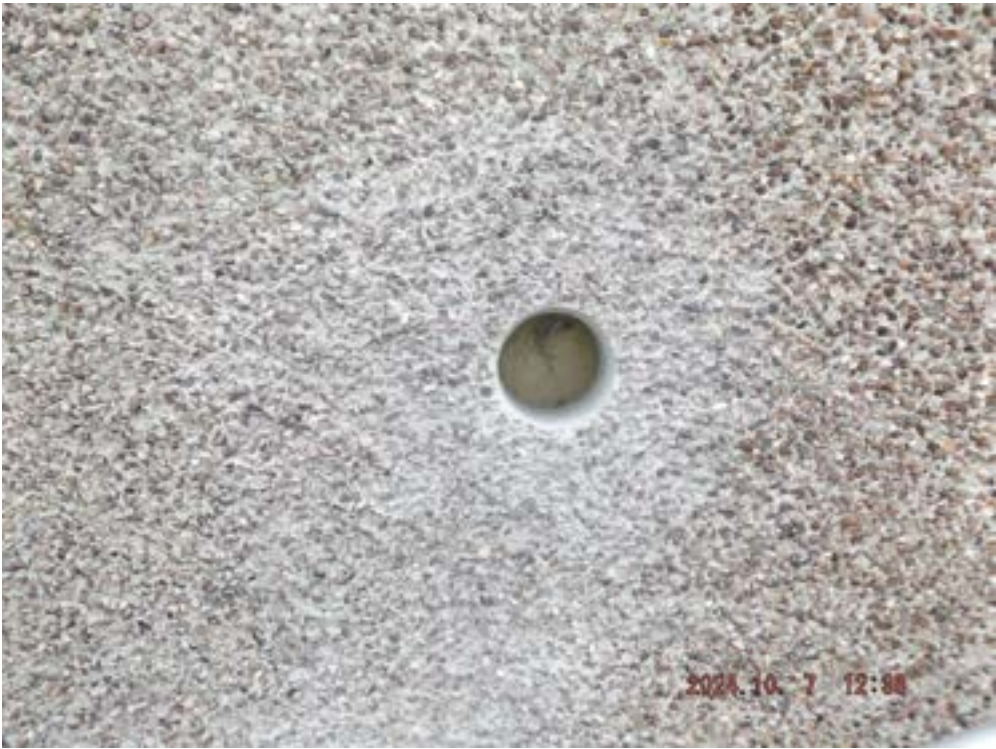
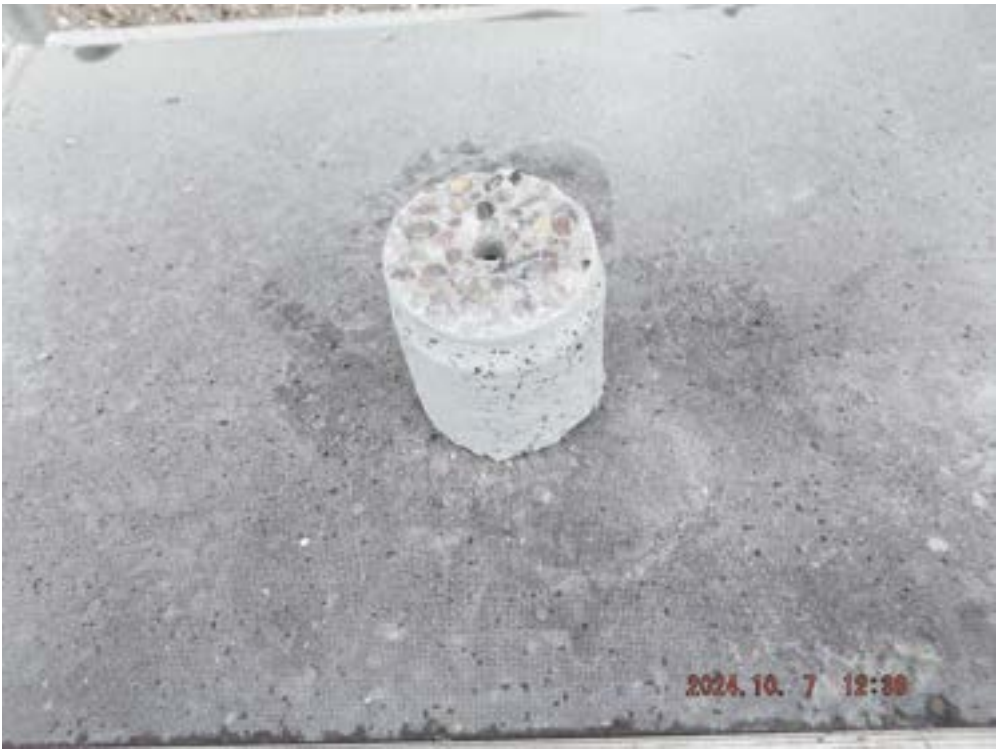
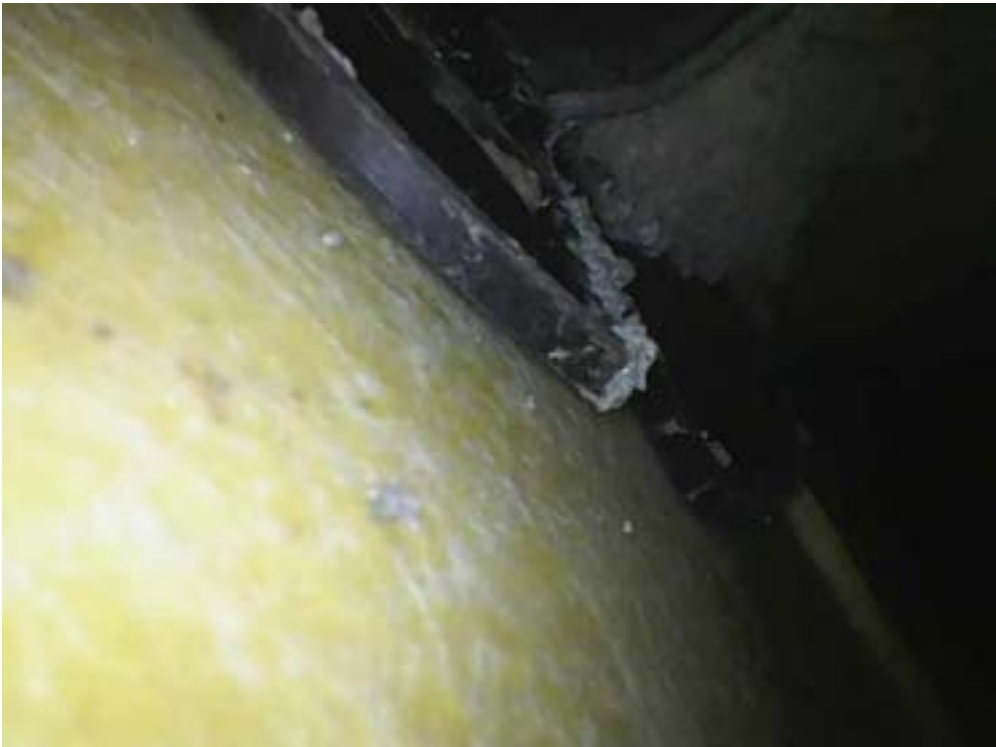
| Core 45 (west wall) | 100mm thick dense concrete in good condition | Reasonable – strength adequate | 2 no 900mm to left upper of core and 600mm below core/good. 1 no 550mm to right upper of core/covered with mortar | 30mm cavity to 25mm insulation board. Lot of mortar droppings in cavity |

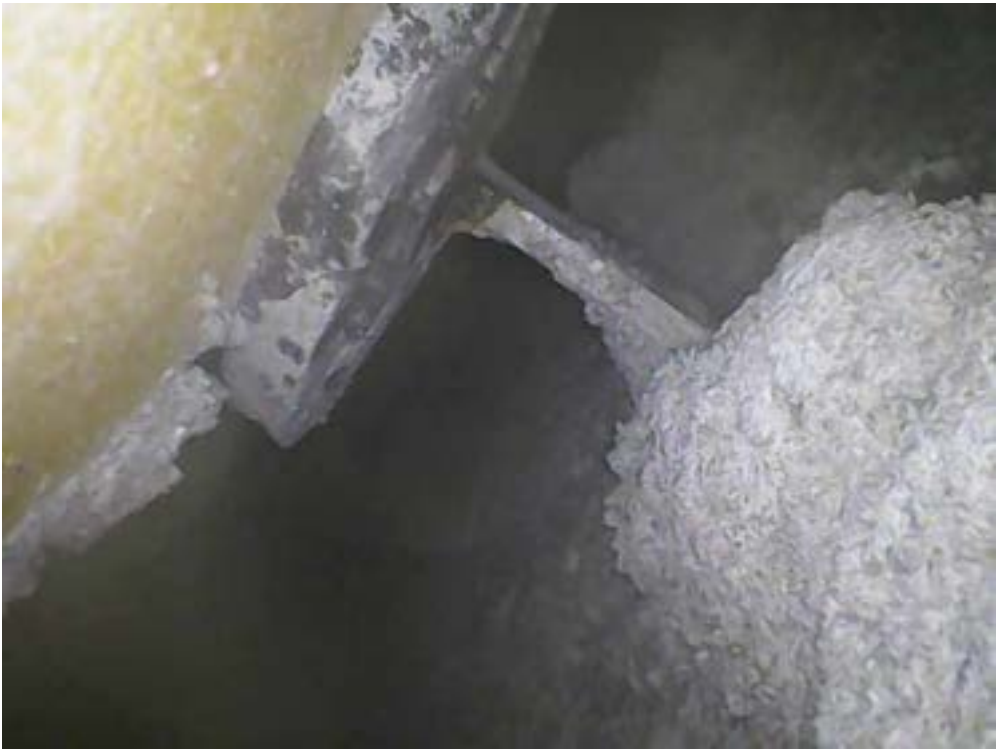
| Core reference | Block condition | Mortar condition | No of Wall Ties found and condition | Comments |
|---|---|---|---|---|
| Core 42 (west wall) | 100mm thick dense concrete in good condition | Poor – weak and friable | 1no 250mm to left of core/good. 1no 650mm to right of core/covered with mortar | 25mm cavity to 25mm insulation board. Lot of mortar droppings in cavity. |

Wall tie at Core 42

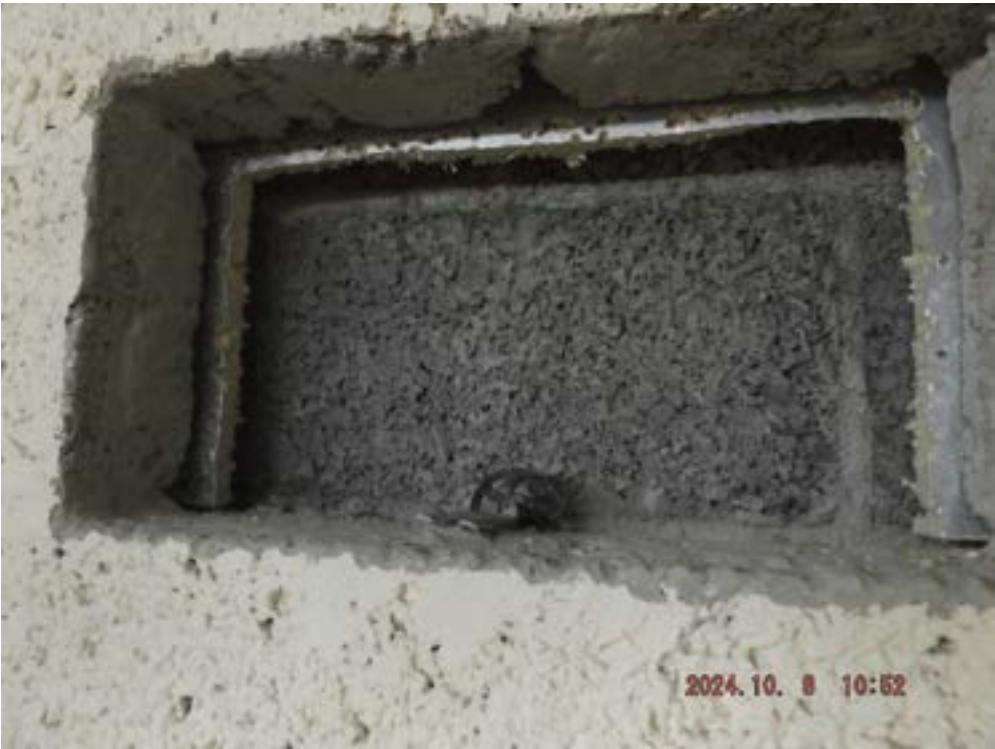
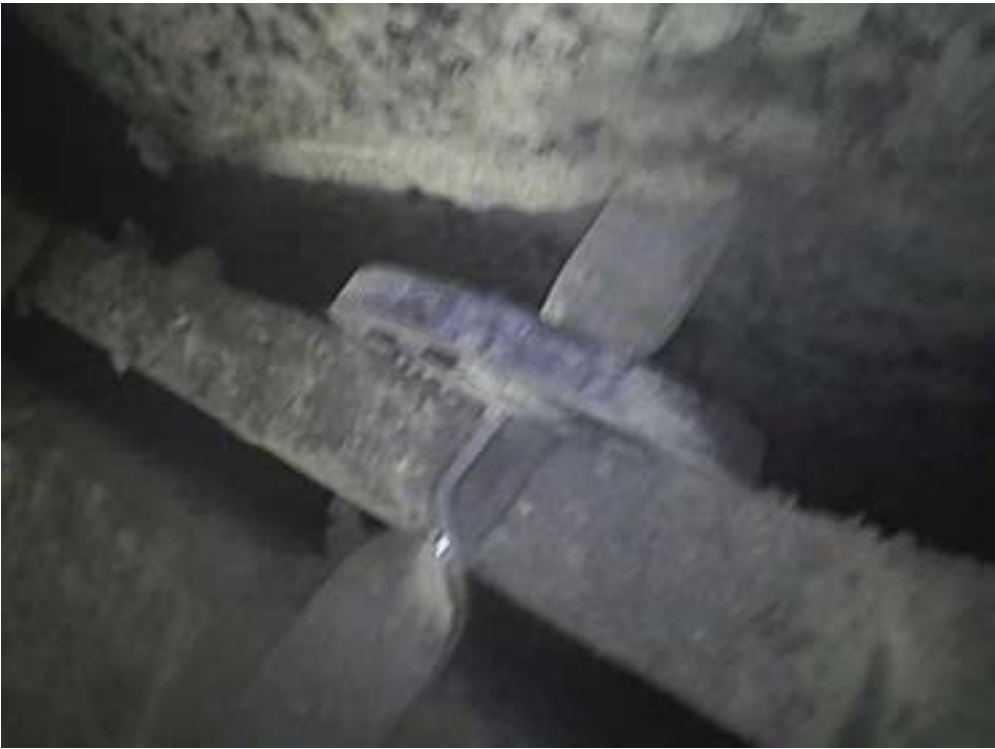
| Block reference | Block condition | Mortar condition | No of Wall Ties found and condition | Comments |
|---|---|---|---|---|
| Block 5 (west wall) | 100mm thick dense concrete in good condition | Poor – inner leaf weak and friable; outer leaf weak and friable | 1no at bottom of block/good; 2 no 600mm to right lower of block and 900mm below block/covered in mortar | 80mm cavity overall with 25mm insulation board displaced 25mm off inner leaf wall. |
