# **Gilbert Bain Hospital Phase 1 Construction**

Report on Condition of External Walls

December 2024

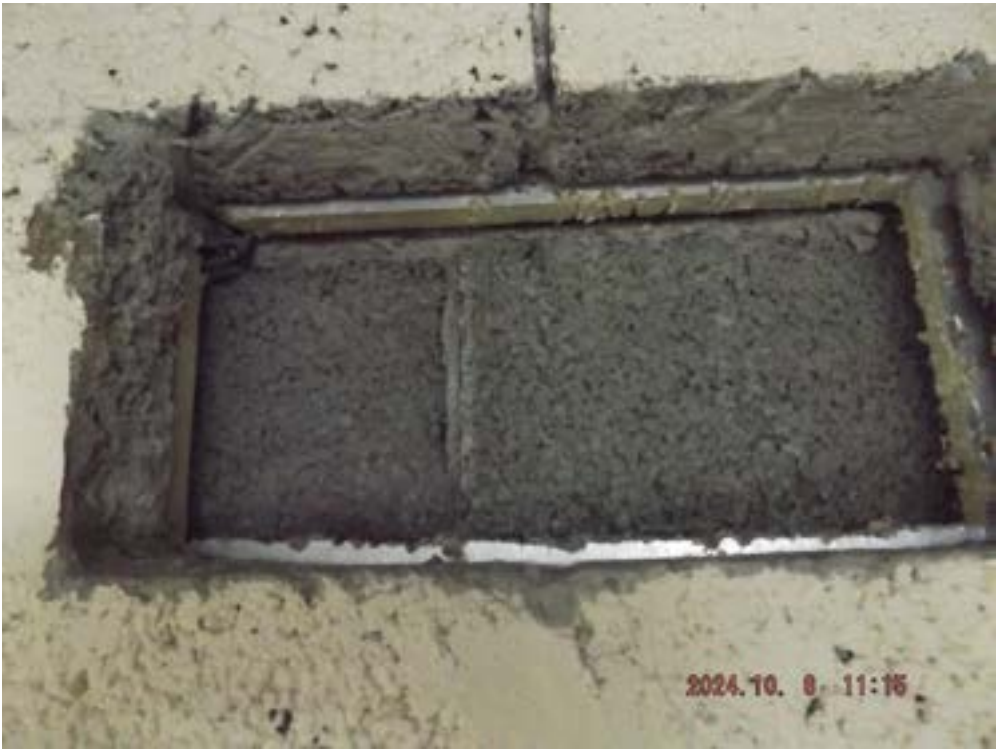
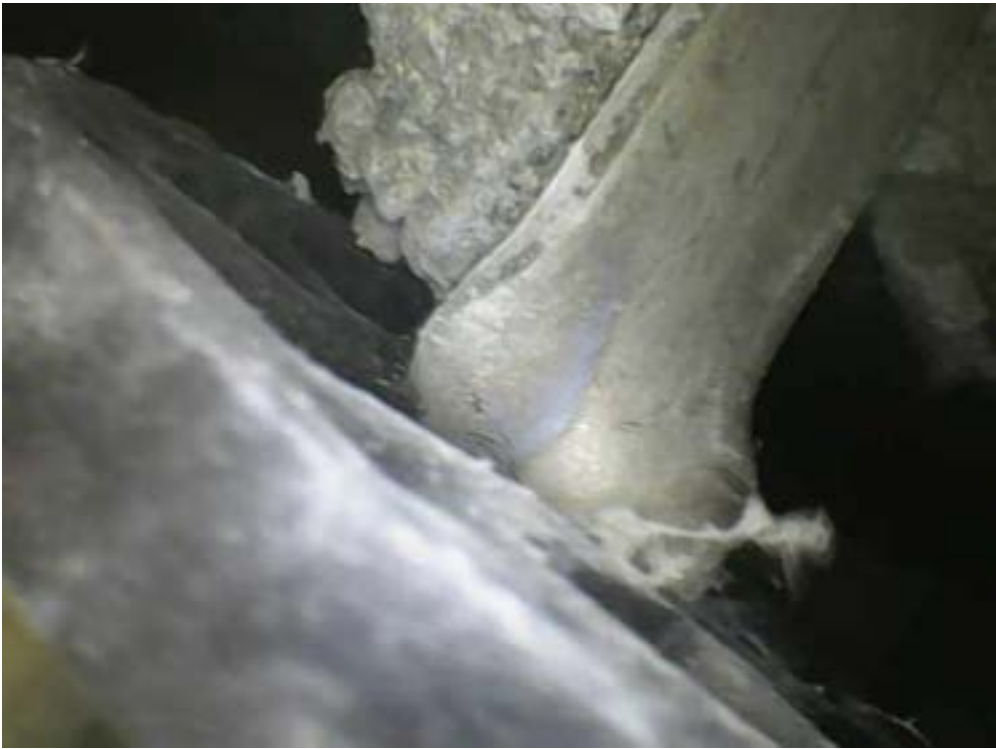
| Block reference | Block condition | Mortar condition | No of Wall Ties found and condition | Comments |
|---|---|---|---|---|
| Block 6 (south wall) | 100mm thick dense concrete in good condition | Reasonable – adequate strength mortar to both inner and outer leaf | 2no at top left of block and 450mm to right of block/good; 1 no 500mm to left lower of block/covered in mortar | 80mm cavity overall with 25mm insulation board displaced 25mm off inner leaf wall. |

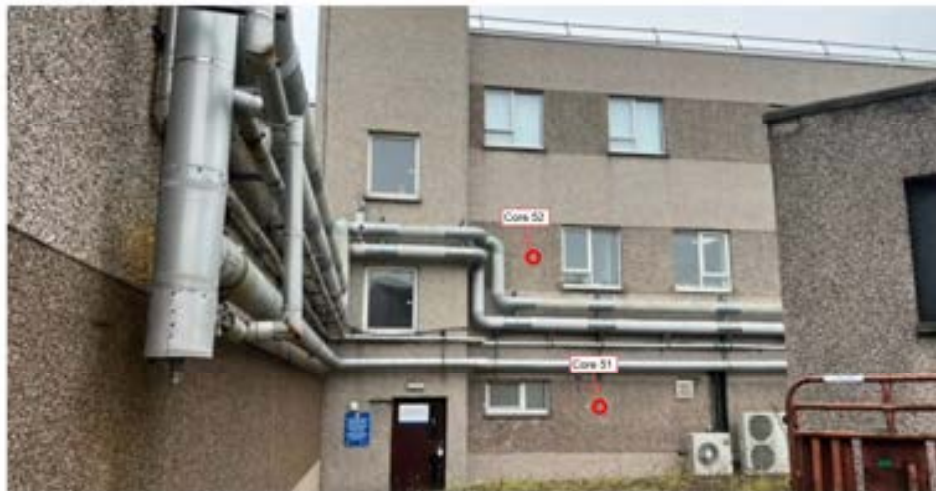
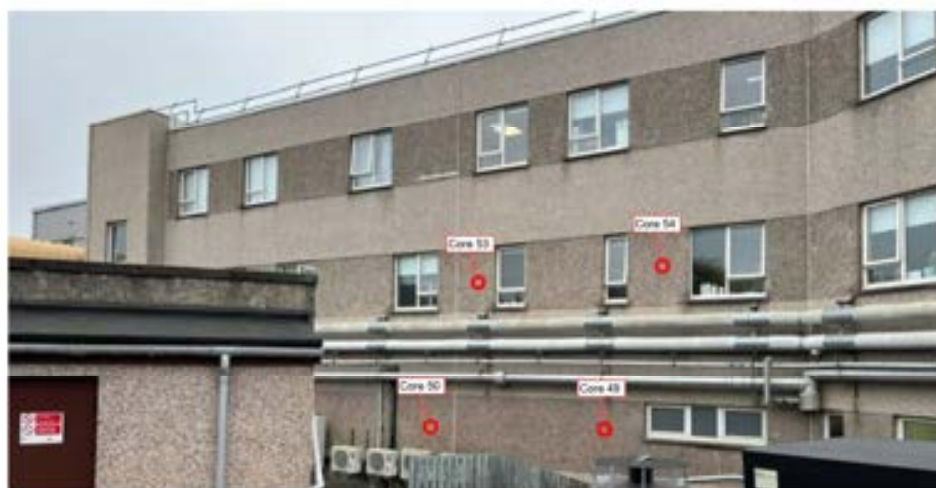
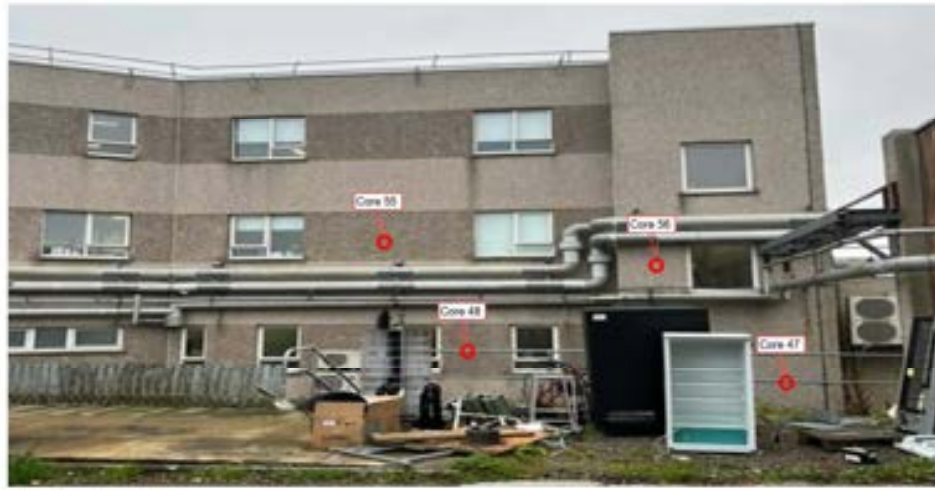
3 Storey North Elevation Wall

#### Summary of Cores at 3 Storey Building North Elevation Wall

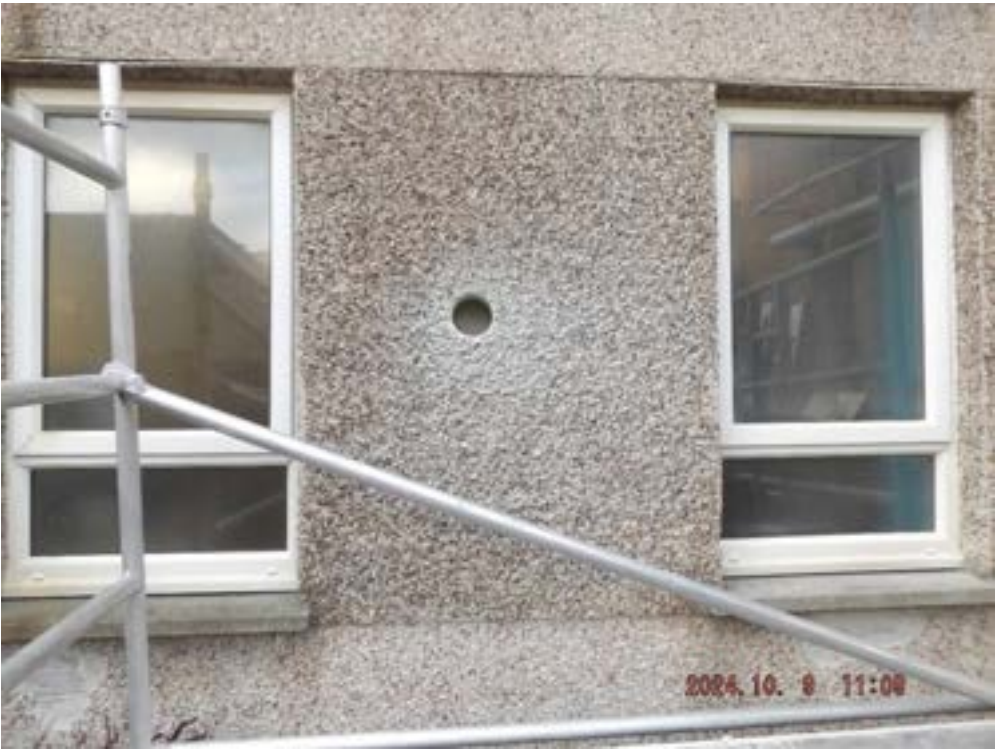
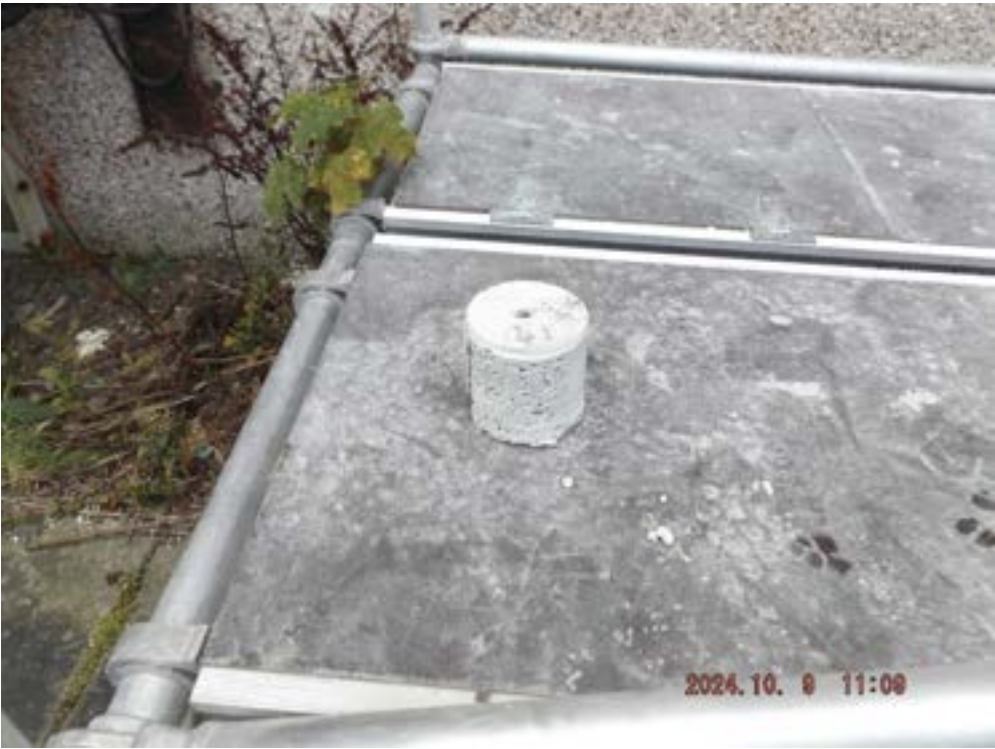
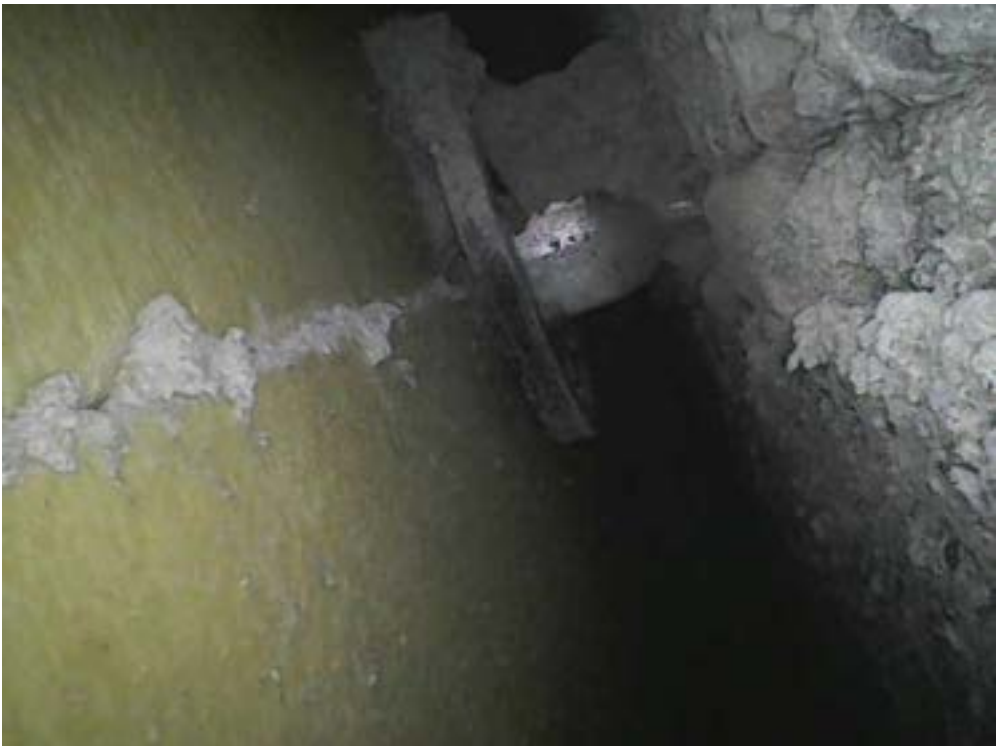
| Core reference | Block condition | Mortar condition | No of Wall Ties found and condition | Comments |
|---|---|---|---|---|
| Core 48 (north wall) | 100mm thick dense concrete in good condition | Reasonable – mortar strength is adequate | 2 no 800mm to right upper of core and 800mm to left upper of core/good. 1 no 1100mm above core/covered with mortar | 35mm cavity to 25mm insulation board. Lot of mortar droppings in cavity. Dry dash render is boss. |

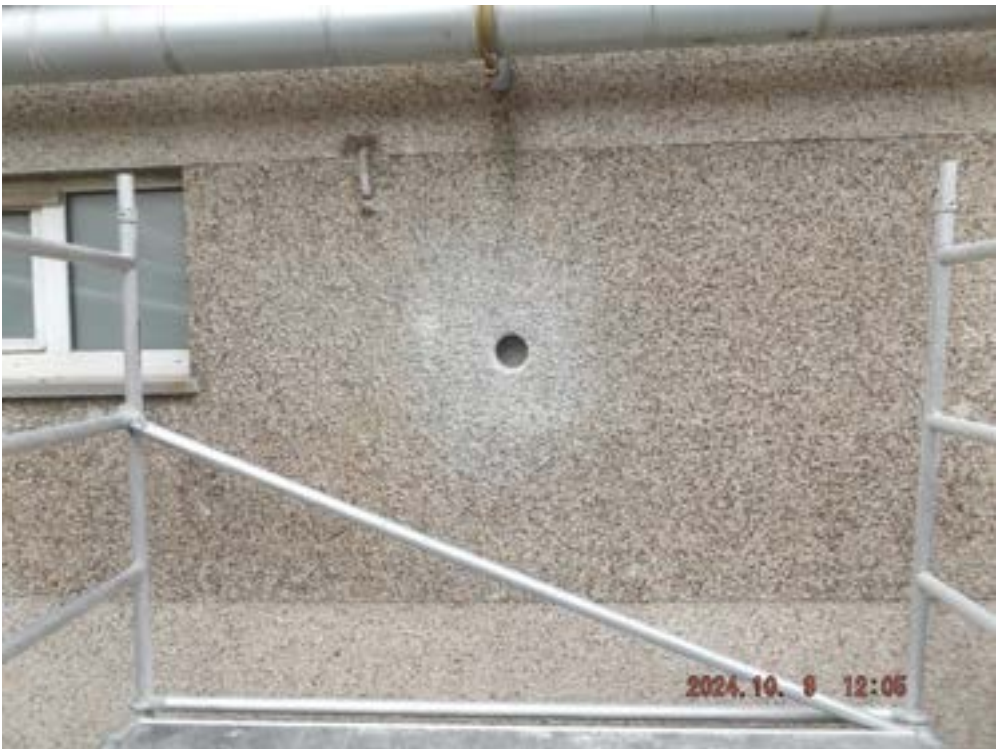
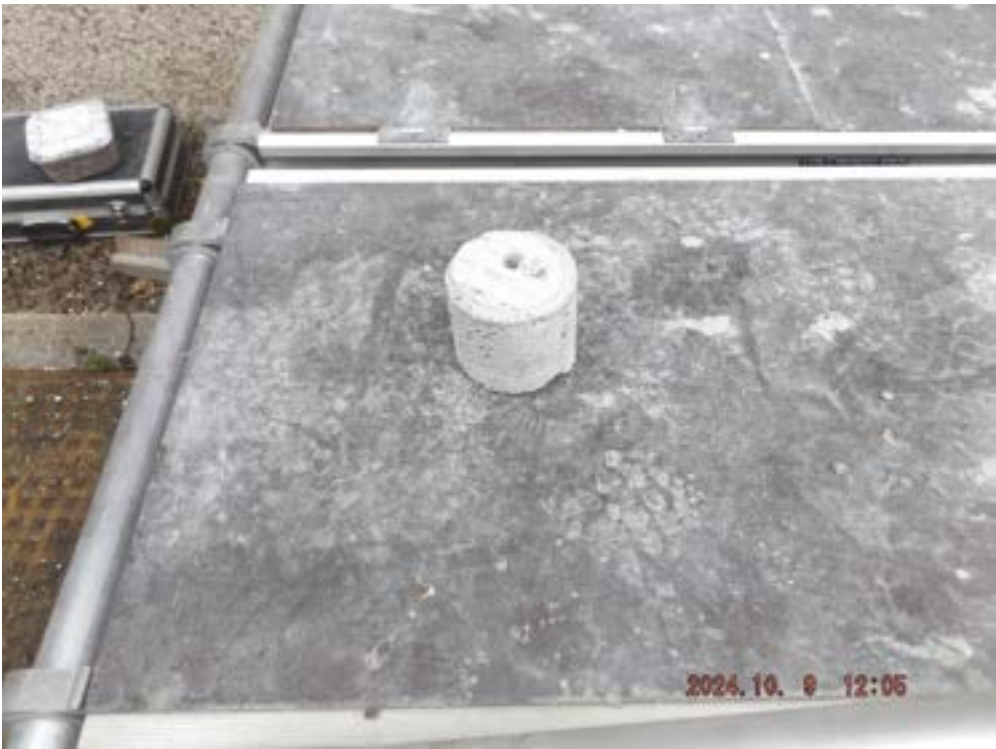
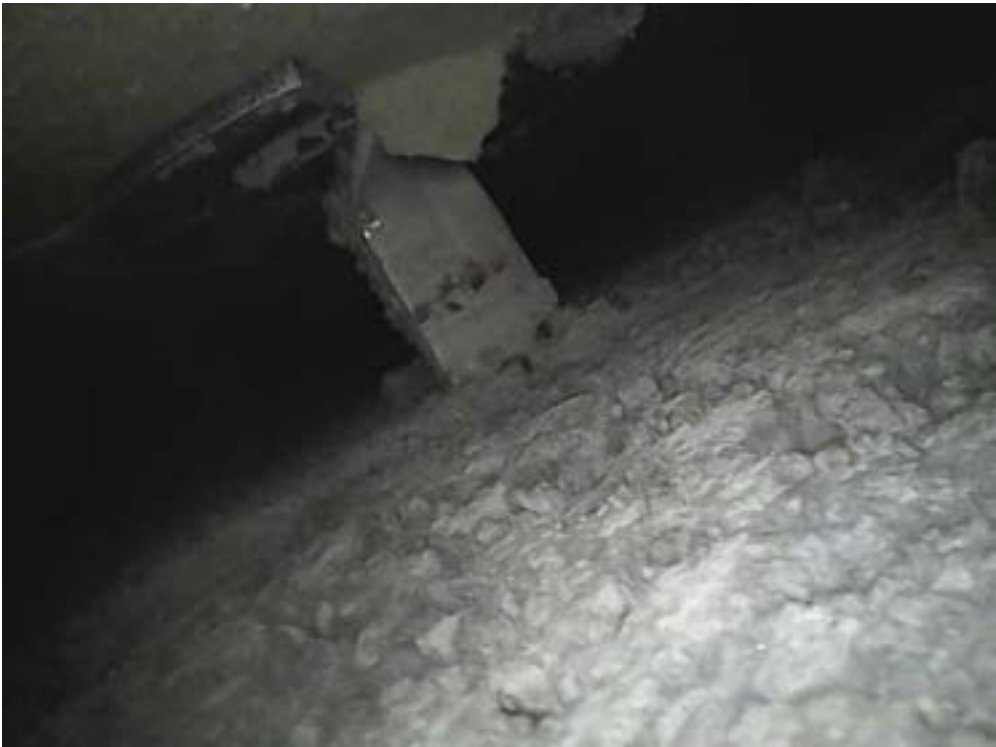
Core 51

| Core 51<br>(north wall) | 100mm thick dense concrete in good condition | Reasonable – mortar strength is adequate | 2 no 600mm to left upper of core and 700mm to right upper of core /good | 35mm cavity to 25mm insulation board. Lot of mortar droppings in cavity |

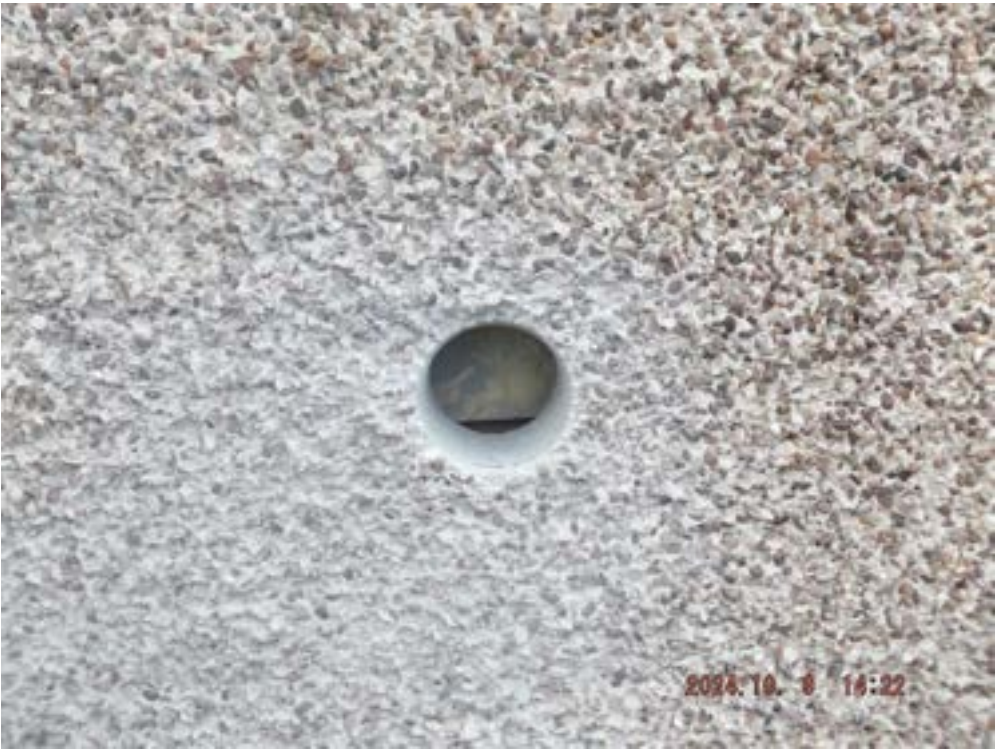
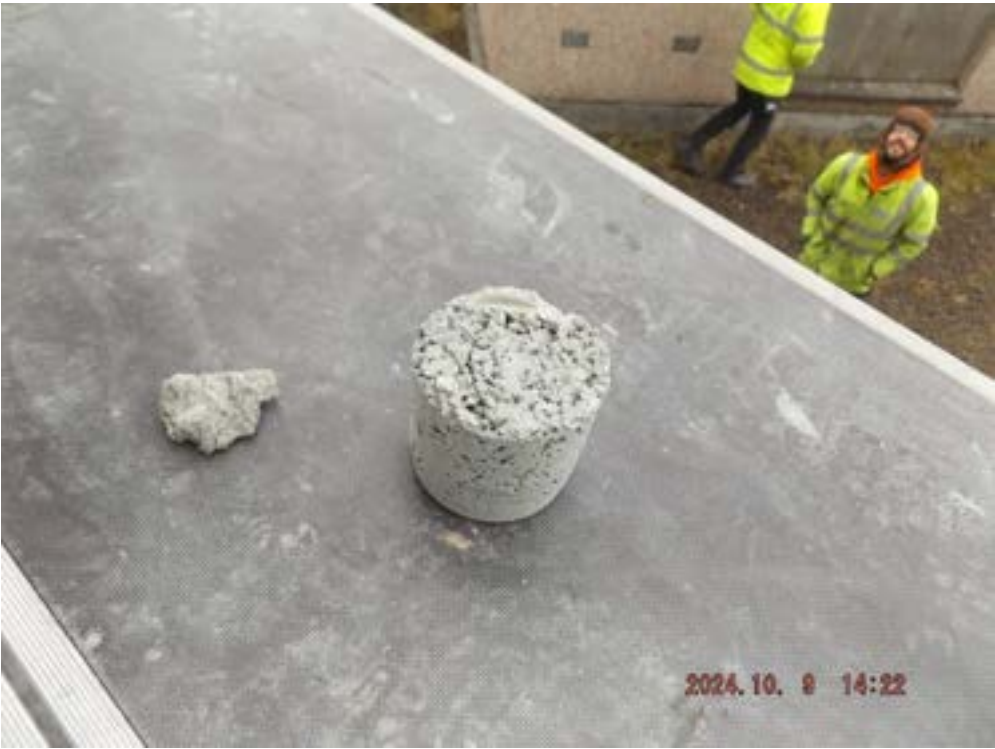
Core 52

| Core 52<br>(north wall) | 100mm thick dense concrete in good condition | Reasonable – mortar strength is adequate | 2 no 600mm to left upper of core and 250mm to left lower of core /good | 35mm cavity to 25mm insulation board. Lot of mortar droppings in cavity. Overall cavity width 65mm. Dry dash render is boss. |

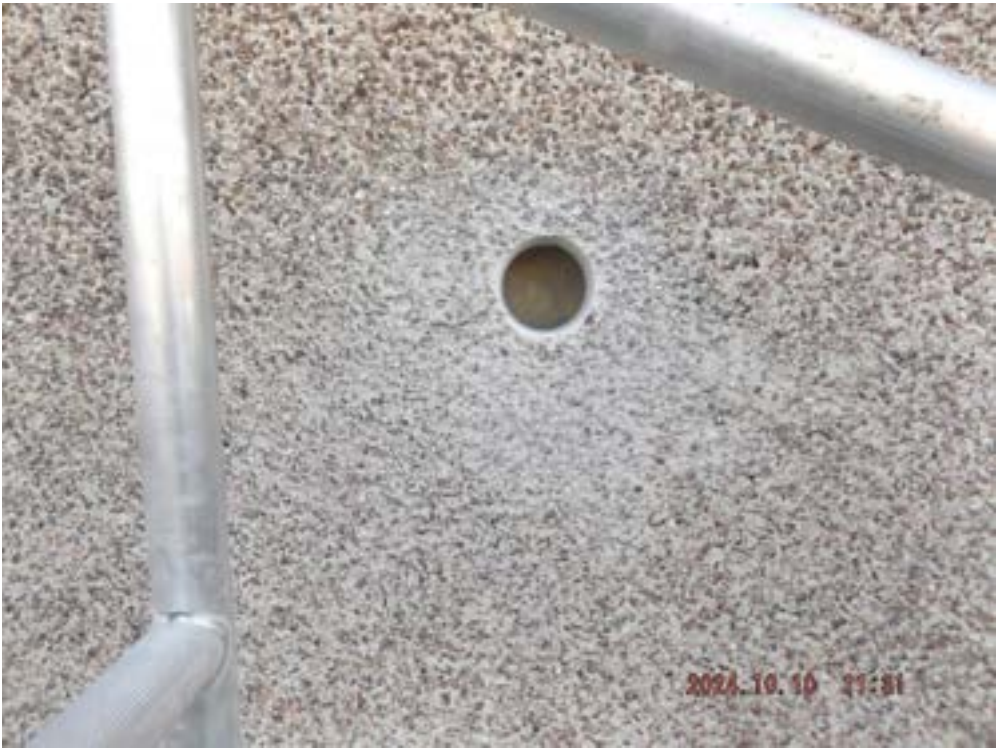
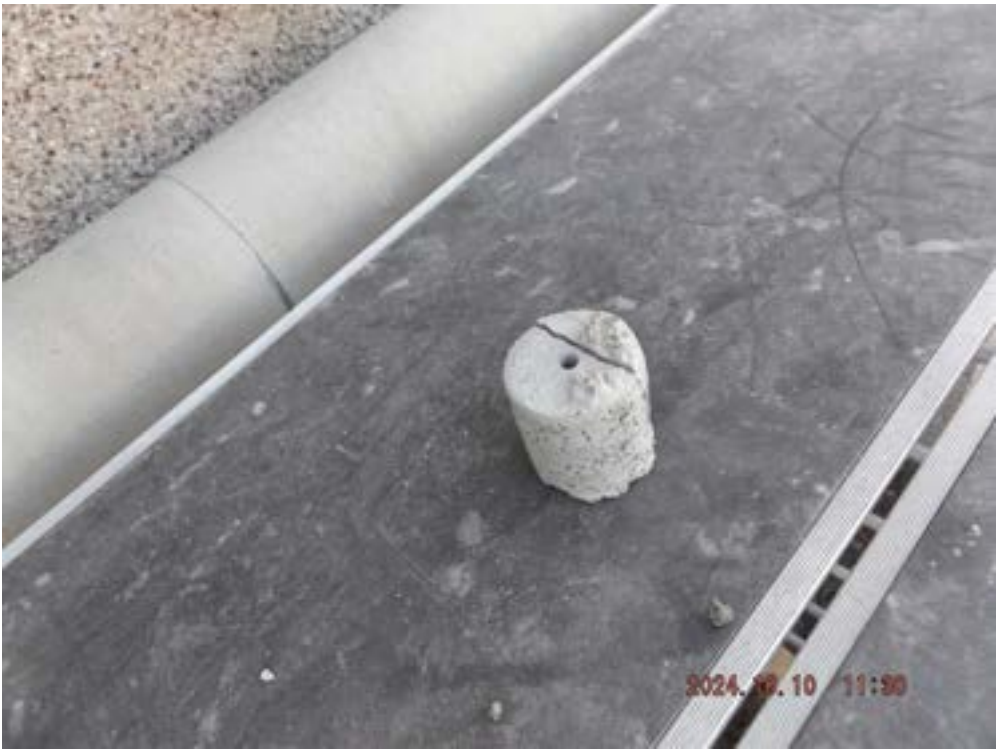
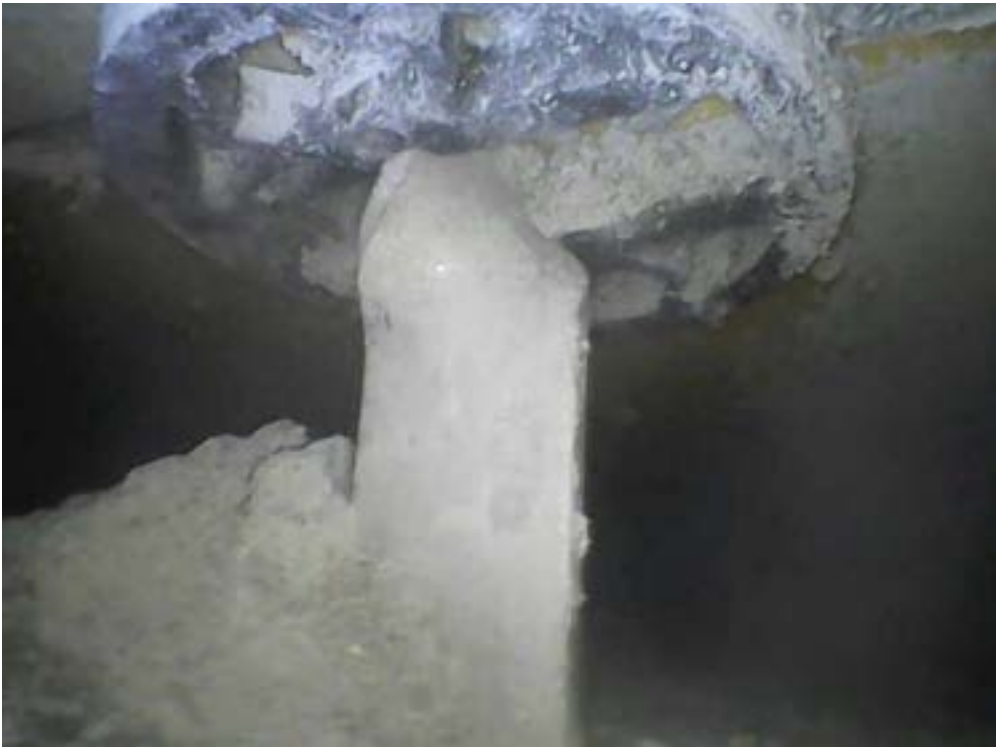
Core 55

| Core 55<br>(north wall) | 100mm thick dense concrete in good condition | Reasonable – mortar strength is adequate | 2 no 600mm to left upper of core and 50mm below core/good. 1 no 600mm to right upper of core/covered with mortar | 50mm cavity to 25mm insulation board. Lot of mortar droppings in cavity |

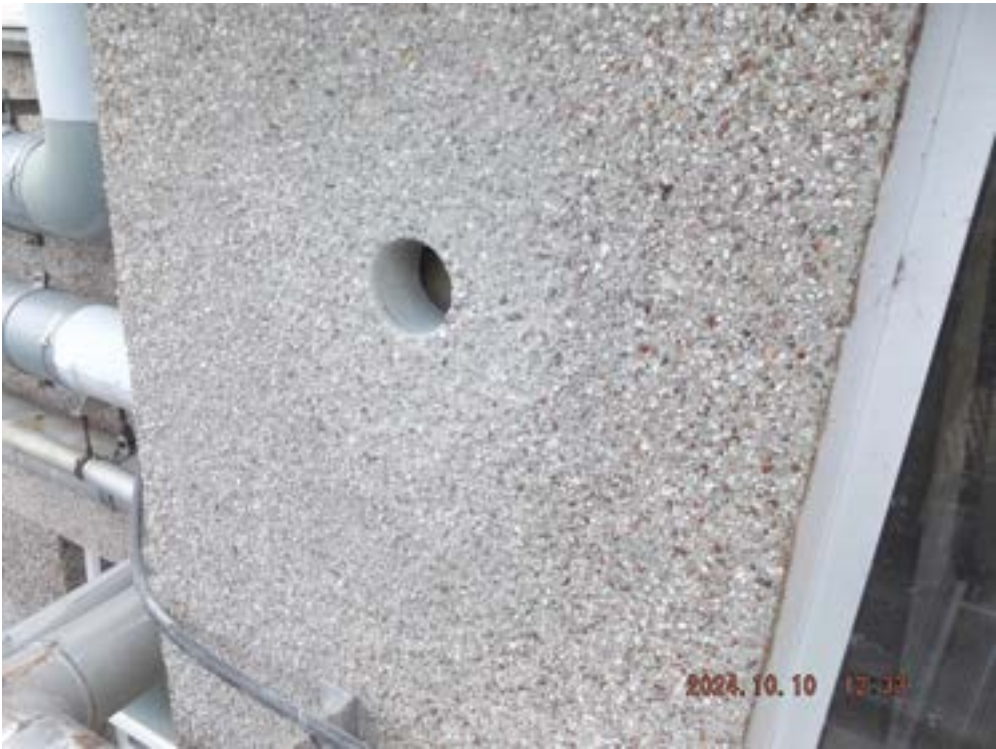
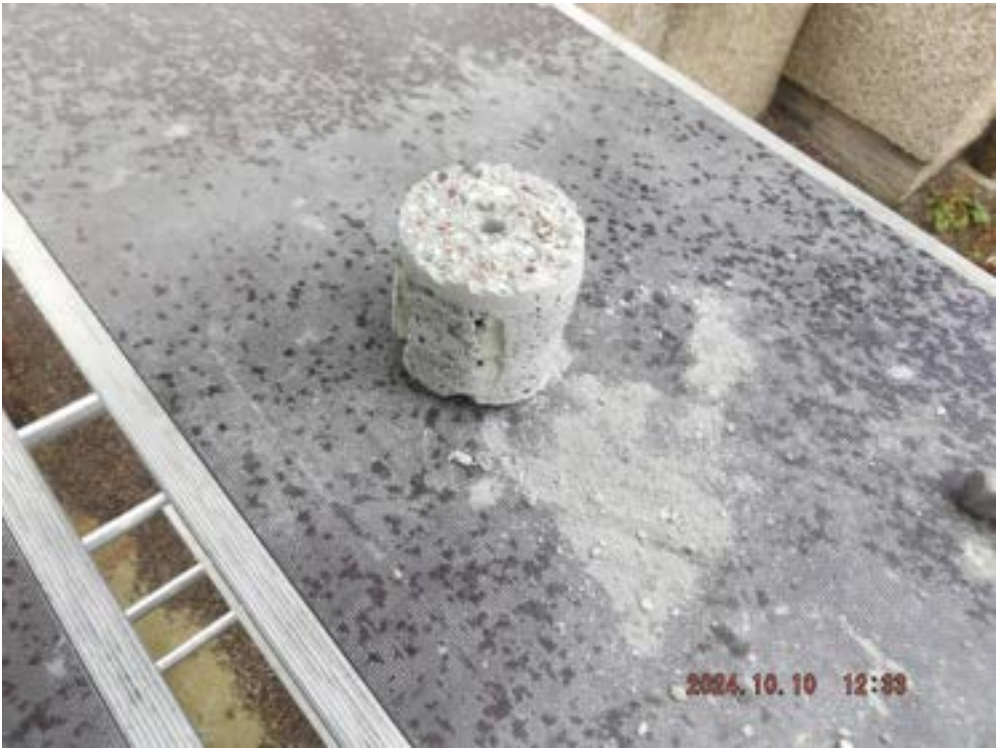
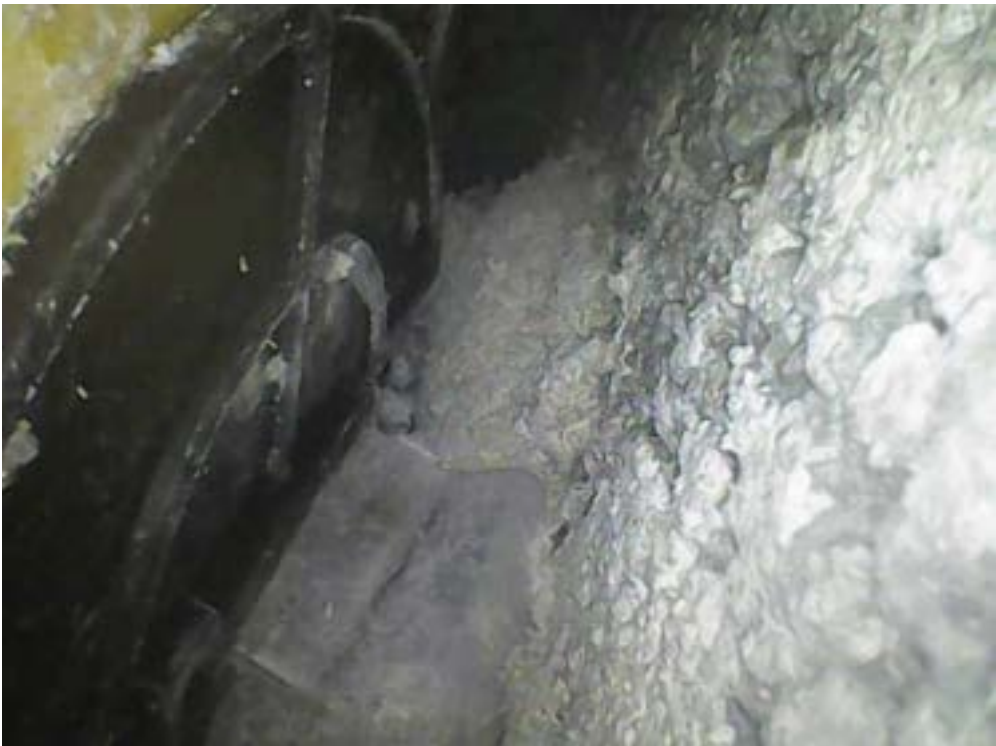
Core 56

| Core 56<br>(north wall) | 100mm thick dense concrete in good condition | Poor to reasonable – low strength | 3 no 400mm to right upper, 600mm to left lower and 600mm to right lower of core/covered with mortar | 30mm cavity to 25mm insulation board. Lot of mortar droppings in cavity |

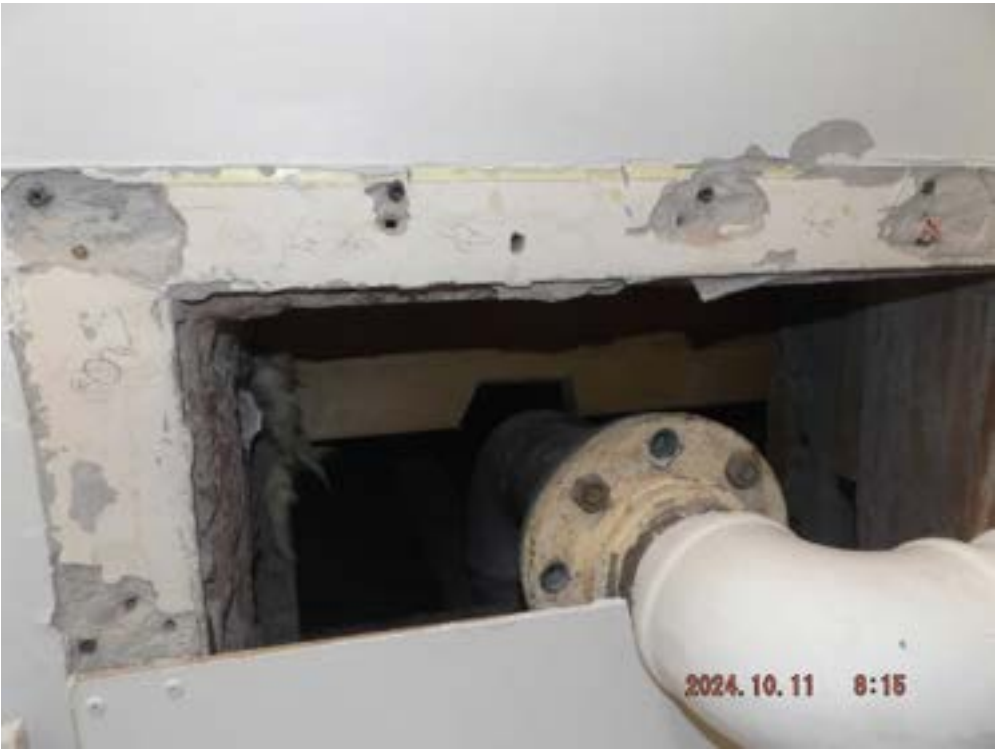
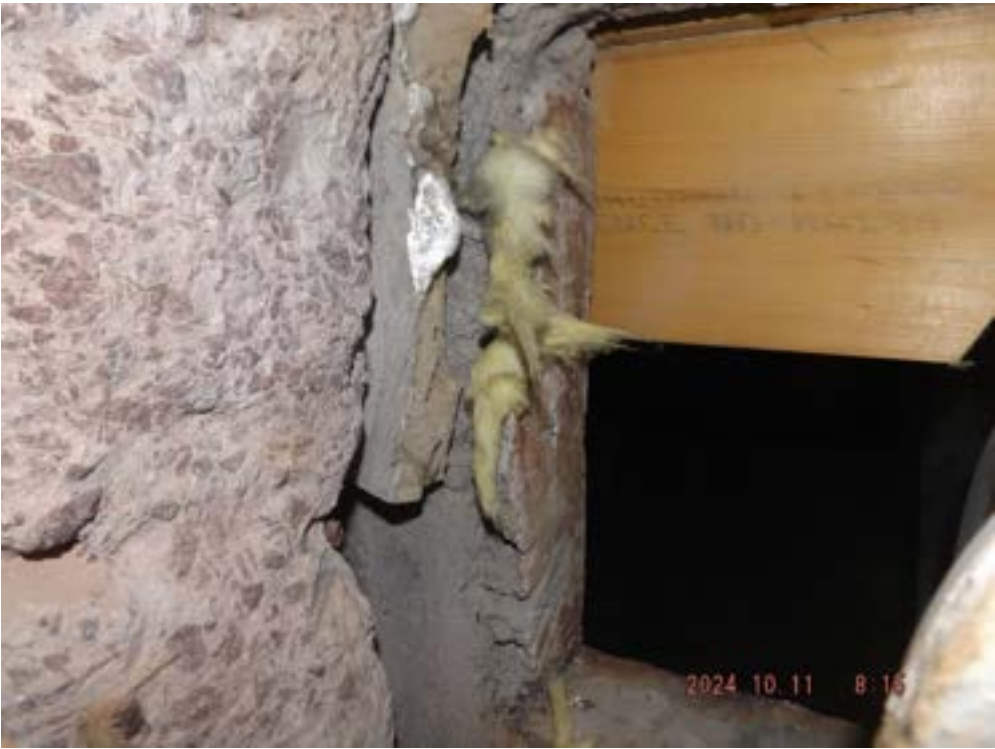
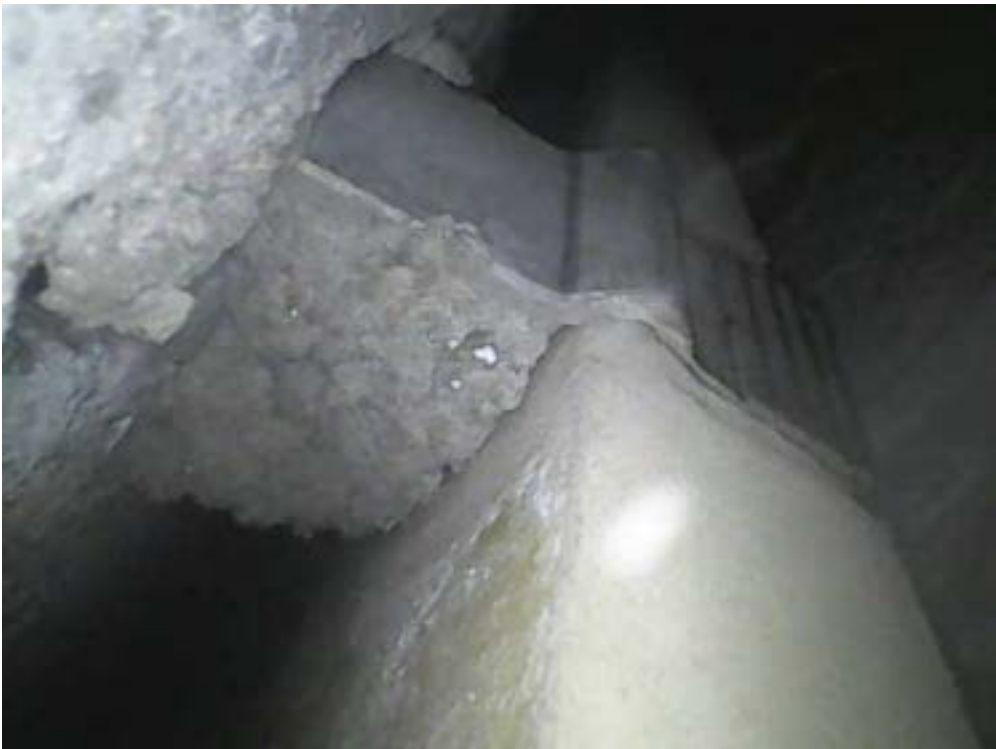
| Core reference | Block condition | Mortar condition | No of Wall Ties found and condition | Comments |
|---|---|---|---|---|
| Visual inspection (south wall, ground storey) | 100mm thick dense concrete outer leaf block in good condition. 200mm thick inner leaf of either dense concrete block or insitu concrete in good condition | Reasonable – mortar strength is adequate | 2 no 450mm to right of service opening and 450mm to left of service opening/good. 1 no 450mm above service opening/covered with mortar. | 65mm width cavity. No insulation noted at service opening for dry riser. Lot of mortar droppings in cavity. |

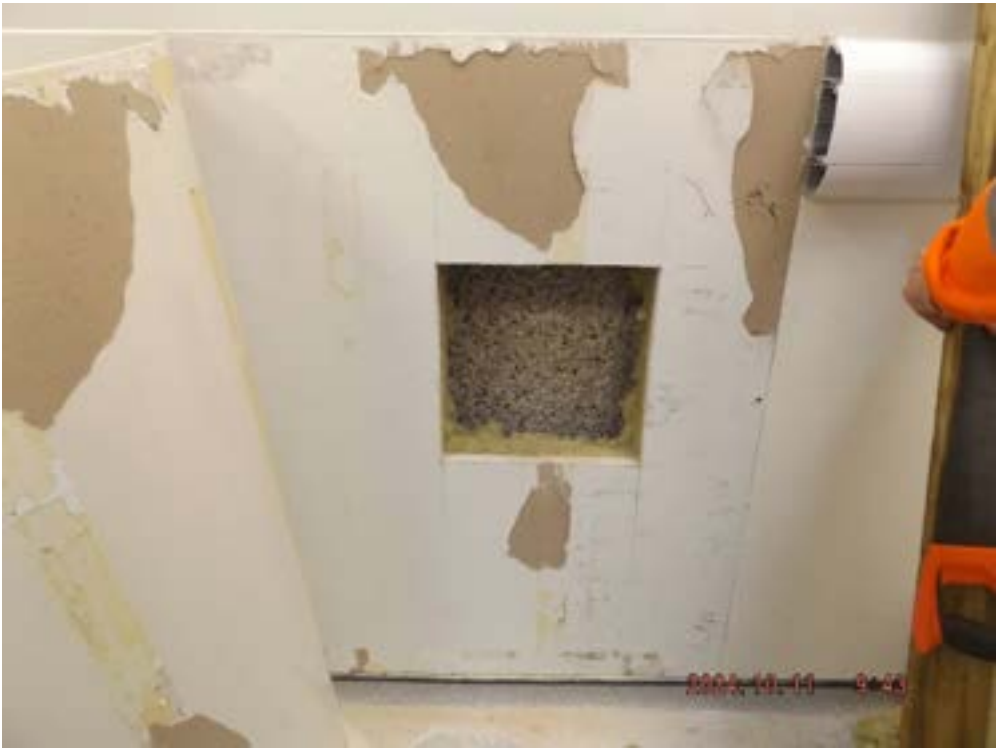
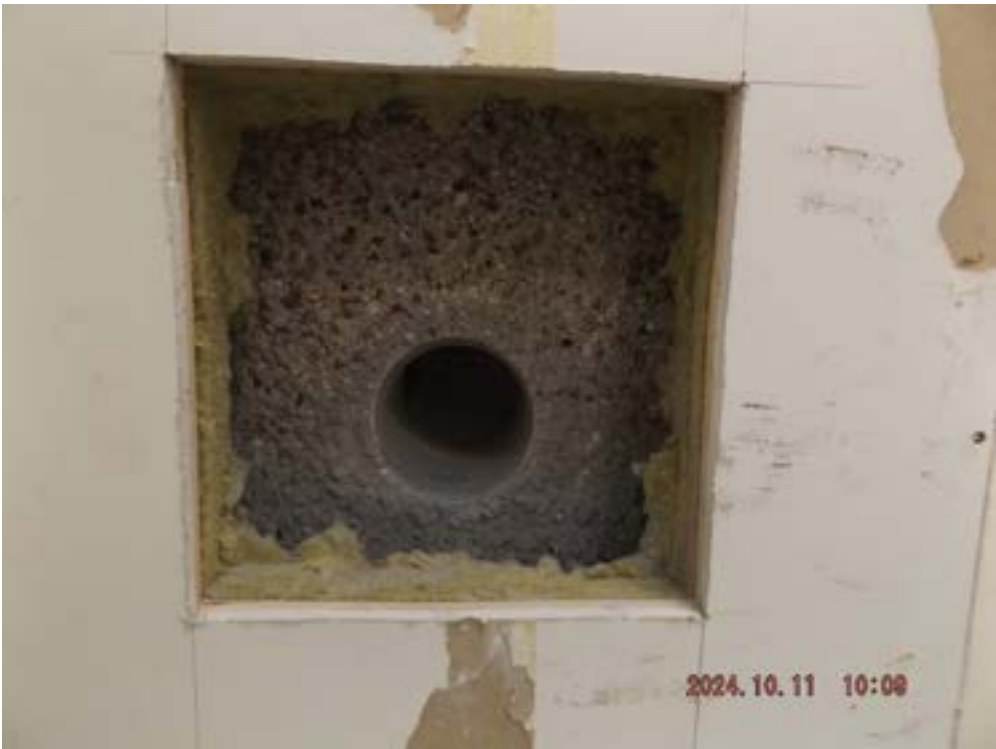
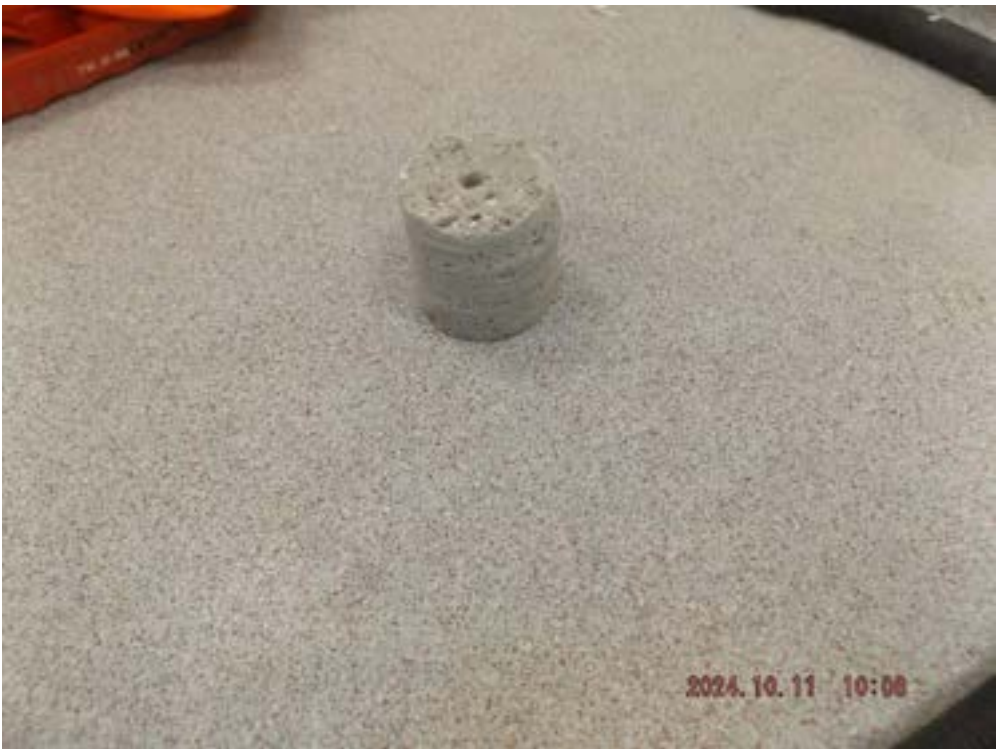
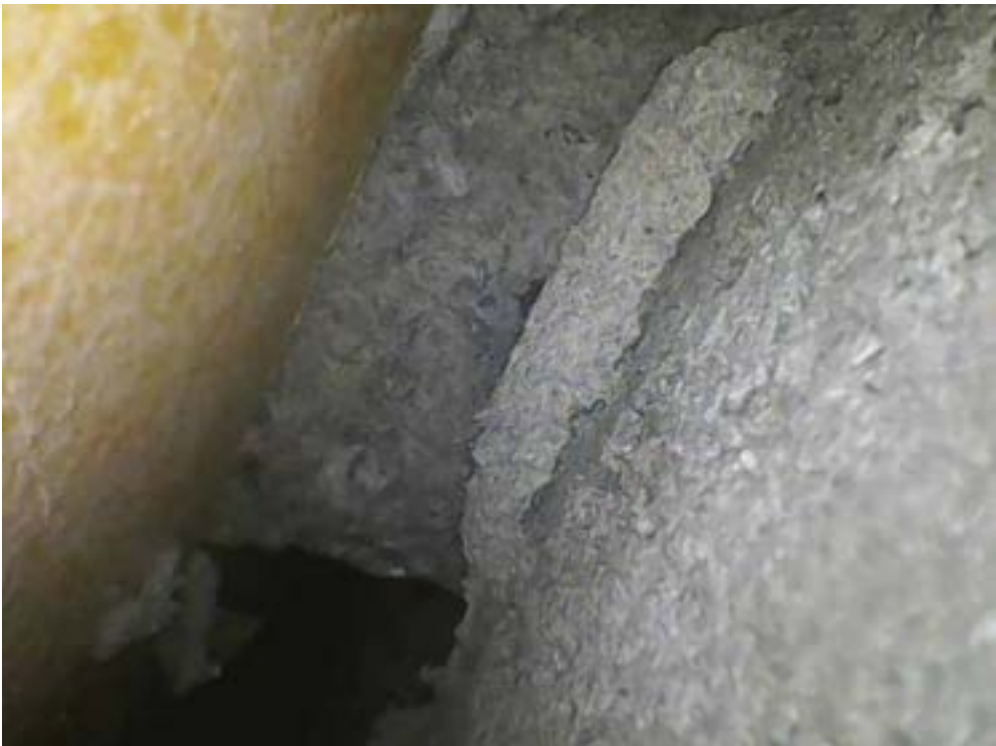
| Core reference | Block condition | Mortar condition | No of Wall Ties found and condition | Comments |
|---|---|---|---|---|
| Core 57 (east wall, ground storey) | 100mm thick dense concrete in good condition | Reasonable – mortar strength is adequate | 2 no 250mm to left upper of core and 700mm to right of core/covered with mortar | 15mm cavity to 25mm insulation board. Lot of mortar droppings in cavity. Cavity width is 50mm overall. 150mm loadbearing stud wall construction in |

| | | | | Outpatients Consulting Room 1 noted to east of Phase 1 construction |

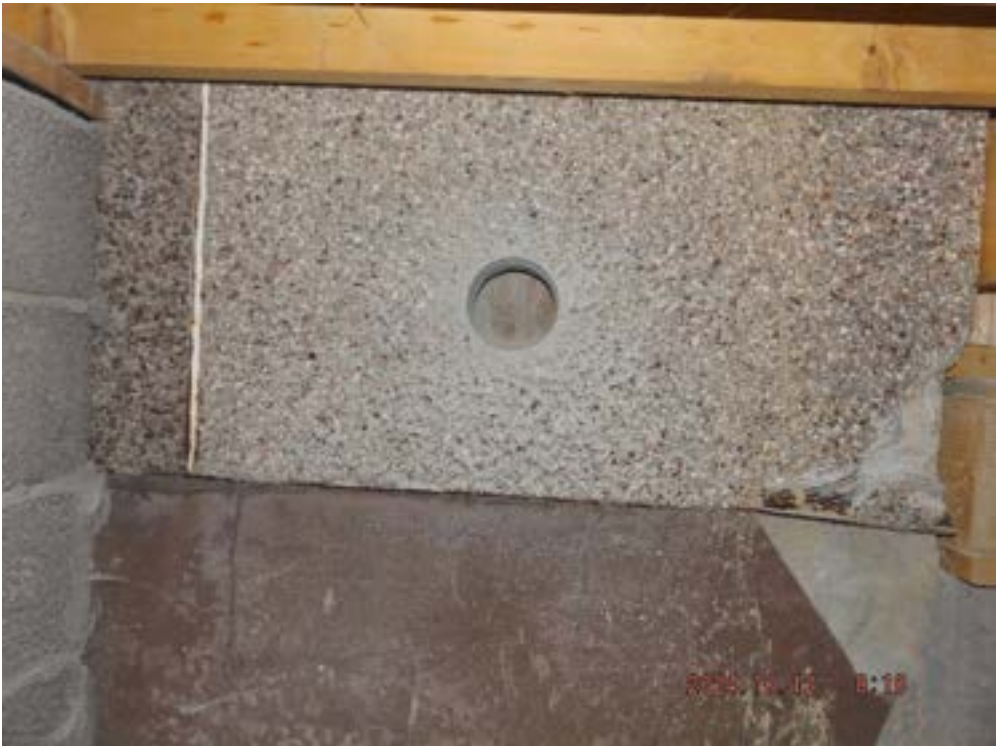
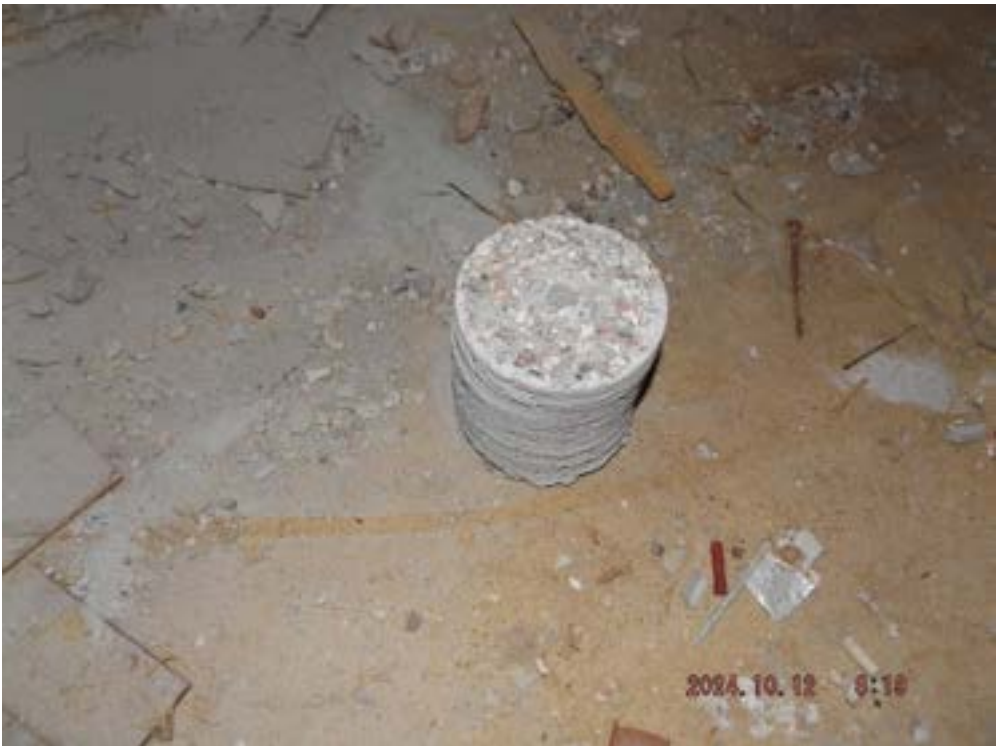
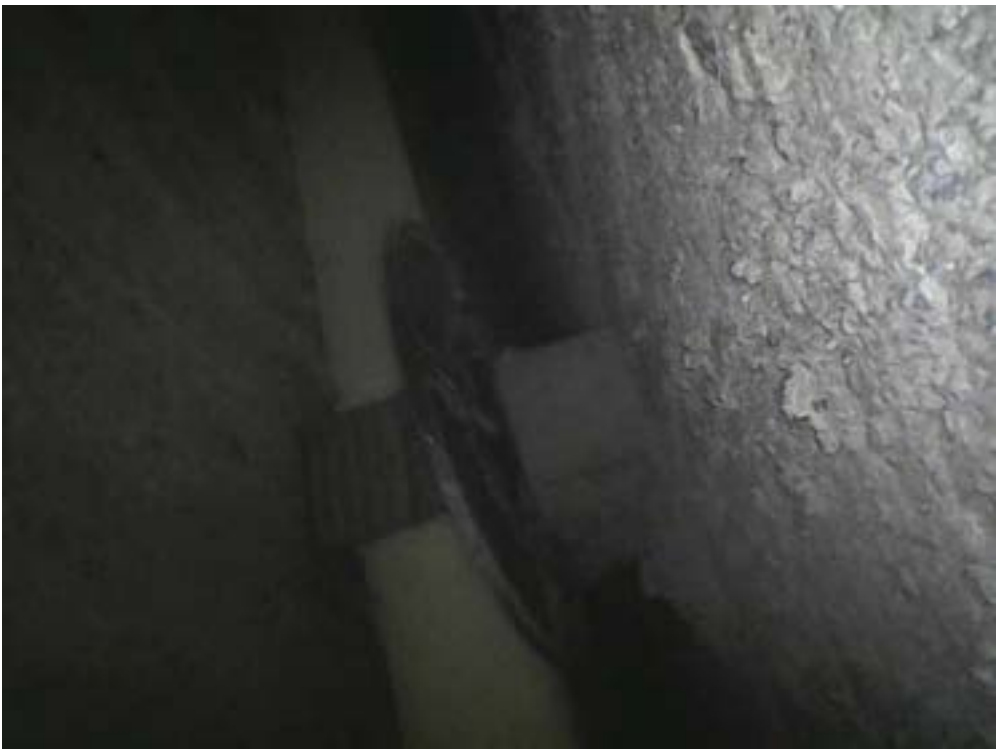
| Core 58 (south wall, solum level) | 100mm thick dense concrete in good condition. Inner leaf either of dense concrete block or insitu concrete in good condition | Reasonable – mortar strength is adequate | 2 no 600mm to right upper of core and 600mm to left upper of core/good | 60mm width cavity. No insulation noted. Lot of mortar droppings in cavity. Concrete solum with 1125mm high blockwork to wall plate. |
