# **Gilbert Bain Hospital Phase 1 Construction**

Report on Condition of External Walls

December 2024

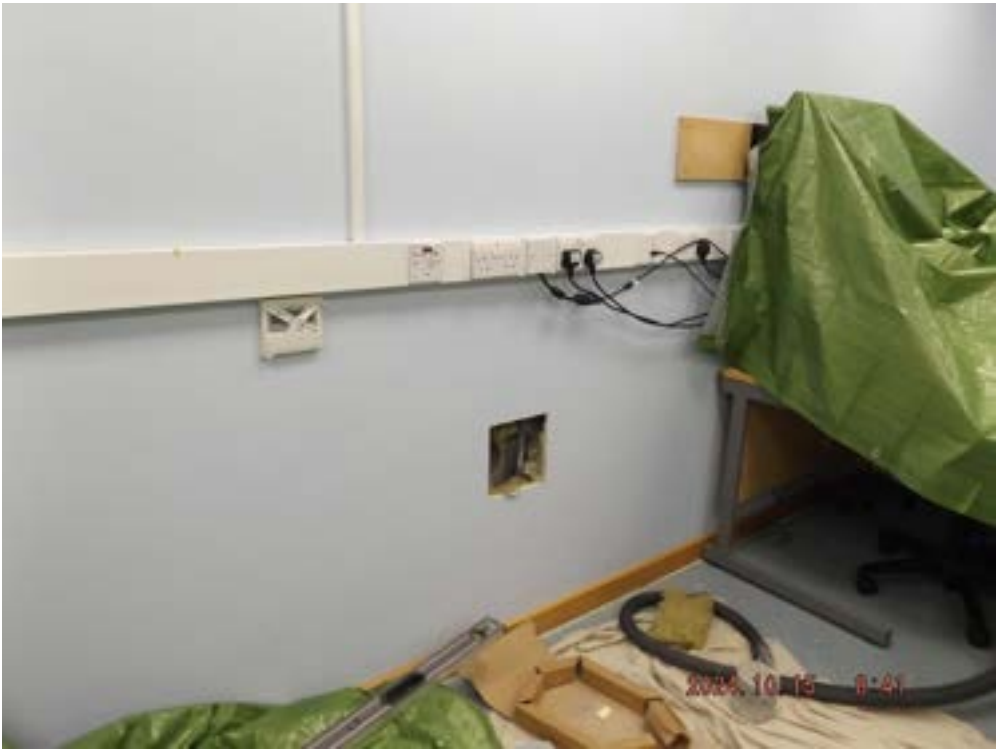
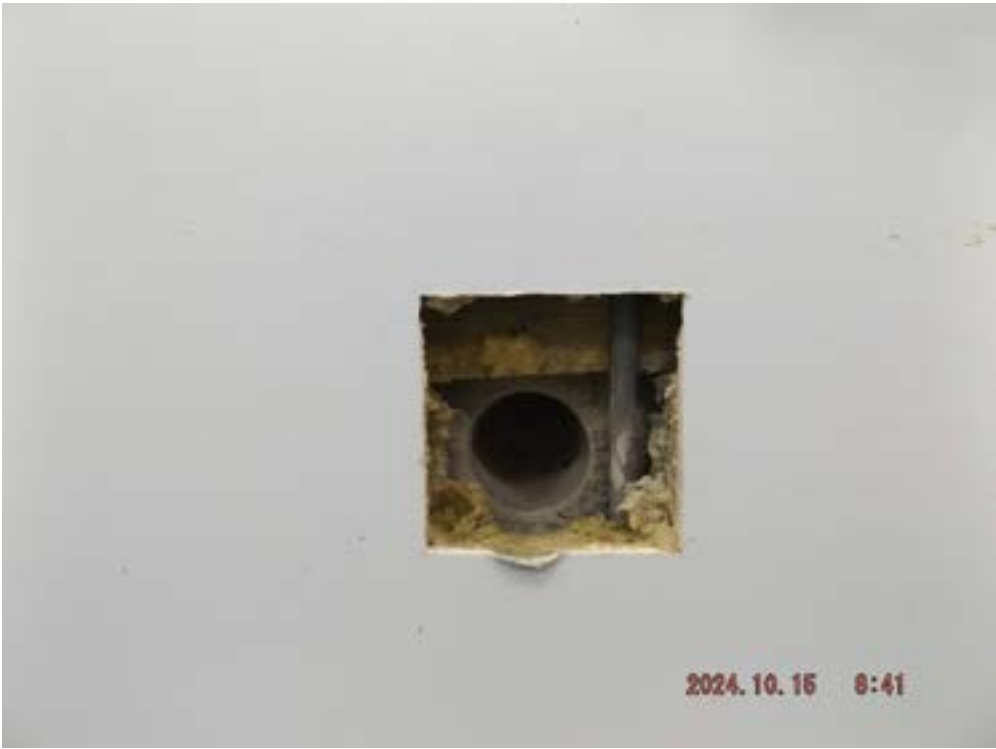
| Core 62 (east wall, ground storey) | 100mm thick dense concrete in good condition | Reasonable – mortar strength is adequate | 2 no 600mm to left upper of core and 600mm to left lower of core/covered with mortar | 20mm cavity to 25mm insulation board. Lot of mortar droppings in cavity. Cavity width is 55mm overall. 105mm non-loadbearing stud wall construction in ECG ETT room noted to east of Phase 1 construction |

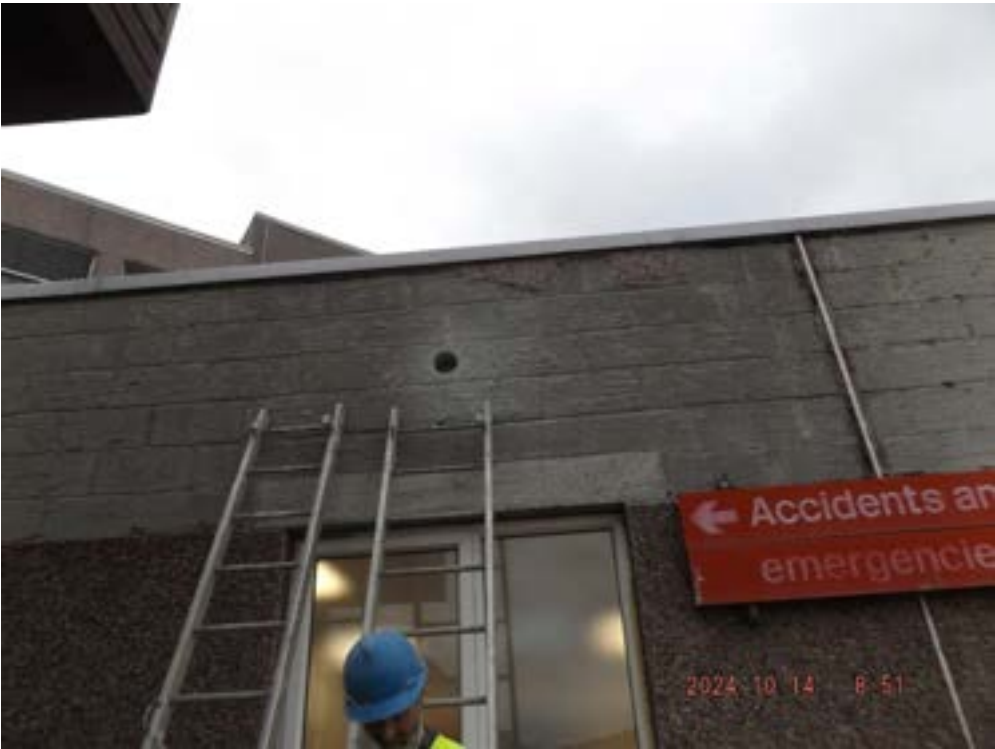
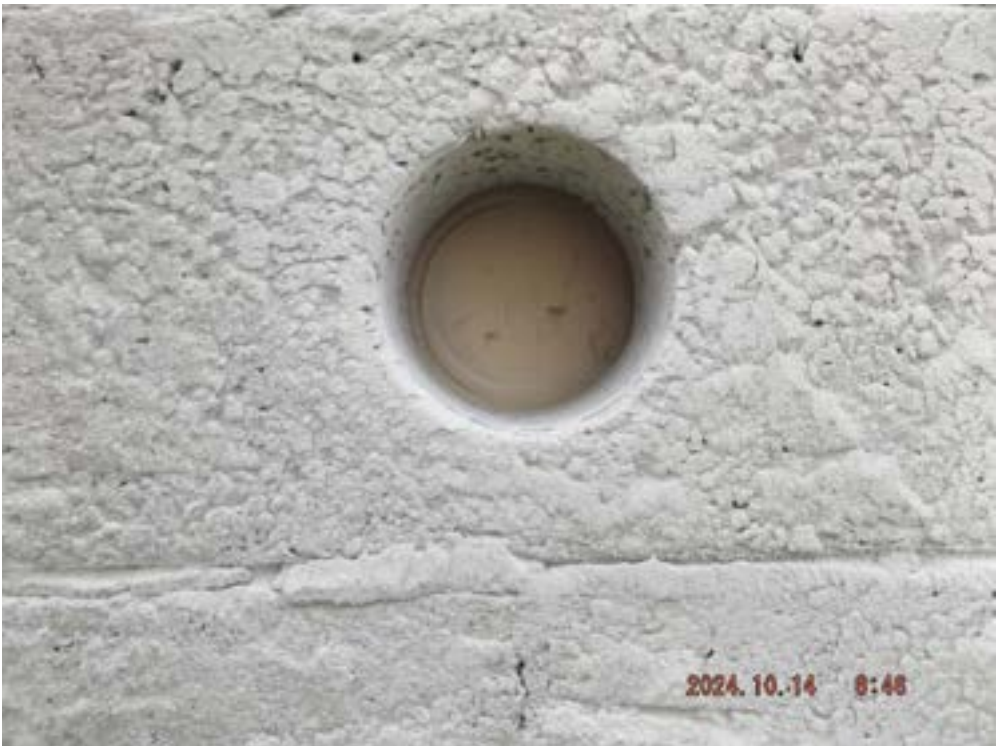
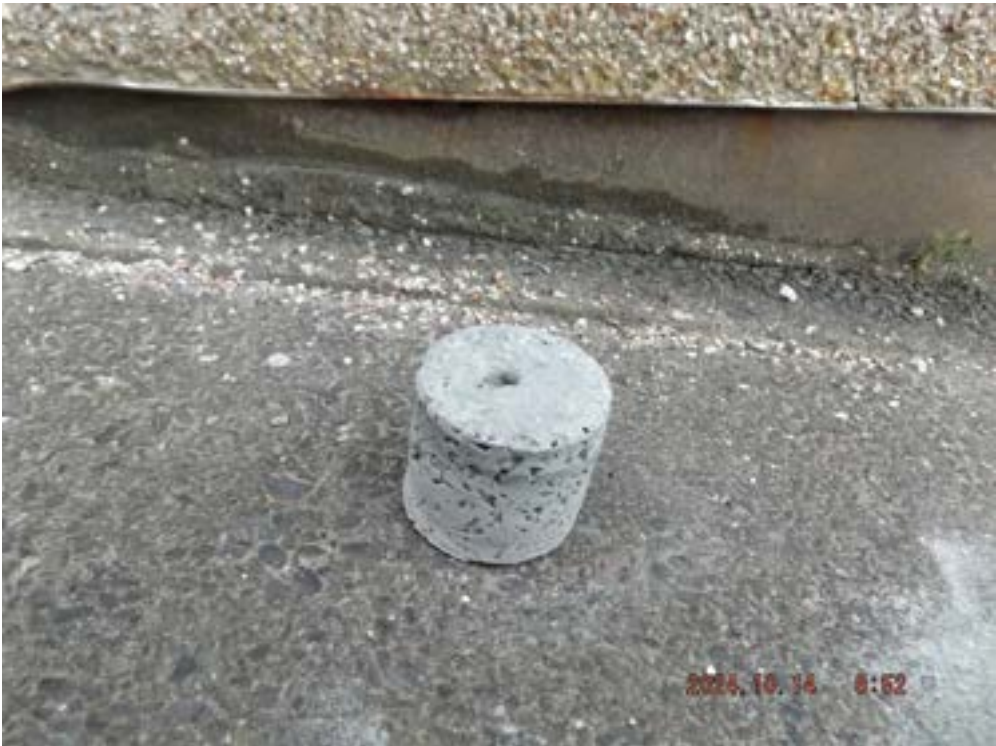
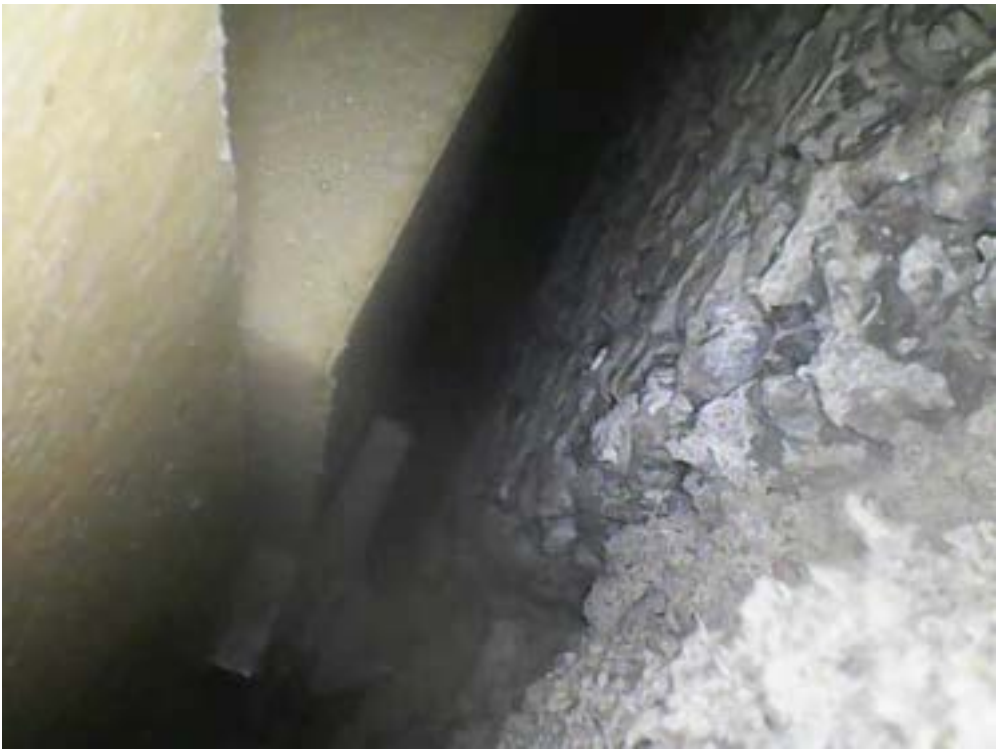
Core 61

| Core reference | Block condition | Mortar condition | No of Wall Ties found and condition | Comments |
|---|---|---|---|---|
| Core 61<br>(west wall, single storey) | 100mm thick dense concrete in good condition. | Poor – weak and friable | 2 no 200mm above and 900mm to right upper of core/good. | 20mm cavity to 25mm insulation board. Lot of mortar droppings in cavity. Boss render has been removed previously due to proximity to main entrance. |

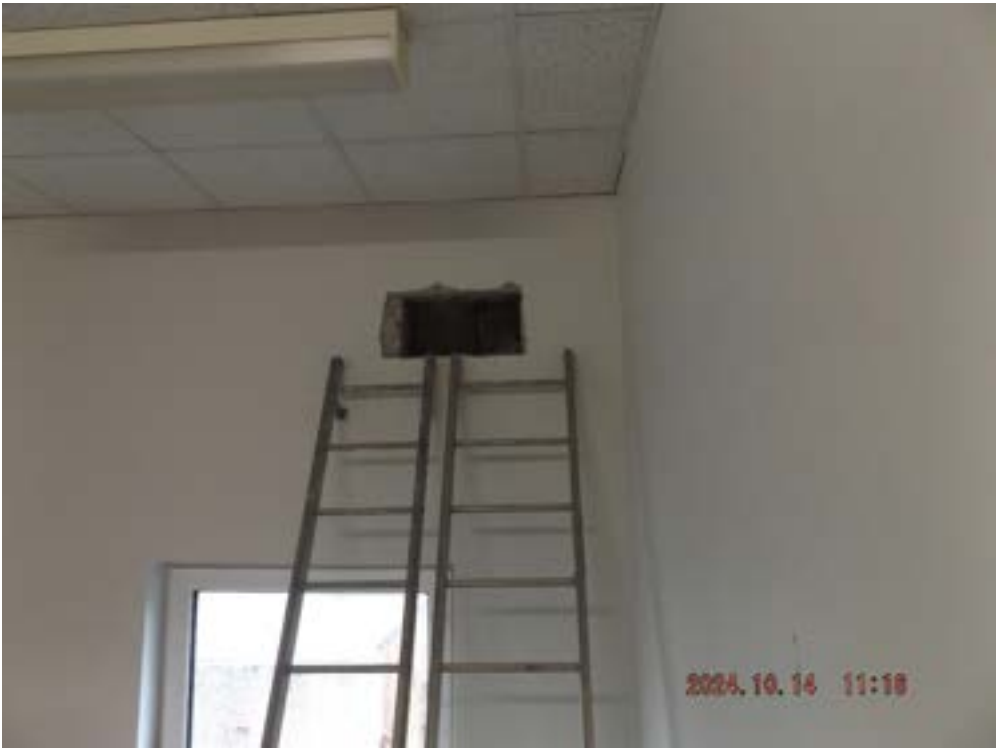
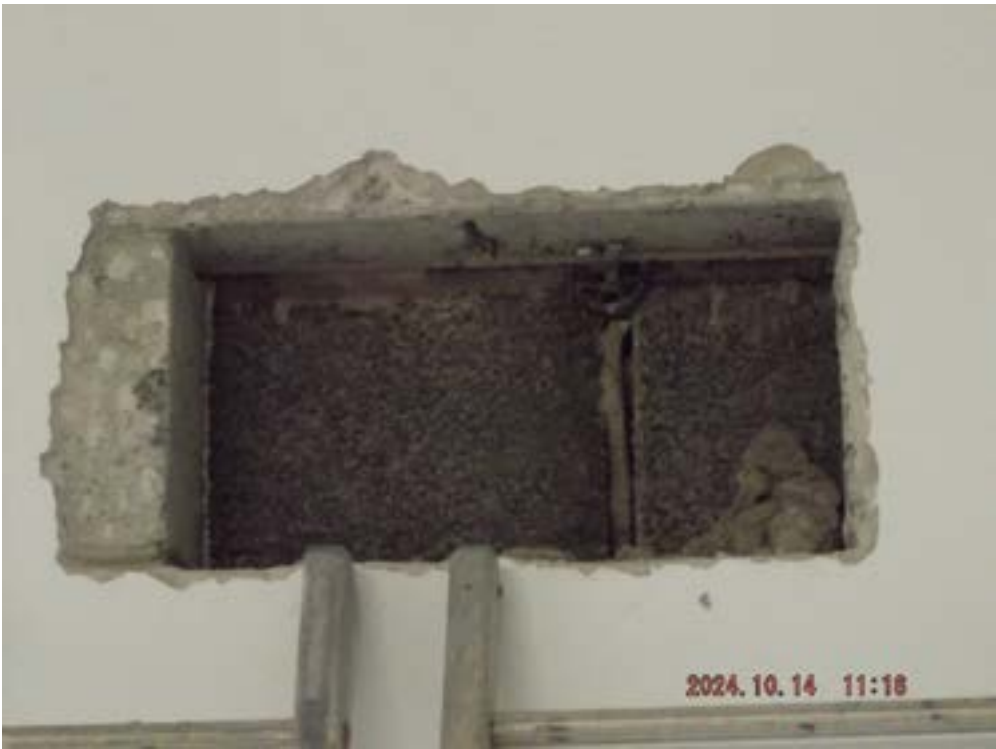
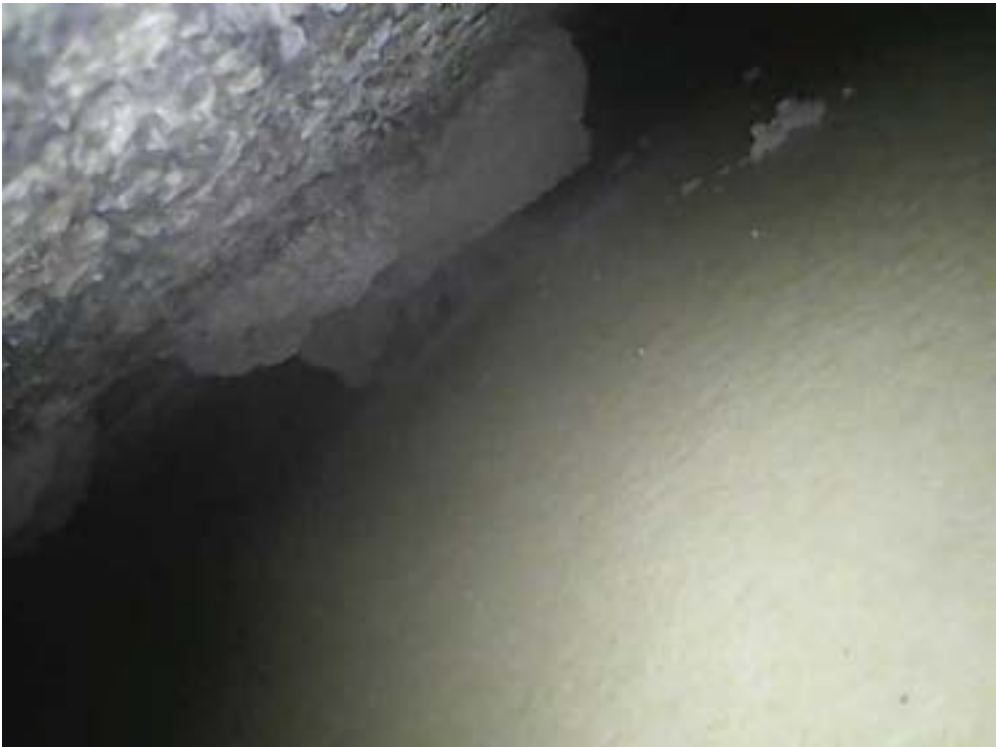
| Core reference | Block condition | Mortar condition | No of Wall Ties found and condition | Comments |
|---|---|---|---|---|
| Inner leaf block removed (3 Storey building stairwell north elevation wall) | 140mm thick dense concrete inner leaf block in good condition | Poor to reasonable – low strength mortar in both inner and outer leafs | 1 no at top of block/good. 1 no 600mm to left lower of block/covered with mortar | 15mm gap to 25mm insulation board. Lot of mortar droppings in cavity. Cavity width is 60mm overall. |

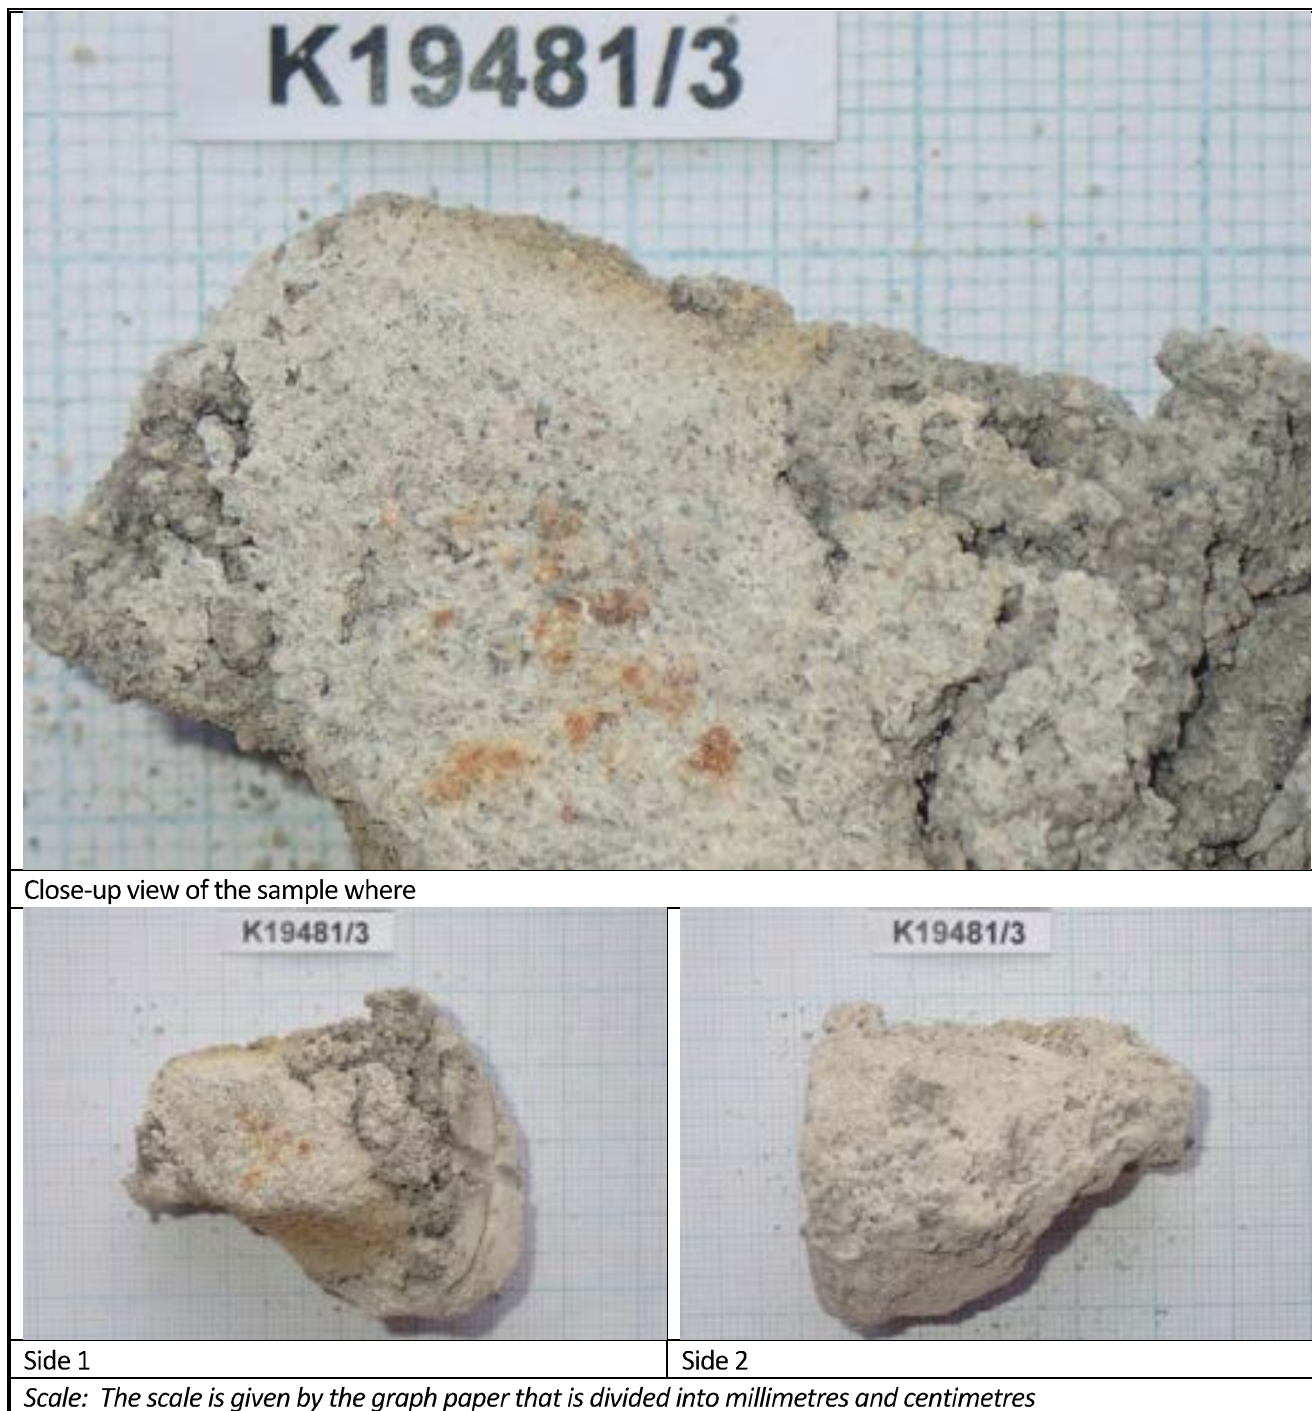
Figure 3

Sample K19481/3 (Outer leaf, Core 11, 2 of 2)

The majority of the sulphate contents of the samples were found to be at normal levels. The sulphate content of the samples K19481/3 (Outer leaf core 11, 2 of 2) and K19481/4 (Outer leaf core 12) were found to be higher than would be expected from the constituent materials indicating the possibility of sulphate leaching from the surrounding building materials.

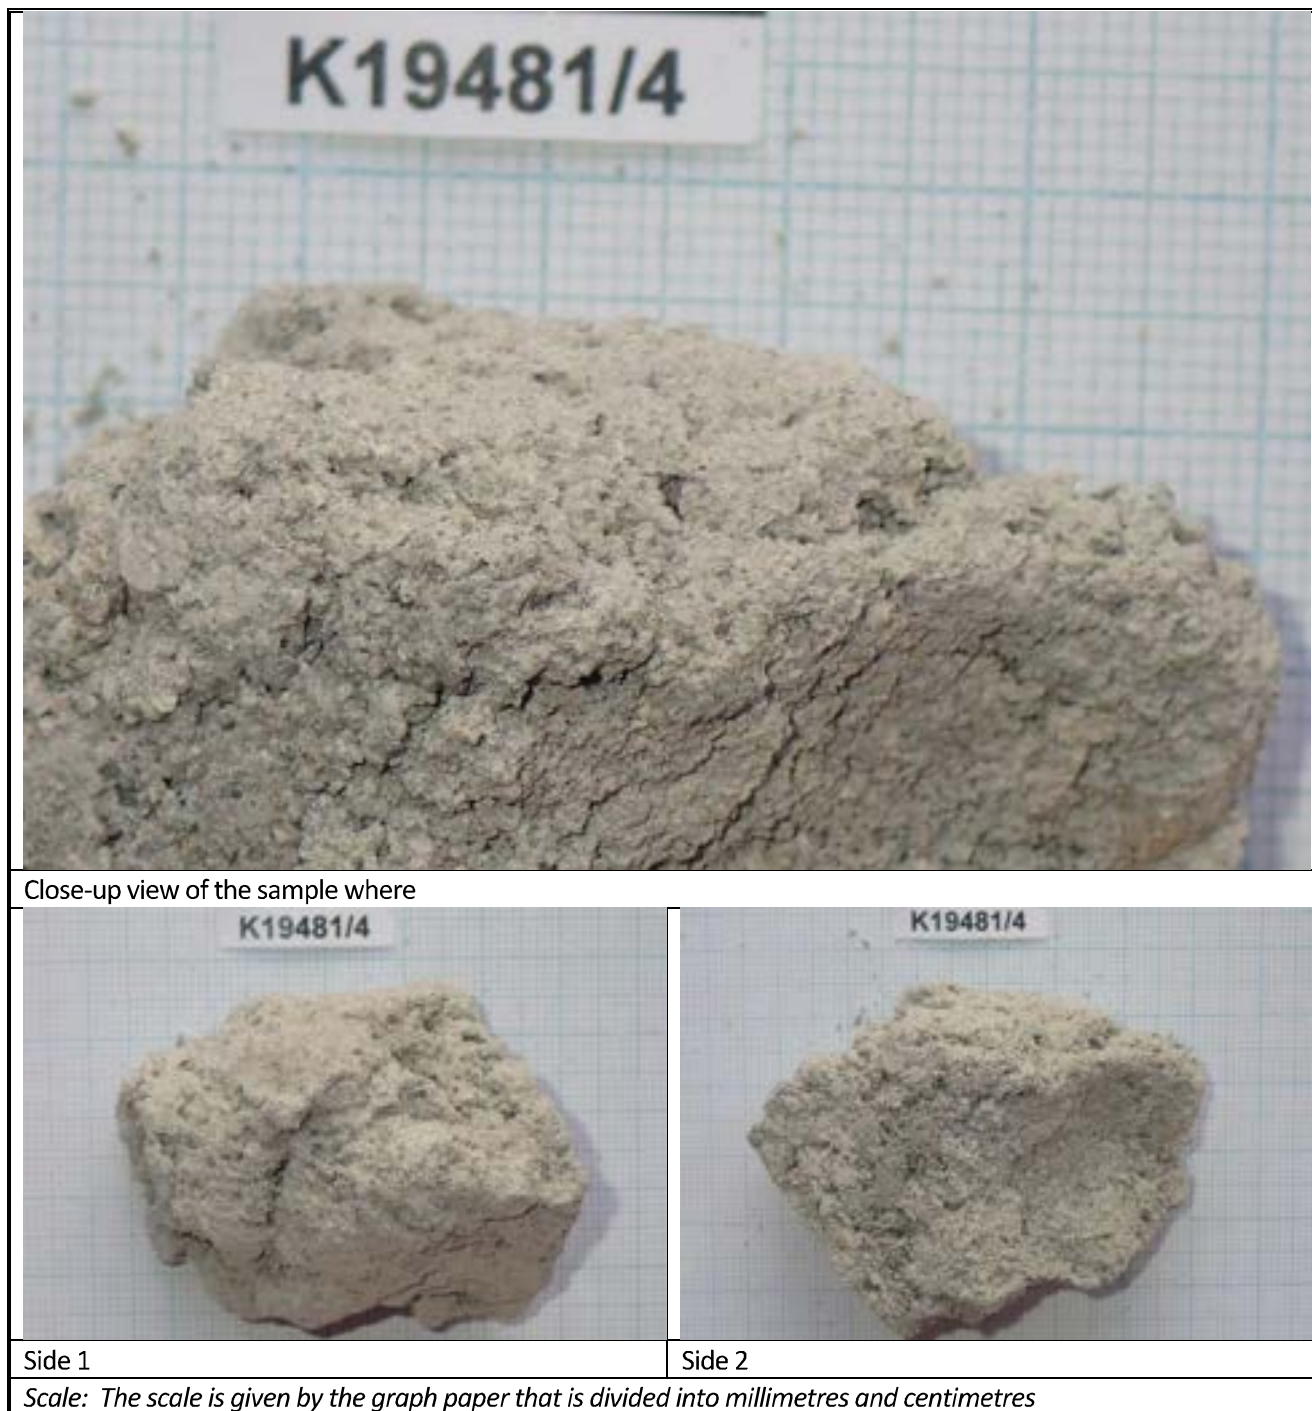
Figure B4

Sample K19481/4 (Outer leaf, Core 12)

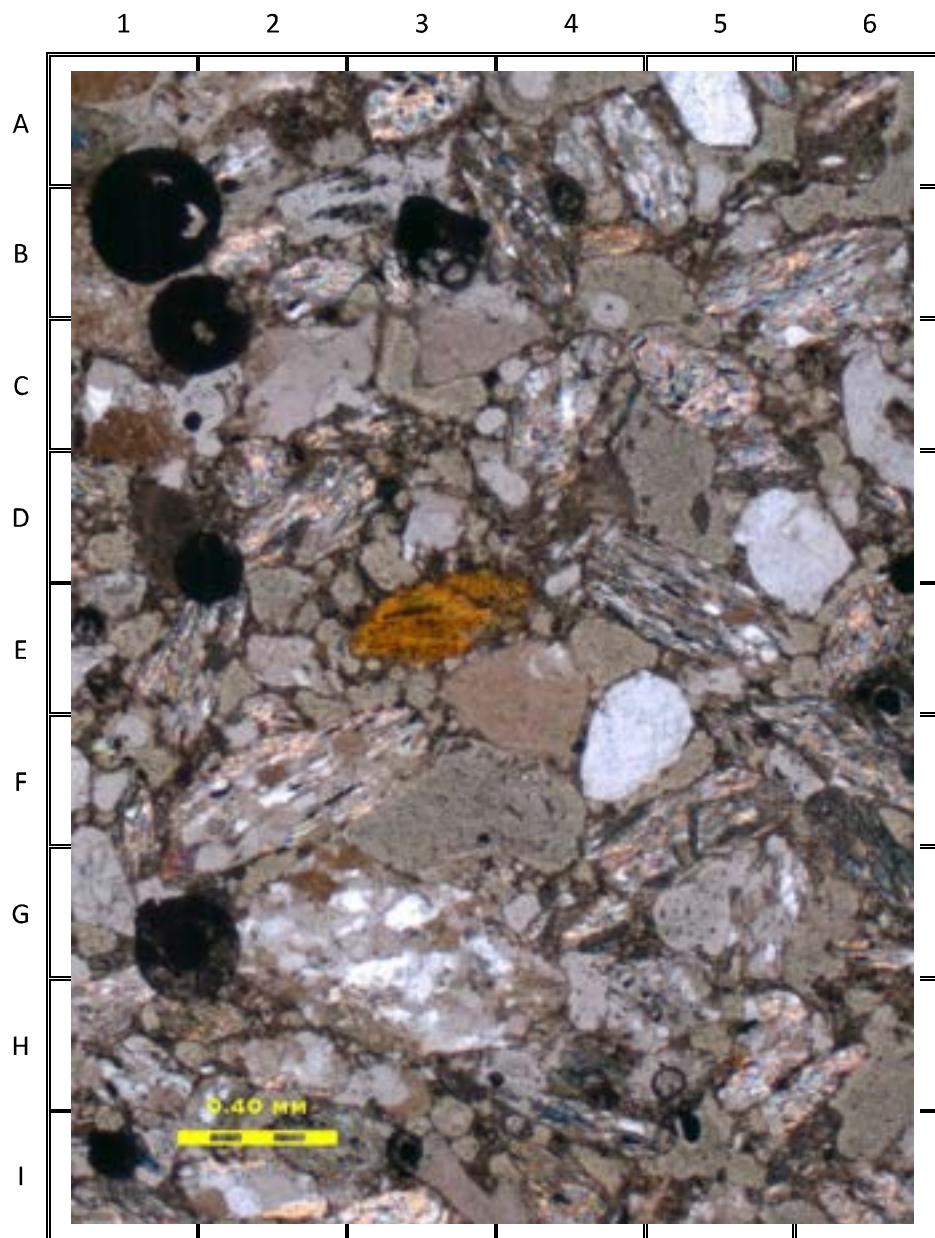
Sample K19481/2 (Outer leaf, Core11, 1 of 2)

Thin section, oblique polars: Low magnification view of the thin section showing abundant schist sand particles, visible for example in B6 and F2 that are surrounded by a carbonated matrix containing Portland cement. There are abundant voids throughout the field of view that have taken in the green fluorescent resin used during sample preparation.

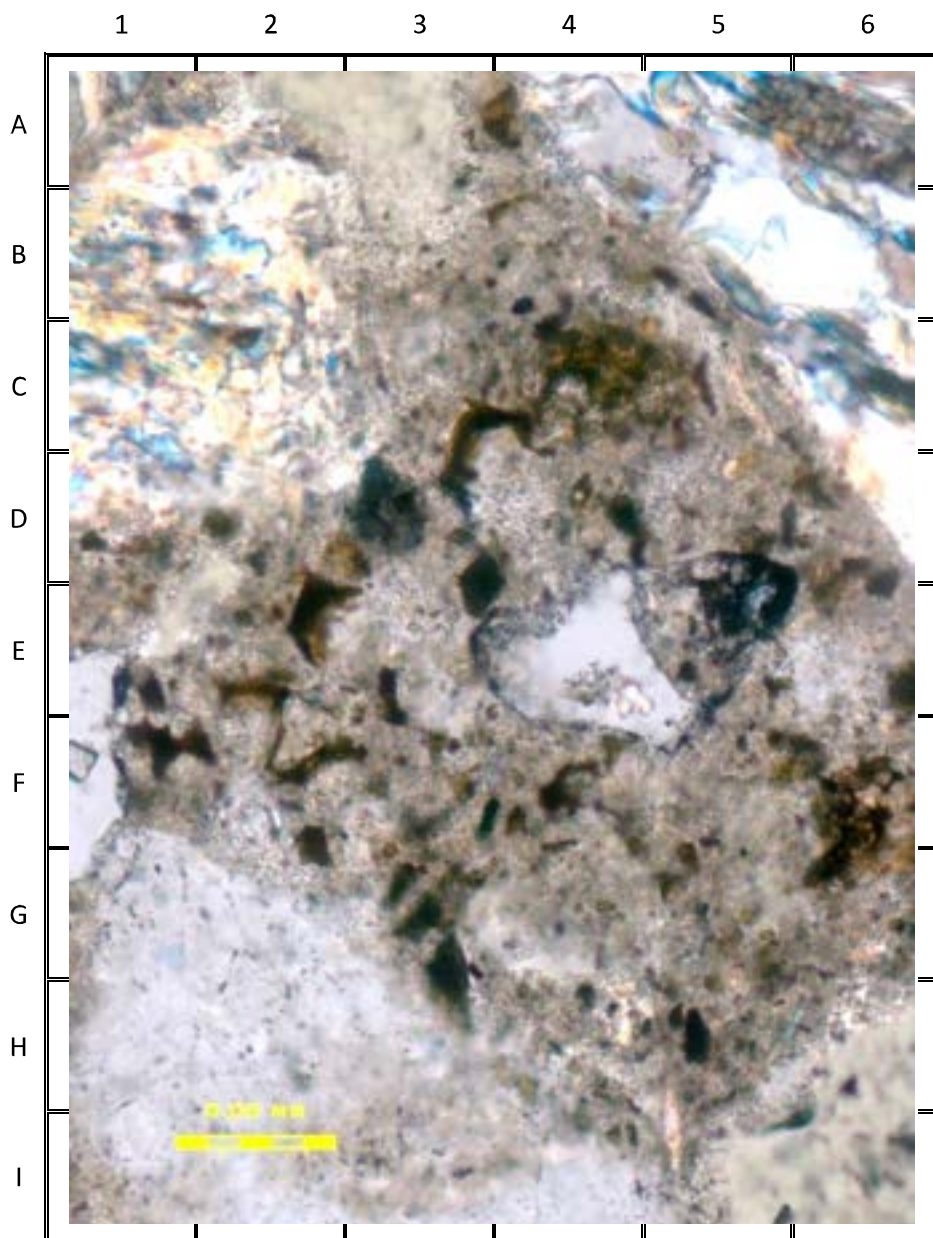
Figure C2

Sample K19481/2 (Outer leaf, Core11, 1 of 2)

Thin section, oblique polars: View showing the typical appearance of the mortar matrix with the outlines of carbonated and hydrated Portland cement grains visible for example in F1/2. Schist particles can be seen in B/C1 and A6. A quartz particle occurs in H1 and an empty void can be seen in I6.

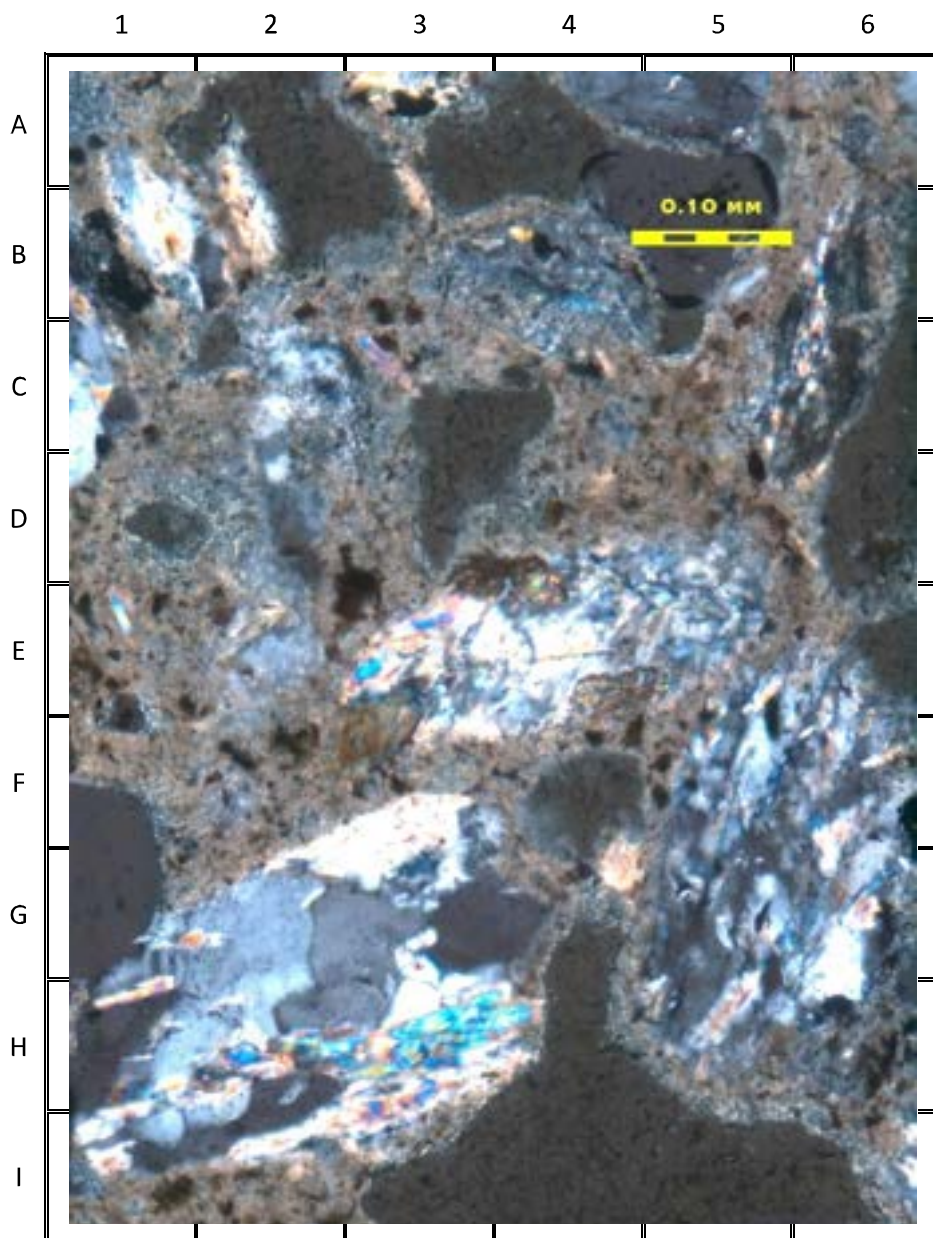
Figure C3

Sample K19481/2 (Outer leaf, Core11, 1 of 2)

Thin section, crossed polars: Areas of carbonated matrix containing the outlines of carbonated Portland cement grains can be seen for example in E1. Schist particles occur in H2/3 and G5/6. Empty voids can be seen for example in G1 and D6.

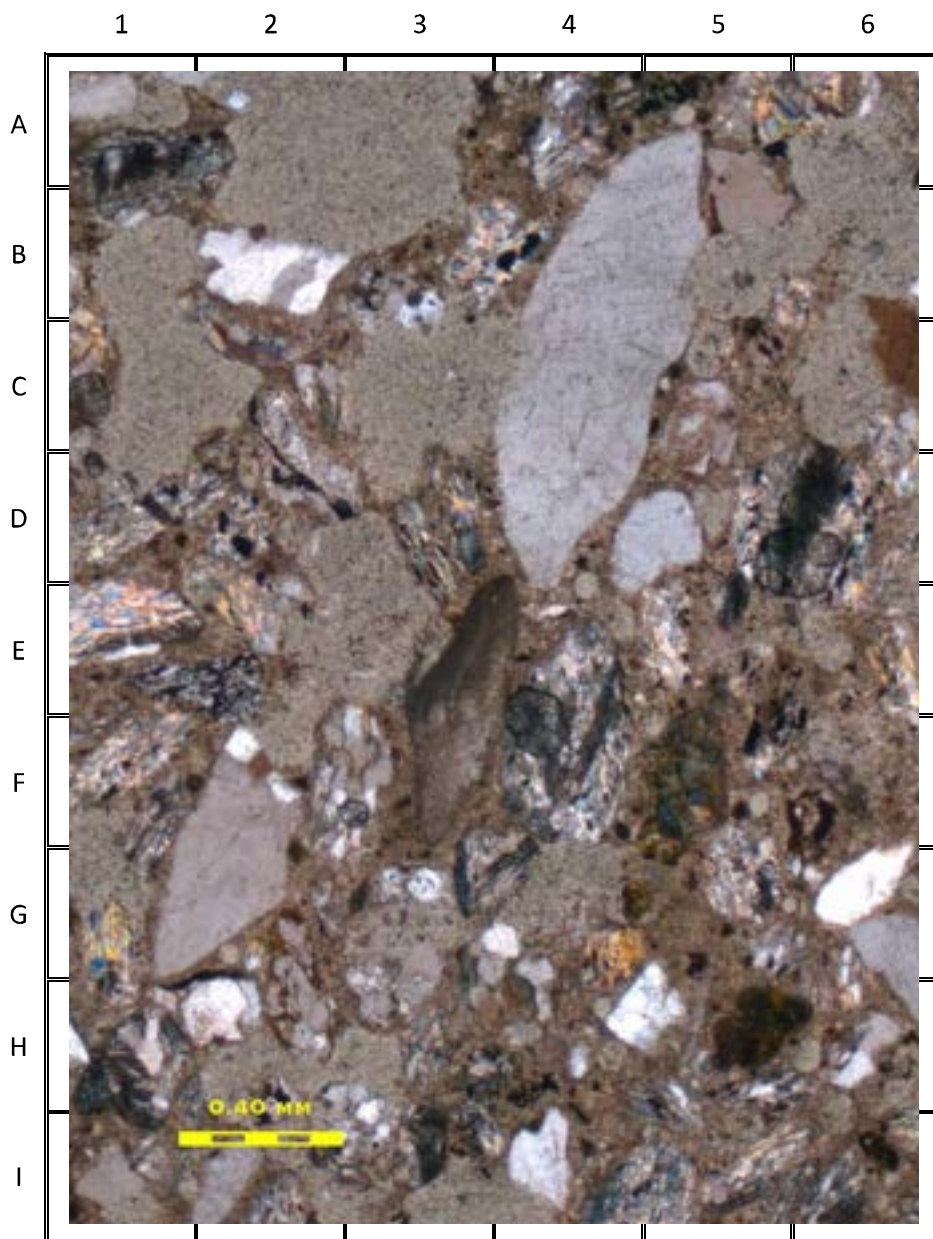
Figure C4

Sample K19481/5 (Inner leaf, East Elevation (South))

Thin section, oblique polars: Low magnification view of the thin section showing abundant schist sand particles, visible for example in E1 and F1 that are surrounded by a carbonated matrix containing Portland cement. Quartz particles can be seen in C4 and G2. There are abundant voids throughout the field of view that have taken in the green fluorescent resin used during sample preparation.

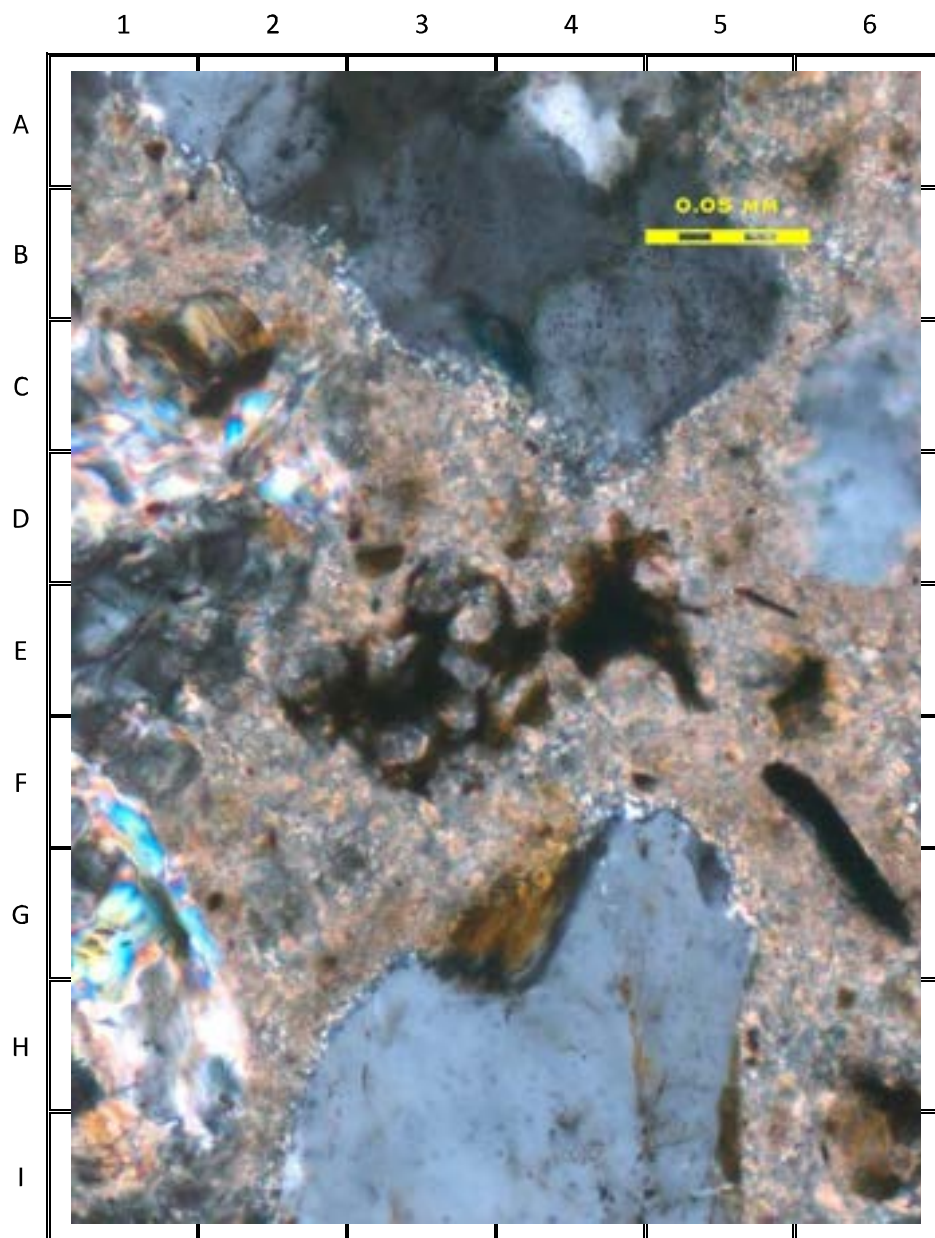
Figure C5

Sample K19481/5 (Inner leaf, East Elevation (South))

Thin section, oblique polars: View showing the typical appearance of the mortar matrix with the outlines of carbonated and hydrated Portland cement grains visible for example in E3. Schist particles can be seen in D1 and H1. Quartz particles occur in B3 and H/13.

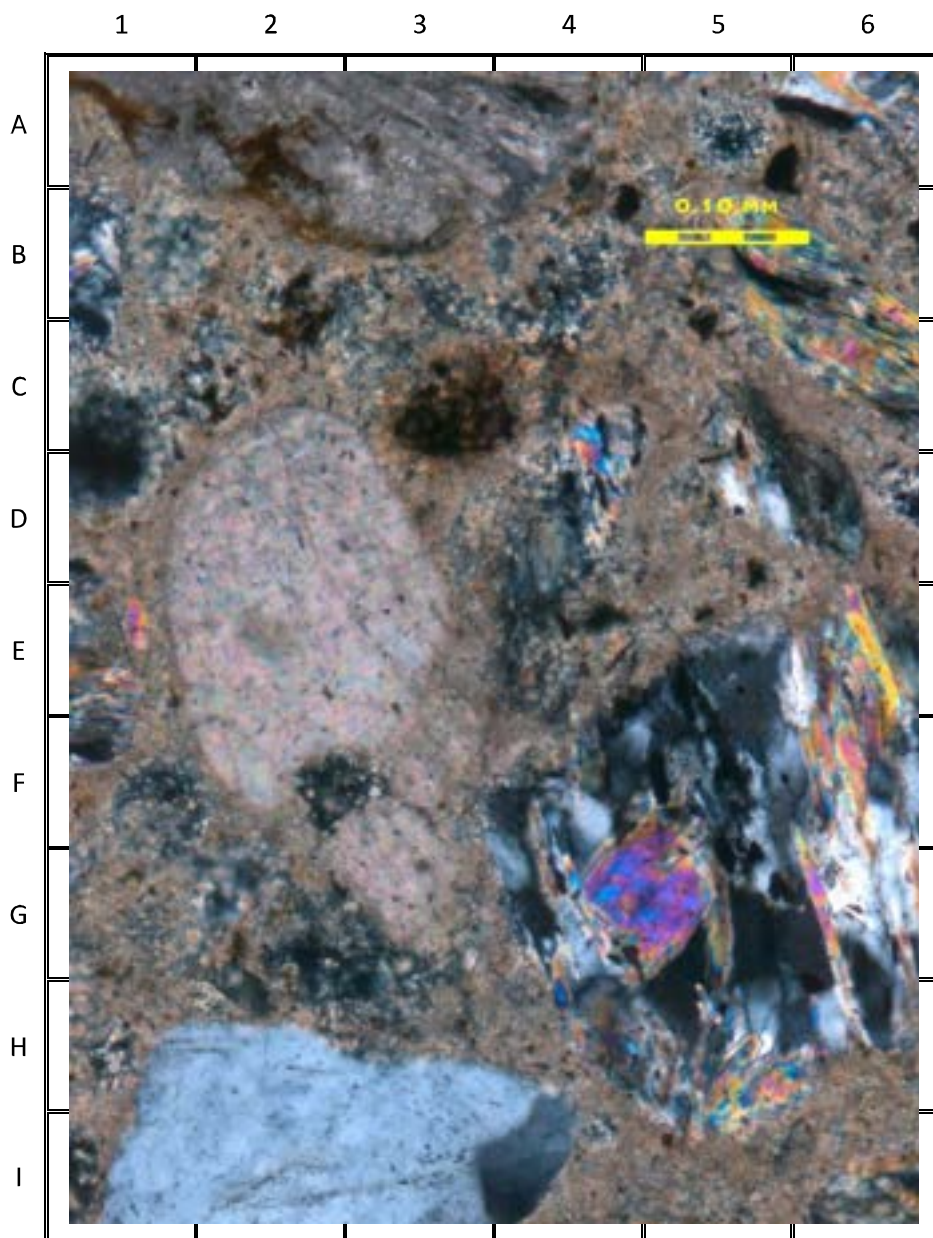
Figure C6

Sample K19481/5 (Inner leaf, East Elevation (South))

Thin section, crossed polars: A shell particle occurs in E2. Schist particles can be seen in G5/6 and A2/3. A quartz particle occurs in I2. The aggregate particles are surrounded by carbonated matrix with a fine-grained texture that can be seen for example in I5 and G1.
